South Jersey Transportation Planning Organization

2007 Road Safety Audit /scan

**Fire Road (CR 651)
Egg Harbor Township,
Atlantic County**

April 19, 2007

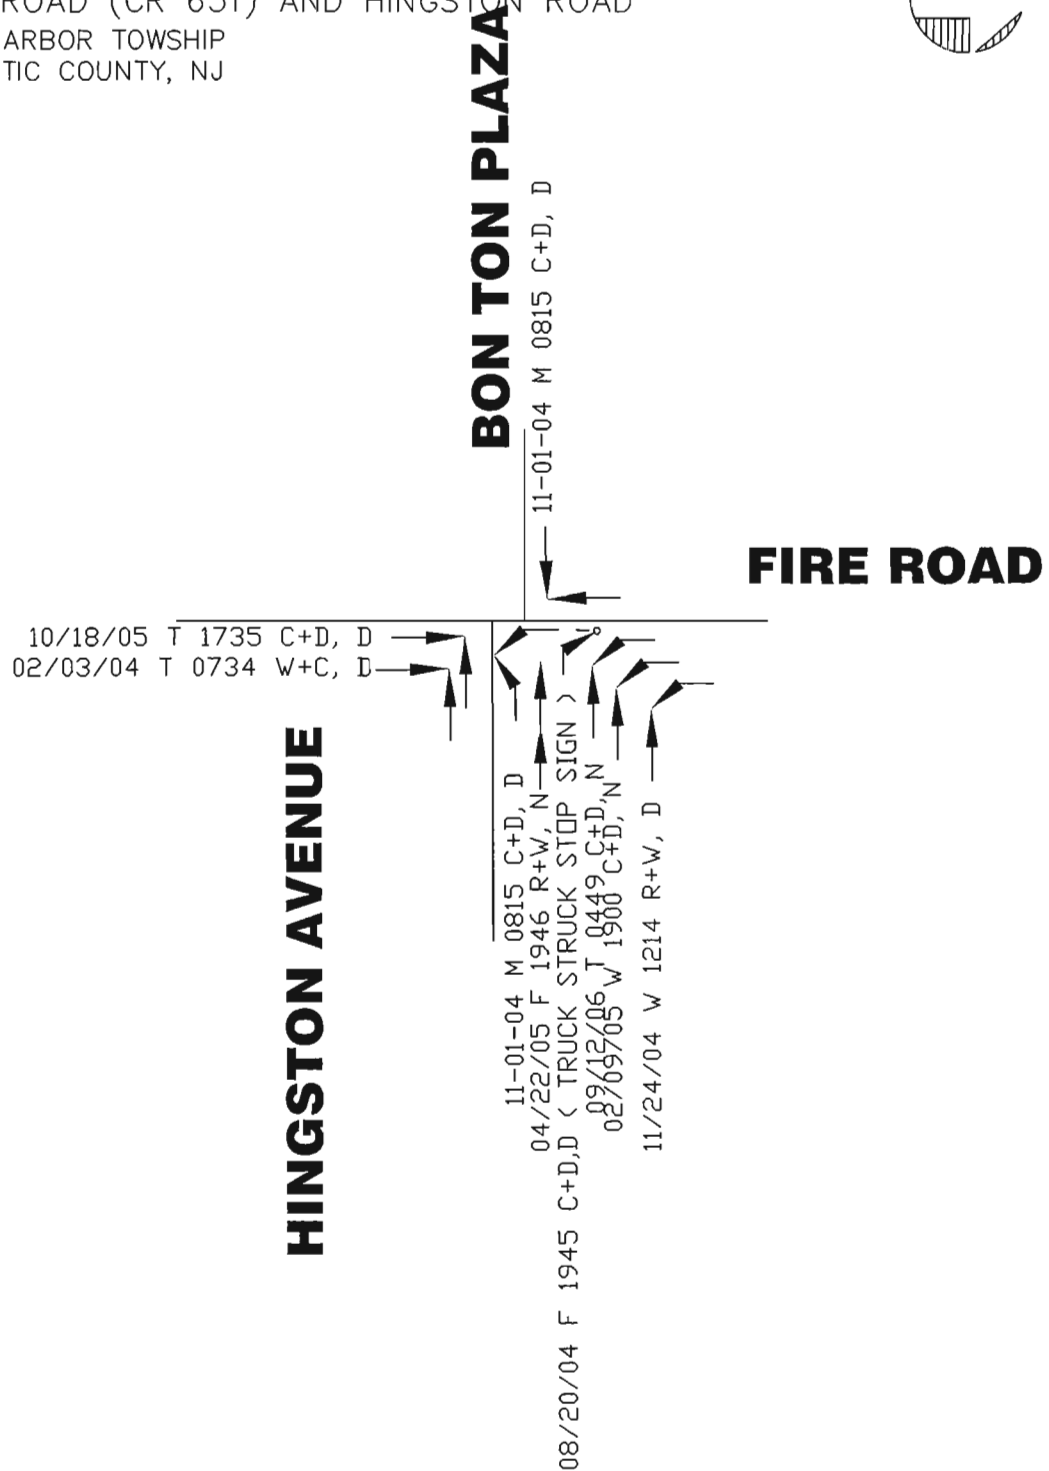
2003-2006 CRASH DIAGRAM

SAFETY ISSUE	REMEDIAL ACTION	LEVEL OF EFFORT REQUIRED			POTENTIAL SAFETY BENEFIT		
			LOW	MEDIUM	HIGH	LOW	MEDIUM	HIGH
39	Hingston Road - quite a bit of time was spent at the intersection. Traffic count was ordered but not yet received at the time of the audit. Crash data was ordered as a result of field observations made during the Scan portion of this study. Because the crash data was ordered and received after the audit, it was not included in the crash summary for the road but was plotted separately and is described here. For the three-year period including 2004, 2005 through October of 2006, there was a total of nine crashes at the intersection. Four right-angle type crashes, one same direction type crash, one fixed-object type crash and three crashes involving vehicles turning left from Fire Road striking vehicles waiting at the stop line on Hingston Road. The traffic count taken at the intersection showed that the Hingston Road approach experienced a peak hour volume of 286 vehicles with an average hourly volume of 249 vehicles. Two-way traffic on Fire Road averaged 1432 vehicles/hour for the same 8-hour period. The intersection easily exceeds Warrant 1 of the MUTCD for signalization. While meeting a warrant alone is not a reason to signalize an intersection, the operational conditions observed at the intersection during the audit also suggest that the intersection should be considered for signalization.	Consideration should be given to installing a traffic signal at the intersection and re-aligning the driveway to the Bon-Ton Plaza opposite Hingston Road to be included in the signalization. An alternative would be to re-align the road opposite the driveway or some combination of re-aligning both the driveway and the road.			X			X
