South Jersey Transportation Planning Organization

2011-12 Road Safety Assessment

**Brigantine Avenue (CR 638)
Brigantine City
Atlantic County**

April 20, 2012

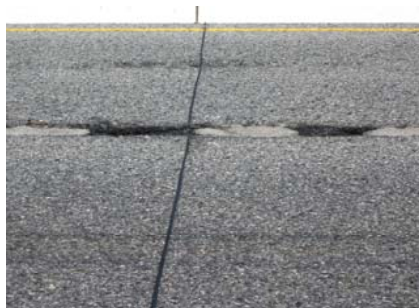
PICTURE #1

SAFETY ISSUE		REMEDIAL ACTION	LEVEL OF EFFORT REQUIRED			POTENTIAL SAFETY BENEFIT		
			LOW	MEDIUM	HIGH	LOW	MEDIUM	HIGH
1	General comment- the pavement markings along the entire roadway are worn and need to be re-painted	Re-install pavement markings.		X				X
2	General comment-many of the RPM's along the entire length of the road are damaged or missing.	Inventory damaged or missing RPM's and replace as needed.			X		X	
3	General comment-roadway surface is deteriorated along the lane line marking (old concrete joint) along the section of road between the southern terminus of the road and Harbor Beach Boulevard. (Picture #1)	Consideration be given to evaluate the pavement condition and making the necessary repairs to the pavement.			X		X

CRACKS IN ROADWAY
(NORTHBOUND)

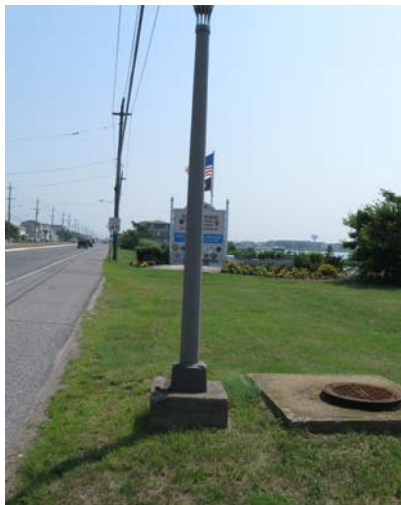
PICTURE #2

SAFETY ISSUE		REMEDIAL ACTION	LEVEL OF EFFORT REQUIRED			POTENTIAL SAFETY BENEFIT		
			LOW	MEDIUM	HIGH	LOW	MEDIUM	HIGH
9	Northbound side- approximately ¼ mile north of bridge- sewer vent foundation with concrete base approximately 12 inches above grade. (Picture #2)	Consideration should be given to grading the surrounding area to reduce the exposed height of the concrete base	X			X		
10	Northbound side- Brigantine garden club plate mounted on boulder by “SLOW DOWN WHATS YOUR HURRY YOU ARE ALREADY HERE” sign. Boulder is a possible road side hazard. (Picture #3)	Consideration should be given to moving the boulder to the far side of the plantings farther from the roadway.	X			X		
11	Northbound side-there are several left turn slots in the grass median. None have signs or pavement markings. (Picture #4)	Consideration should be given to installing the appropriate signs and pavement markings for the left turn slots.	X				X

SEWER VENT, ¼ MILE NB BRIGANTINE BLVD

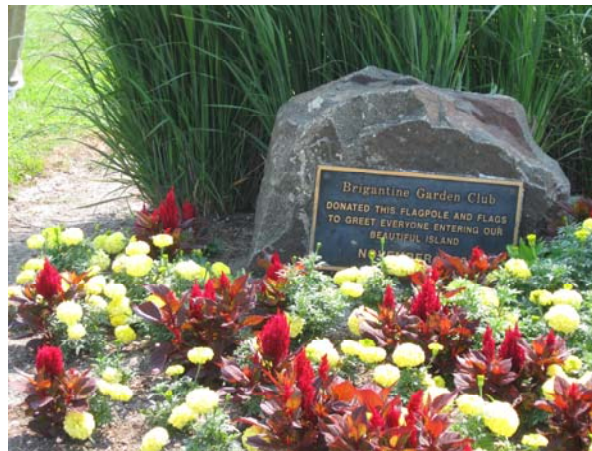
PICTURE #3

BRIGANTINE GARDEN CLUB

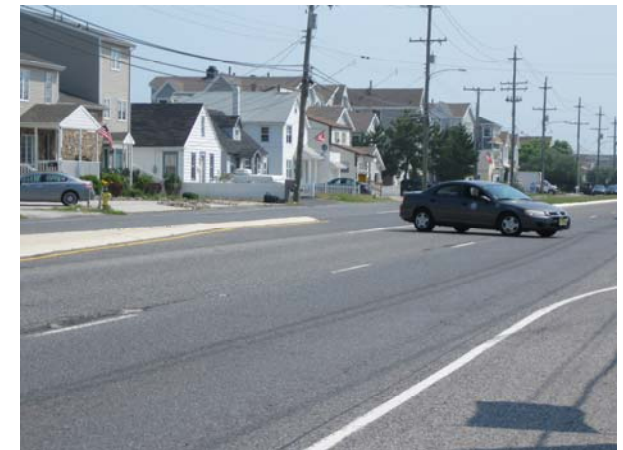
PICTURE #4

FIRST U-TURN SLOT NORTH OF THE BRIDGE

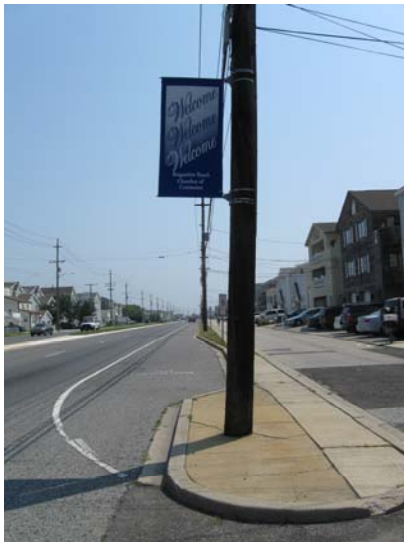
PICTURE #5

SAFETY ISSUE		REMEDIAL ACTION	LEVEL OF EFFORT REQUIRED			POTENTIAL SAFETY BENEFIT		
			LOW	MEDIUM	HIGH	LOW	MEDIUM	HIGH
12	Northbound side- There is a utility pole (#A-2599) on the divider at the beginning of the service road. (Picture #5)	Consideration should be given to installing an object marker in front of the pole.	X			X		
13	Northbound side-Stop signs and stop lines facing the service road are worn.	Consideration should be given to contacting the City regarding replacing the signs and re-installing the stop lines.	X			X		
14	Northbound side- there are no stop signs controlling access to Brigantine Boulevard (CR 638) from the service road (traffic turning left from the service road then turning right onto Brigantine Boulevard (CR 638)).	Consideration should be given to reviewing the access control to determine the appropriate type of control.	X			X

ISLAND, BEGINNING OF SERVICE
ROAD, NB

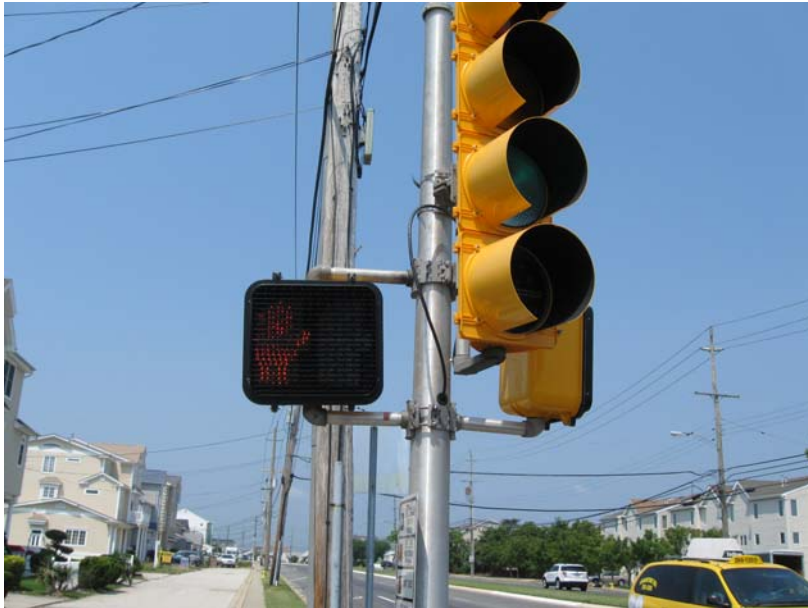
PICTURE #6

SAFETY ISSUE		REMEDIAL ACTION	LEVEL OF EFFORT REQUIRED			POTENTIAL SAFETY BENEFIT		
			LOW	MEDIUM	HIGH	LOW	MEDIUM	HIGH
17	Harbor Beach Boulevard Signalized Intersection: Pedestrian signal indications and four section pole mounted vehicular indication installed on the signal pole on the southeast corner of the intersection are installed lower then the required 8' height. (Picture #6)	Reinstall indications at appropriate height.	X			X

SOUTH EAST CORNER AT HARBOR
BEACH BOULEVARD

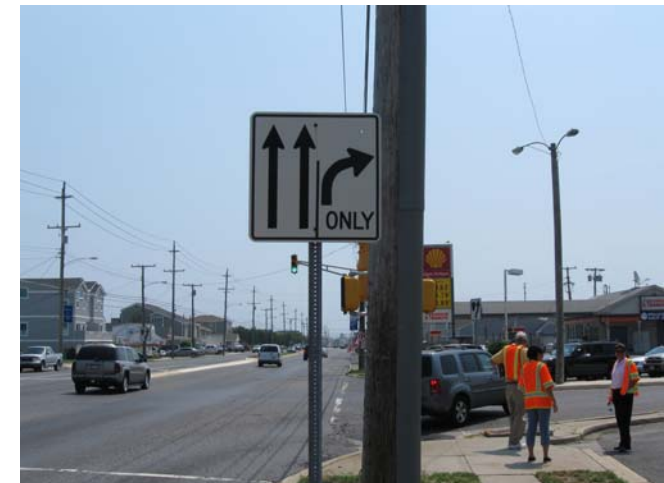
PICTURE #8
LANE USE
CONTROL
SIGN, NB
VICINITY OF
STOP LINE

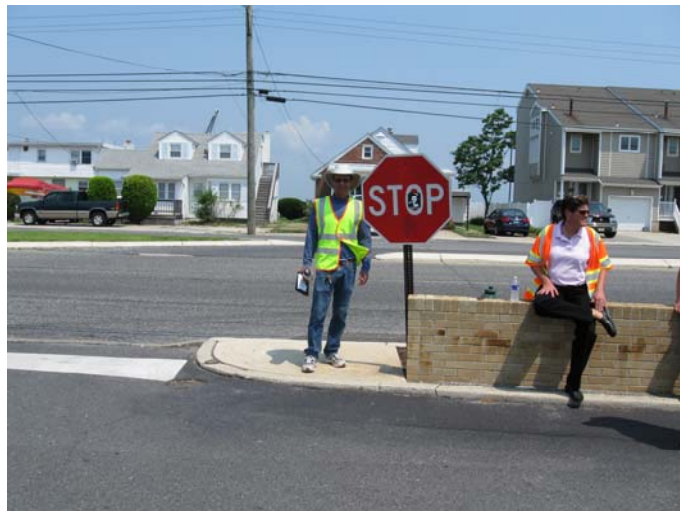
PICTURE #9

SAFETY ISSUE		REMEDIAL ACTION	LEVEL OF EFFORT REQUIRED			POTENTIAL SAFETY BENEFIT		
			LOW	MEDIUM	HIGH	LOW	MEDIUM	HIGH
21	Northbound side-northerly most driveway to Wawa shared with shopping center. Driveway is located opposite left turn slot for SB Brigantine Boulevard (CR 638). Existing Stop sign on driveway is worn and installed only 3' above the ground. (Picture #9)	Install new sign at appropriate height. Consideration be given to installing additional signs at the location to control the access onto Brigantine Boulevard (CR 638)	X			X		
22	Northbound side-right lane ends symbol warning sign located in the vicinity of Sun National Bank is worn and damaged	Replace with new sign.	X			X		
23	Northbound side- southern most driveway from Sun National Bank "DO NOT ENTER" sign is worn and installed parallel to driveway.	Install new sign correctly orientated to traffic. Consideration be given to installing a "ONE WAY" sign at the driveway.	X			X

EXIT STOP
SIGN AT
NORTH SIDE
EXIT OF
WAWA

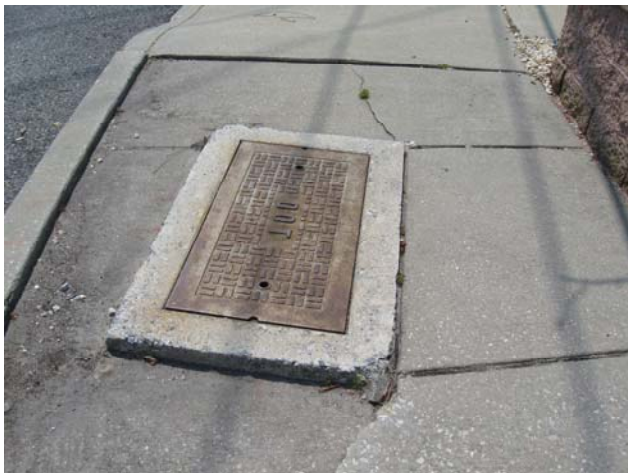
PICTURE #10

SAFETY ISSUE		REMEDIAL ACTION	LEVEL OF EFFORT REQUIRED			POTENTIAL SAFETY BENEFIT		
			LOW	MEDIUM	HIGH	LOW	MEDIUM	HIGH
24	Northbound side- at access road just north of Sun National Bank- “REDUCE SPEED AHEAD” sign is worn and on a non-break away post. County considers sign unnecessary. There is no “ONE WAY” sign on the center median facing the driveway. STOP sign on driveway is undersized.	Remove sign and post. Install “ONE WAY” sign. Replace STOP sign with new 30” x 30” sign.	X			X		
25	Northbound side – approaching S.38 th Street existing “RIGHT LANE MUST TURN RIGHT” sign at stop line. No advance sign.	Install advance “RIGHT LANE MUST TURN RIGHT” sign.	X			X		
26	S.38th Street Signalized Intersection: Southeast corner- two junction boxes are possible tripping hazard. (Picture #10)	Consideration be given to taking the appropriate action to eliminate the possible tripping hazard.		X			X

JUNCTION BOX, SOUTH EAST CORNER OF
BRIGANTINE BLVD & S. 38TH STREET

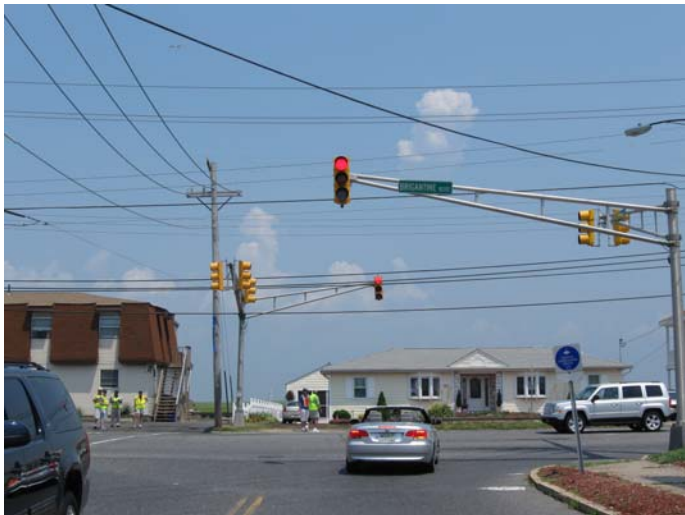
PICTURE #11

SAFETY ISSUE		REMEDIAL ACTION	LEVEL OF EFFORT REQUIRED			POTENTIAL SAFETY BENEFIT		
			LOW	MEDIUM	HIGH	LOW	MEDIUM	HIGH
26	S.38th Street Signalized Intersection: Southeast corner-two vehicular indications are being used to control pedestrian movements.	Consideration be given to installing pedestrian indications at the intersection.			X		X	
	The County had requested that back-plates be installed at Harbor Beach Boulevard intersection to increase signal visibility. The team concurs with this comment.	If back-plates are installed at Harbor Beach Boulevard intersection, consideration should be given to also installing them at this intersection.		X			X	
	Signals facing the S.38 th Street approach appear not to have the required 8' spread between the primary signal indications. The submitted sign plan has the 8 foot spread. (Picture #11)	Investigate discrepancy between plan and field observations to ensure 8 foot spread is provided.	X			X

SIGNAL ALIGNMENT AT BRIGANTINE
BLVD & S.38TH STREET

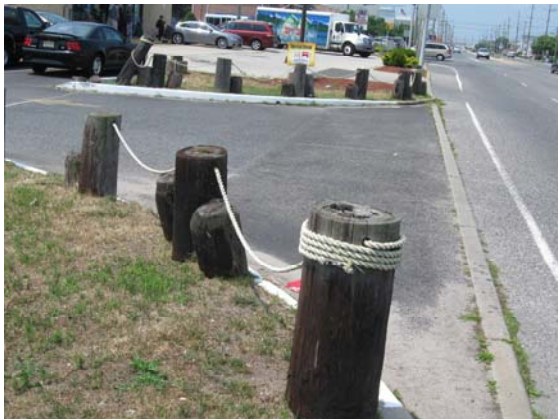
PICTURE #12

SAFETY ISSUE		REMEDIAL ACTION	LEVEL OF EFFORT REQUIRED			POTENTIAL SAFETY BENEFIT		
			LOW	MEDIUM	HIGH	LOW	MEDIUM	HIGH
28	Northbound side- Steakhouse 38 restaurant driveway has post and rope fence almost to curb forcing pedestrians into roadway to get around it. (Picture #12)	Contact property owner to remove part of fence from pedestrian path. It may be installed on public right-of-way.		X			X	
29	Northbound side- At S. 37 th Street-“STOP” sign is worn and undersized.	Replace with new 30” x 30” sign.	X			X		
30	Northbound side- “20 MPH” advisory speed plate installed below circle sign is worn.	Replace with new advisory plate.	X			X		
31	Circle at S. 34 th Street- many deficiencies noted at the circle including the need to reduce the pavement area and pedestrian access to the circle. Scope of study needed to determine improvements beyond the scope of this project. (Picture #13)	Consideration be given to initiating a project to evaluate long term improvements to the circle.			X			X

ENTRANCE TO
STEAKHOUSE, WOOD
POSTS ON BOTH
SIDES OF DRIVEWAY

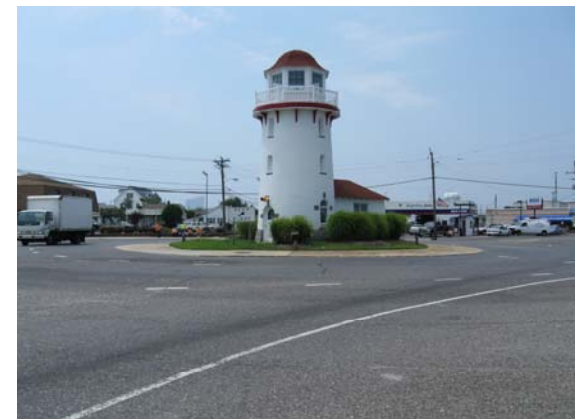
PICTURE #13

LIGHT HOUSE
AT THE
TRAFFIC
CIRCLE

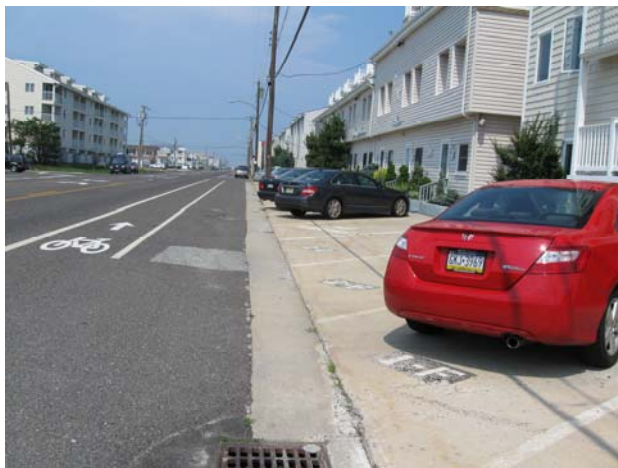
PICTURE #14

SAFETY ISSUE		REMEDIAL ACTION	LEVEL OF EFFORT REQUIRED			POTENTIAL SAFETY BENEFIT		
			LOW	MEDIUM	HIGH	LOW	MEDIUM	HIGH
50	Northbound side- between N.4 th and N.5 th Streets- angle parking in front of businesses forces pedestrians to walk on shoulder of road. (Picture #14)	Consideration be given to investigating alternatives to the angle parking.		X			X	
51	Southbound side- vicinity of MP 0.00- substandard guide rail.	Review need for guide rail. If it is to be retained upgrade to current standards.		X			X	
52	Southbound side- vicinity of MP 0.00- no reflectors on utility poles.	Consideration be given to installing reflectors on utility poles.	X				X	
53	Southbound side- vicinity of MP 0.00- R (NJ) 7-4 sign (No Parking) sign worn.	Replace with new sign.	X			X		
54	Southbound side- vicinity of #4821- safety edge needs re-paving.	Re-pave safety edge		X		X		
55	Southbound side- vicinity of #4805- vacant sign post.	Remove sign post.	X			X

PARKING AT HOTEL,
NORTHBOUND AT N.4TH STREET

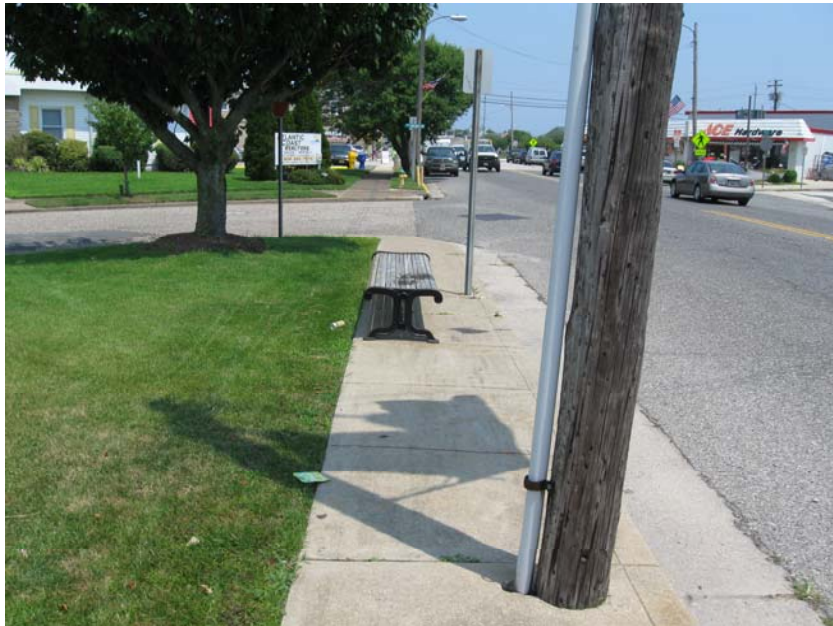
PICTURE #15

SAFETY ISSUE		REMEDIAL ACTION	LEVEL OF EFFORT REQUIRED			POTENTIAL SAFETY BENEFIT		
			LOW	MEDIUM	HIGH	LOW	MEDIUM	HIGH
83	Southbound side at S.27 th street- signs obstructed by trees.	Trim trees to remove obstructions.	X			X		
84	Southbound side-bench for bus stop located far from bus stop.	Move bench closer to bus stop.	X			X		
85	Southbound side- vicinity of S.34 th Street- circle ahead warning sign is worn.	Replace with new sign.	X			X		
86	Southbound side at Revere- no painted crosswalks at intersection, no painted stop line, benches in sidewalk area. (Picture #15)	Consideration be given to installing crosswalks at the intersection as well as a stop line. Benches be relocated out of the sidewalk area.	X			X

BENCHES ON THE
SIDEWALK AT
BRIGANTINE BLVD. &
REVERE BLVD.
