South Jersey Transportation Planning Organization

2011-12 Road Safety Assessment

**Wildwood Traffic Signals
North Wildwood
Wildwood City
Cape May County**

April 20, 2012

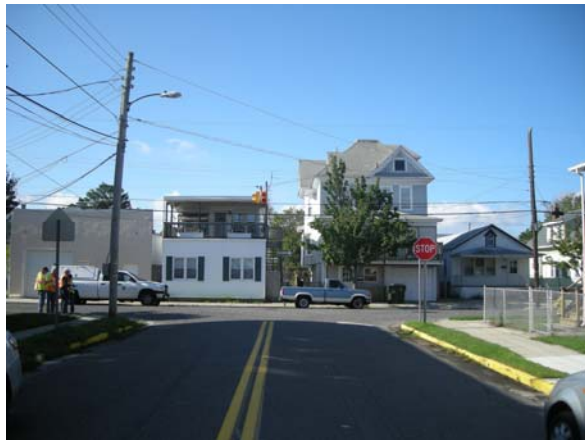
PICTURE 1:
MAPLE AVENUE & NEW YORK AVENUE

SAFETY ISSUE		REMEDIAL ACTION	LEVEL OF EFFORT REQUIRED			POTENTIAL SAFETY BENEFIT		
			LOW	MEDIUM	HIGH	LOW	MEDIUM	HIGH
1. NEW YORK AVENUE AND MAPLE AVENUE								
1-1	General comment- this is a “T” type intersection with Maple Avenue extending in the east-west direction forming the top of the “T” and New York Avenue intersecting the Maple Avenue northerly curb line forming the stem of the “T”. Maple Avenue is one way westbound. The intersection is stop sign controlled with the stop sign facing the New York Avenue approach to the intersection. (Picture 1)							
1-2	The stop control is supplemented by a wire span intersection control beacon suspended from wood poles. The beacon has one two section head facing the Maple Avenue approach that flashes yellow and one facing the New York Avenue approach that flashes red. The signal appears to have over head electrical service. Signal equipment is old and as stated above suspended from wooden poles.	Replace existing installation with entire new mast-arm installation.			X	X

1-3	It appears that statutory parking prohibitions are not enforced at the intersection limiting sight distance.	Statutory parking prohibitions be enforced at the intersection.	X				X	
1-4	There are handicap ramps on the northeast and northwest corners of the intersection but they do not appear to be ADA compatible	When road work is done at the intersection consideration be given to installing ADA compatible handicap ramps at the intersection.		X		X		
1-5	There are inlets grates on the northeast and northwest corners that are not bicycle safe. (Picture 2)	Consideration be given to installing bicycle safe inlet grates at the intersection.	X			X		
1-6	“STOP” sign on the New York Avenue approach is worn.	Replace with new sign.	X			X

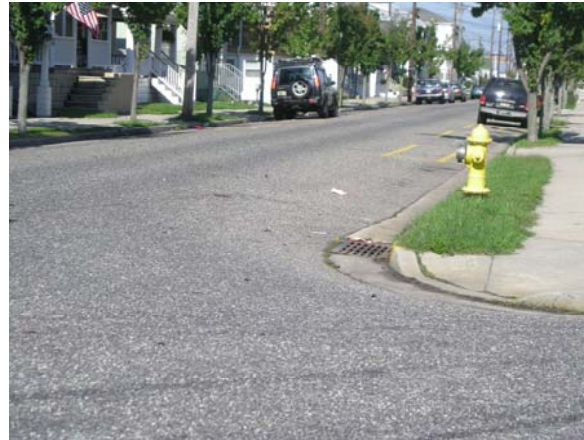
SAFETY ISSUE		REMEDIAL ACTION	LEVEL OF EFFORT REQUIRED			POTENTIAL SAFETY BENEFIT		
			LOW	MEDIUM	HIGH	LOW	MEDIUM	HIGH
1-7	County made comment that “DO NOT ENTER” signs may be needed at intersection to prevent New York Avenue traffic from mistakenly turning left onto Maple Avenue.	Install “DO NOT ENTER” signs at intersection.	X			X		
1-8	The existing “ONE WAY” sign at the intersection is worn. (Picture 3)	Replace with new sign.	X			X

PICTURE 2:
INLET GRATE

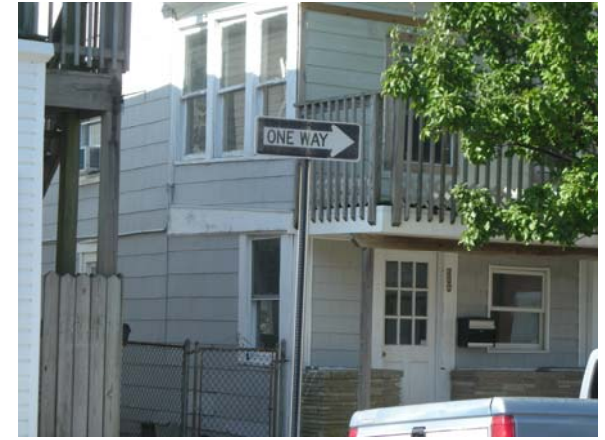
PICTURE 3:
WORN “ONE WAY” SIGN

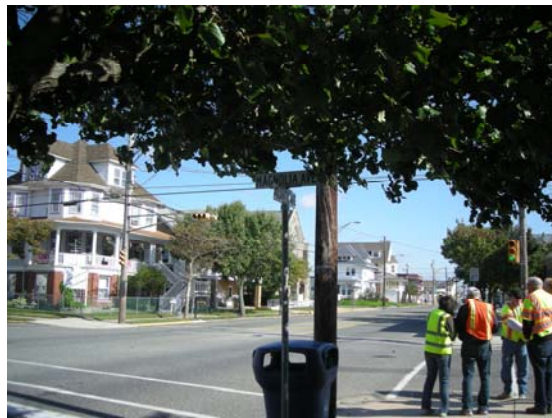
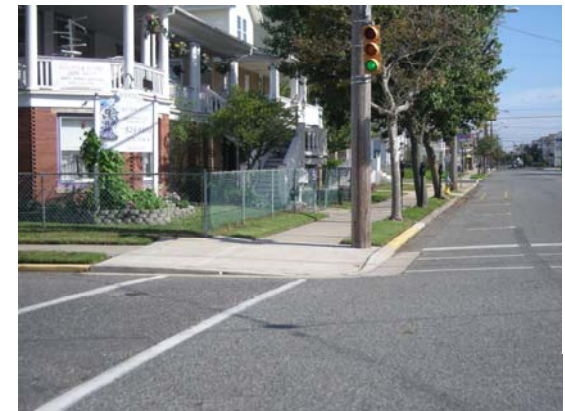
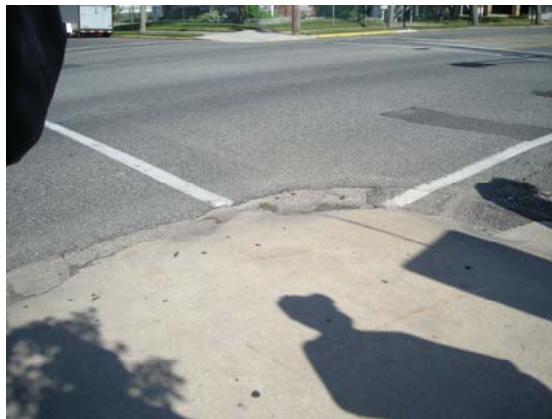
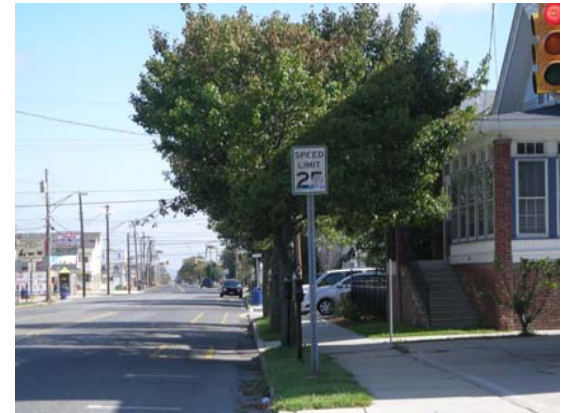
**PICTURES 7, 8, 9 & 10:
ATLANTIC AVENUE AND MAGNOLIA AVENUE**

3. ATLANTIC AVENUE AND MAGNOLIA AVENUE							
3-1	General comment- this is a cross type intersection with Atlantic Avenue extending in the north-south direction and Magnolia Avenue extending in the east-west direction. Magnolia Avenue is one way westbound. The intersection is controlled by a fixed time traffic signal.						
3-2	The traffic signal design at this intersection consist of a near right far left over- the- road display to all approaches. Pole mounted vehicular indications are installed on three corners of the intersection which serve as indication for pedestrians. The over- the- roadway signals facing the westerly approach to the intersection has the potential to drawn motorist the wrong way on this one way approach .All of the signal equipment is old and mounted on wood poles. The intersections appears to operate off of the traffic controller located at Glenwood Avenue and Atlantic Avenue located approximately 250 feet south of this intersection The intersection has overhead electrical service.			X			X

3-3	There are handicap ramps on all of the corners of the intersection but they lack the detectable warning surface and may not be ADA compatible.		X		X		
3-4	There are no mast arm mounted street name signs at the intersection.	X			X

SAFETY ISSUE		REMEDIAL ACTION	LEVEL OF EFFORT REQUIRED			POTENTIAL SAFETY BENEFIT		
			LOW	MEDIUM	HIGH	LOW	MEDIUM	HIGH
3-5	There is no lane use control sign for the left turn slot on the Atlantic Avenue northbound approach to the intersection.	Install missing lane use control sign.	X			X		
3-6	The crosswalk across the Magnolia Avenue easterly approach does not line up with the handicap ramps.	Reinstall crosswalk to line up with handicap ramps.	X			X		
3-7	Northbound side just north of intersection "SPEED LIMIT 25" sign defaced.	Replace with new sign.	X			X

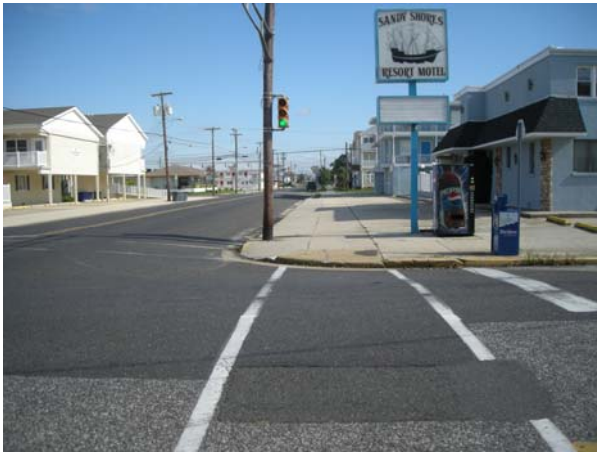
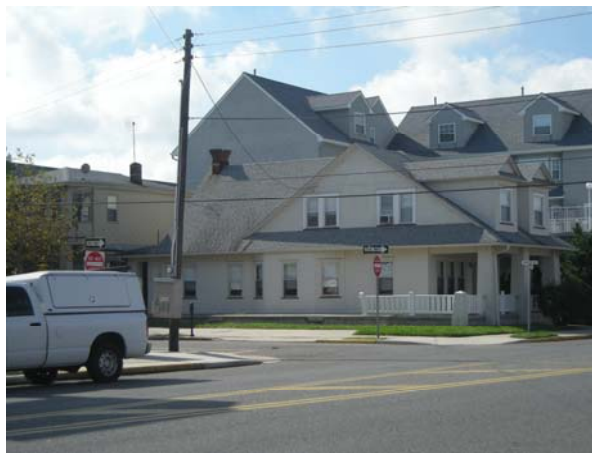
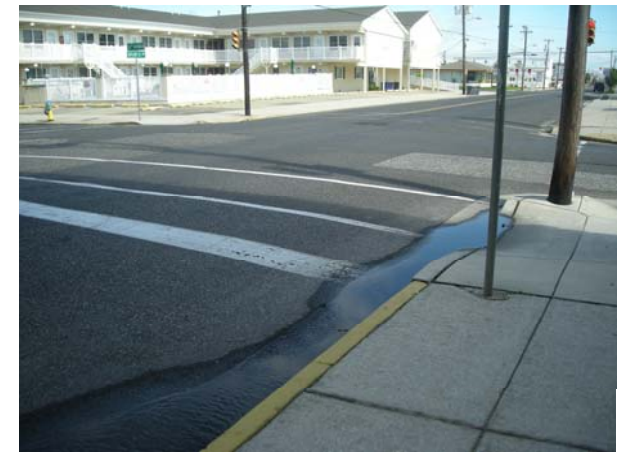
**PICTURES 11, 12 & 13:
ATLANTIC AVENUE AND 26TH STREET**

SAFETY ISSUE		REMEDIAL ACTION	LEVEL OF EFFORT REQUIRED			POTENTIAL SAFETY BENEFIT		
			LOW	MEDIUM	HIGH	LOW	MEDIUM	HIGH
4. ATLANTIC AVENUE AND 26 TH STREET								
4-1	General comment- this is a cross type intersection with Atlantic Avenue extending in the north-south direction and 26 th Street extending in the east-west direction. The intersection is controlled by a fixed time traffic signal.							
4-2	The traffic signal design at this intersection consists of a near right far left over- the- road display to all approaches. Pole mounted vehicular indications are installed on three corners of the intersection which serve as indications for pedestrians. No indication is readily visible to pedestrians crossing from the northeast to the northwest corner of the intersection. All of the signal equipment is old and mounted on wood poles. The signal controller for this intersection is located at Juniper Avenue approximately 200 feet south of this intersection. The intersection has overhead electrical service.	Consideration be given to replacing the entire signal installation with new aluminum poles and pedestrian walk-don't walk signals.			X			X

4-3	There are no mast arm mounted street name signs at the intersection.	Consideration be given to installing mast arm mounted street name signs.	X			X		
4-4	Crosswalk across the 26 th Street approaches does not align with the handicap ramps.	Re-install crosswalks to align with handicap ramp.	X			X		
4-5	There are handicap ramps on all of the corners of the intersection but they lack the detectable warning surface and may not be ADA compatible.	Consideration be given to installing detectable warning surfaces on the handicap ramps and verify ADA compatibility.		X		X		
4-6	Water was observed ponding along the southeast corner of the intersection.	Consideration be given to investigating what can be done to eliminate the ponding.			X	X

SAFETY ISSUE		REMEDIAL ACTION	LEVEL OF EFFORT REQUIRED			POTENTIAL SAFETY BENEFIT		
			LOW	MEDIUM	HIGH	LOW	MEDIUM	HIGH
4-7	Wood pole supporting the signal equipment on the southeast corner of the intersection is located on the radius of the curb and is leaning inward towards 26 th Street.	Consideration be given to investigating what can be done to eliminate or prevent more severe leaning of this pole.		X			X

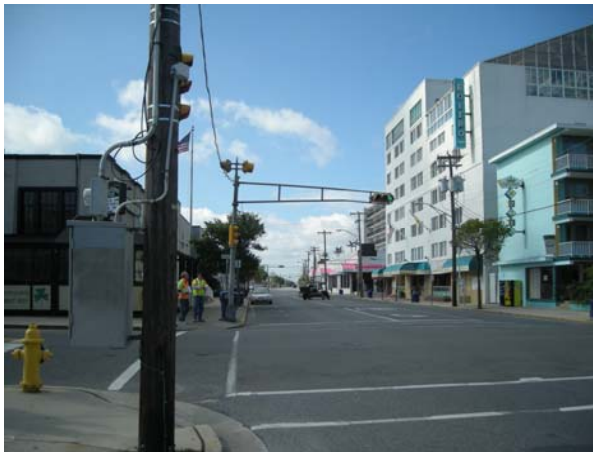
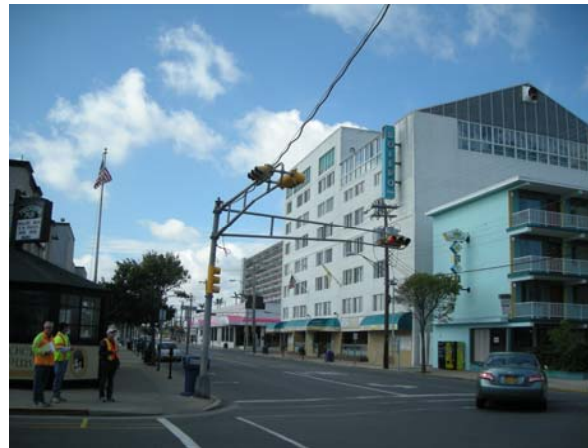
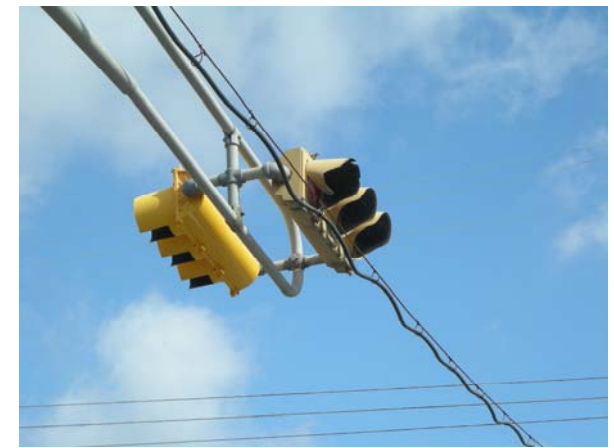
PICTURES 14, 15 & 16:
ATLANTIC AVENUE AND WILDWOOD AVENUE

SAFETY ISSUE		REMEDIAL ACTION	LEVEL OF EFFORT REQUIRED			POTENTIAL SAFETY BENEFIT		
			LOW	MEDIUM	HIGH	LOW	MEDIUM	HIGH
5. ATLANTIC AVENUE AND WILDWOOD AVENUE								
5-1	General comment- this is a cross type intersection with Atlantic Avenue extending in the north-south direction and Wildwood Avenue in the east-west direction. The intersection is controlled by a fixed time traffic signal.							
5-2	The traffic signal design at this intersection consists of a three pole layout with near right, far left over- the-road display to the Atlantic Avenue approaches to the intersection and a near left far right display to the Wildwood Avenue approaches to the intersection. There are two mast arms installed on a wood pole on the northwest corner of the intersection, a pole mounted signal mounted on a wood pole on the northeast corner of the intersection and two mast arms and a pole mounted indication installed on an aluminum pole on the southeast corner of the intersection. No indication is readily visible to pedestrians crossing from the northwest to the southwest corner of the intersection. All of the signal equipment is old. The aluminum pole is leaning as it appears the base has settled. The signal controller for this intersection is mounted on a wood pole on the northeast corner of the intersection. The intersection has overhead electrical service.	Consideration be given to replacing the entire signal installation with new aluminum poles and pedestrian walk-don't walk signals.			X			X

5-3	There are no mast arm mounted street name signs at the intersection.	Consideration be given to installing mast arm mounted street name signs.	X			X

SAFETY ISSUE		REMEDIAL ACTION	LEVEL OF EFFORT REQUIRED			POTENTIAL SAFETY BENEFIT		
			LOW	MEDIUM	HIGH	LOW	MEDIUM	HIGH
5-4	Crosswalks across the 26 th Street approaches do not align with the handicap ramps.	Re-install crosswalks to align with handicap ramps.	X			X		
5-5	There are handicap ramps on all of the corners of the intersection but two lack the detectable warning surface.	Consideration be given to installing detectable warning surfaces on the handicap ramps.	X			X		
5-6	Water was observed ponding along the southeast corner of the intersection.	Consideration be given to investigating what can be done to eliminate the ponding.			X	X		
5-7	There are left turn slots along both of the Atlantic Avenue approaches to the intersection but no lane use control signs.	Install the appropriate lane use control signs.	X			X

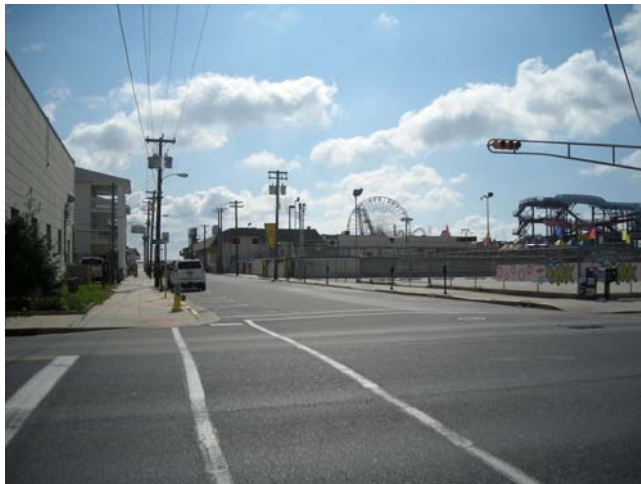
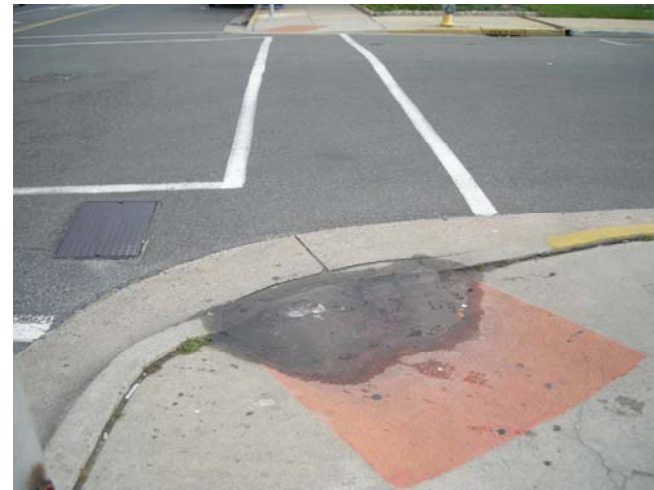
PICTURES 17 & 18:
ATLANTIC AVENUE AND OAK AVENUE

SAFETY ISSUE		REMEDIAL ACTION	LEVEL OF EFFORT REQUIRED			POTENTIAL SAFETY BENEFIT		
			LOW	MEDIUM	HIGH	LOW	MEDIUM	HIGH
6. ATLANTIC AVENUE AND OAK AVENUE								
6-1	General comment- this is a cross type intersection with Atlantic Avenue extending in the north-south direction and Oak Avenue in the east-west direction. The intersection is controlled by a fixed time traffic signal. The Oak Avenue easterly approach is one way eastbound.							
6-2	The traffic signal design at this intersection consists of a three pole layout with near right far left over- the-road display to the Atlantic Avenue approaches to the intersection and a near left far right display to the Wildwood Avenue approaches to the intersection. There are two mast arms and a pole mounted indication installed on a wood pole on the northwest corner of the intersection, a pole mounted signal mounted on a wood pole on the southwest corner of the intersection and two mast arms installed on an aluminum pole on the southeast corner of the intersection. No indications are readily visible to pedestrians crossing several crosswalks at the intersection. All of the signal equipment is old. The signal controller for this intersection is mounted on a wood pole on the northeast corner of the intersection. The intersection has overhead electrical service.	Consideration be given to replacing the entire signal installation with new aluminum poles and pedestrian walk-don't walk signals.			X			X

6-3	There are no mast arm mounted street name signs at the intersection.	Consideration be given to installing mast arm mounted street name signs.	X			X

SAFETY ISSUE		REMEDIAL ACTION	LEVEL OF EFFORT REQUIRED			POTENTIAL SAFETY BENEFIT		
			LOW	MEDIUM	HIGH	LOW	MEDIUM	HIGH
6-4	There are handicap ramps on all of the corners of the intersection but they lack the detectable warning surface and may not be ADA compatible. The curb across the handicap ramp on the northeast corner is raised creating a possible tripping hazard.	Consideration be given to installing detectable warning surfaces on the handicap ramps and verify ADA compatibility. Correct height of curb on the northeast corner to eliminate tripping hazard.		X		X		
6-5	There are left turn slots along both of the Atlantic Avenue approaches to the intersection but no lane use control signs.	Install the appropriate lane use control signs.	X			X		
6-6	There are no signs at the intersection indicating that the Oak Avenue easterly approach is one way eastbound.	Install appropriate one way signs at the intersection.	X				X

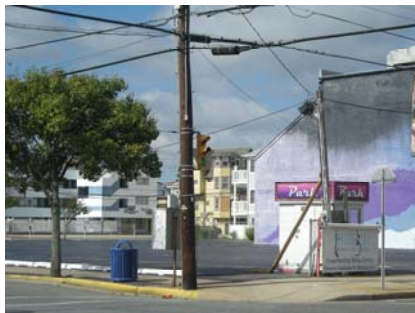
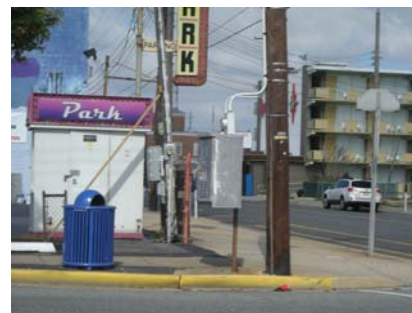
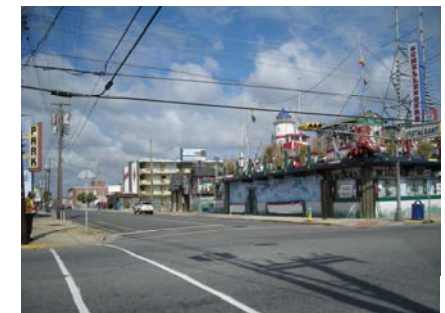
**PICTURES 19, 20 & 21:
ATLANTIC AVENUE AND
SCHELLENGER AVENUE**

SAFETY ISSUE		REMEDIAL ACTION	LEVEL OF EFFORT REQUIRED			POTENTIAL SAFETY BENEFIT		
			LOW	MEDIUM	HIGH	LOW	MEDIUM	HIGH
7. ATLANTIC AVENUE AND SCHELLENGER AVENUE								
7-1	General comment- this is a cross type intersection with Atlantic Avenue extending in the north-south direction and Schellenger Avenue in the east-west direction. The intersection is controlled by a fixed time traffic signal.							
7-2	The traffic signal design at this intersection consists of a four pole layout with near right far left over- the-road display to the Atlantic Avenue approaches to the intersection and a near left far right display to the Schellenger Avenue approaches to the intersection. There are two mast arms and a pole mounted signal installed on a wood pole on the southeast corner of the intersection, pole mounted signals mounted on wood poles on the southwest and northeast corners of the intersection and two mast arms installed on an aluminum pole on the northwest corner of the intersection. No indications are readily visible to pedestrians crossing several crosswalks at the intersection. County representative stated that pedestrian activity at this intersection is very substantial and warrants special attention due to the existence of the splash and water park in the immediate vicinity (high pedestrian attractor). All of the signal equipment is old. The signal controller for this intersection is mounted on a wood pole on the southwest corner of the intersection. The intersection has overhead electrical service.	Consideration be given to replacing the entire signal installation with new aluminum poles and pedestrian walk-don't walk signals.			X			X

SAFETY ISSUE		REMEDIAL ACTION	LEVEL OF EFFORT REQUIRED			POTENTIAL SAFETY BENEFIT		
			LOW	MEDIUM	HIGH	LOW	MEDIUM	HIGH
7-3	Crosswalk across the Schellenger Avenue westerly approach does not align with the handicap ramps.	Re-install crosswalks to align with handicap ramp.	X			X		
7-4	There are no mast arm mounted street name signs at the intersection.	Consideration be given to installing mast arm mounted street name signs.	X			X		
7-5	There are handicap ramps on all of the corners of the intersection but they lack the detectable warning surface and may not be ADA compatible.	Consideration be given to installing detectable warning surfaces on the handicap ramps and verify ADA compatibility.	X			X		
7-6	Left turn slots exist along both Atlantic Avenue approaches to the intersection but no lane use control signs.	Install the appropriate lane use control signs.	X			X		
7-7	The pavement markings along the Schellenger Avenue easterly approach indicate that the right lane is reserved for right turns only and the left lane for through and left turning traffic. There are no lane use control signs along the approach. The right lane lacks the word "ONLY" installed beneath the right turn arrow.	Install the appropriate lane use control signs. Install "ONLY" pavement marking.	X			X

7-8	The signal indication on the southwest corner of the intersection is missing a visor on one of the indications.	Install missing visor.	X			X		
7-9	Southeast corner of the intersection-inlet which is not bicycle safe.	Consideration be given to installing bicycle safe inlet grate.	X			X

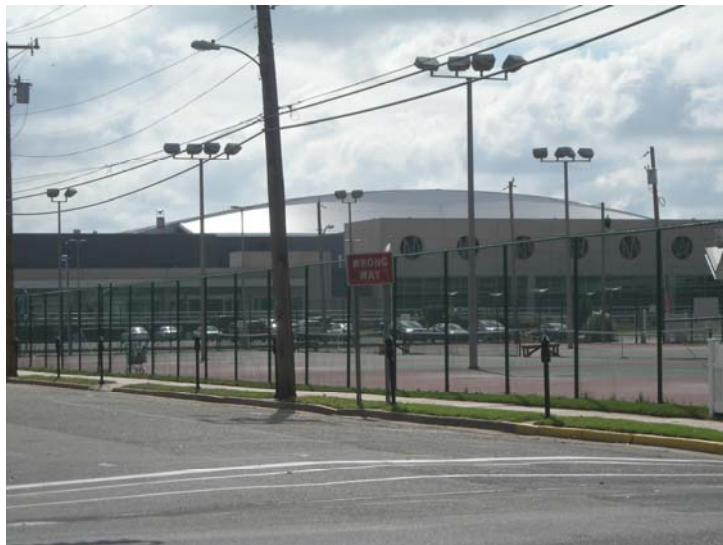
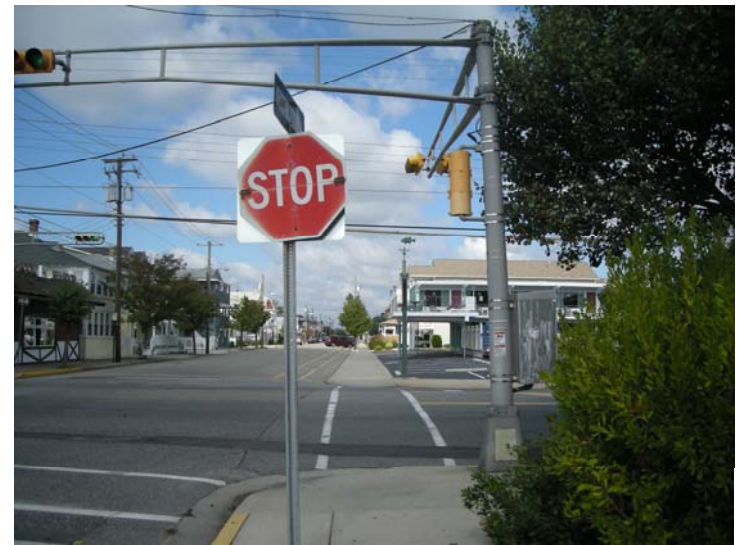
**PICTURES 22 & 23:
ATLANTIC AVENUE AND
MONTGOMERY AVENUE**

SAFETY ISSUE		REMEDIAL ACTION	LEVEL OF EFFORT REQUIRED			POTENTIAL SAFETY BENEFIT		
			LOW	MEDIUM	HIGH	LOW	MEDIUM	HIGH
8. ATLANTIC AVENUE AND MONTGOMERY AVENUE								
8-1	General comment- this is a cross type intersection with Atlantic Avenue extending in the north-south direction and Montgomery Avenue in the east-west direction. Montgomery Avenue is one way westbound. The intersection is controlled by a fixed time traffic signal.							
8-2	The traffic signal design at this intersection consists of a three pole layout with near left far right over- the-road display to the Atlantic Avenue approaches to the intersection and a near right far left display to the Montgomery Avenue easterly approach to the intersection. There are two mast arms and a pole mounted signal installed on an aluminum pole on the northeast corner of the intersection, a pole mounted signal mounted on a wood pole on the southeast corner of the intersection and two mast arms installed on a wood pole on the southwest corner of the intersection. No indications are readily visible to pedestrians crossing several crosswalks at the intersection. All of the signal equipment is old. The signal controller for this intersection is mounted on an aluminum pole on the northeast corner of the intersection. The intersection has overhead electrical service.	Consideration be given to replacing the entire signal installation with new aluminum poles and pedestrian walk-don't walk signals.			X			X

8-3	Crosswalks at the intersection do not align with the handicap ramps.	Re-install crosswalks to align with handicap ramp. This may require a second handicap ramp be installed on the southwest corner of the intersection.	X			X

SAFETY ISSUE		REMEDIAL ACTION	LEVEL OF EFFORT REQUIRED			POTENTIAL SAFETY BENEFIT		
			LOW	MEDIUM	HIGH	LOW	MEDIUM	HIGH
8-4	There are no mast arm mounted street name signs at the intersection.	Consideration be given to installing mast arm mounted street name signs.	X			X		
8-5	There are handicap ramps on all of the corners of the intersection but they lack the detectable warning surface.	Consideration be given to installing detectable warning surfaces on the handicap ramps.	X			X		
8-6	Lane use control sign for the left turn lane along the Atlantic Avenue northerly approach to the intersection is worn and obstructed by trees.	Replace with new sign and trim trees to ensure adequate visibility. Continue maintenance of trees or relocate signs.	X			X		
8-7	“DO NOT ENTER,” “ONE WAY,” and “WRONG WAY” signs at the intersection are not installed on breakaway posts.	Reinstall signs on breakaway posts.	X			X

8-8	Hinged “STOP” sign on the Montgomery Avenue approach is un-hinged and worn.	Install new hinged “STOP” sign.	X			X		
8-9	Southeast corner of the intersection-inlet which is not bicycle safe.	Consideration be given to installing bicycle safe inlet grate.	X			X

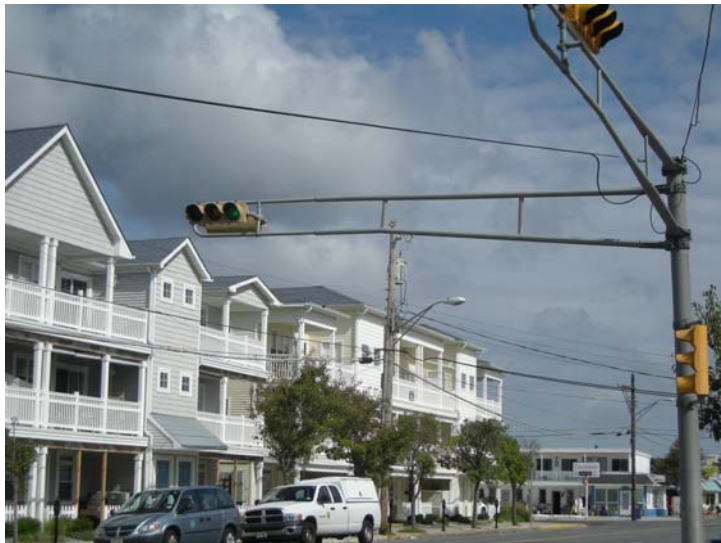
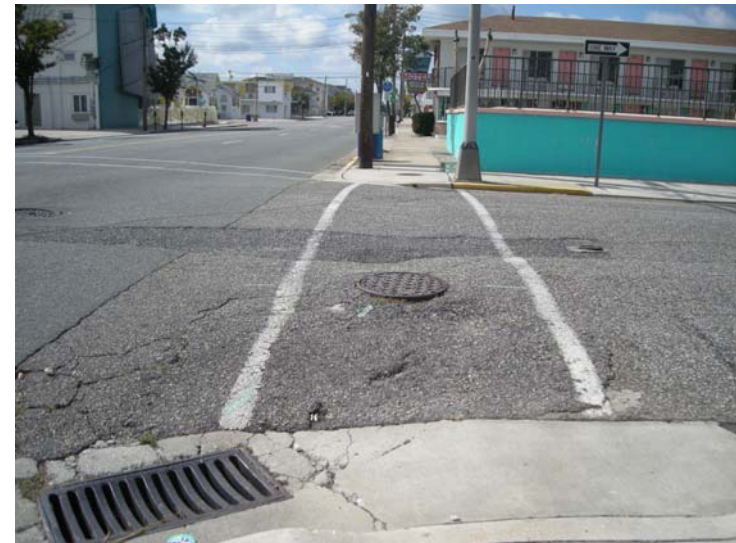
PICTURES 24 & 25:
ATLANTIC AVENUE AND TAYLOR
AVENUE

SAFETY ISSUE		REMEDIAL ACTION	LEVEL OF EFFORT REQUIRED			POTENTIAL SAFETY BENEFIT		
			LOW	MEDIUM	HIGH	LOW	MEDIUM	HIGH
9. ATLANTIC AVENUE AND TAYLOR AVENUE								
9-1	General comment- this is a cross type intersection with Atlantic Avenue extending in the north-south direction and Taylor Avenue in the east-west direction. Taylor Avenue is one way westbound. The intersection is controlled by a fixed time traffic signal.							
9-2	The traffic signal design at this intersection consist of a three pole layout with near left far right over-the- road display to the Atlantic Avenue approaches to the intersection and a near right far left display to the Taylor Avenue easterly approach to the intersection. There are two mast arms and a pole mounted signal installed on an aluminum pole on the northeast corner of the intersection, pole mounted signals installed on a wood pole on the southeast corner of the intersection and two mast arms installed on an aluminum pole on the southwest corner of the intersection. No indications are readily visible to pedestrians crossing several crosswalks at the intersection. All of the signal equipment is old. The signal controller for this intersection is mounted on a wood pole on the southwest corner of the intersection. The intersection has overhead electrical service.	Consideration be given to replacing the entire signal installation with new aluminum poles and pedestrian walk-don't walk signals.			X			X

9-3	There is a raised manhole and uneven pavement in the crosswalk across the westerly approach to the intersection causing a possible tripping hazard.	Consideration be given to investigating what can be done to correct this condition.		X		X

SAFETY ISSUE		REMEDIAL ACTION	LEVEL OF EFFORT REQUIRED			POTENTIAL SAFETY BENEFIT		
			LOW	MEDIUM	HIGH	LOW	MEDIUM	HIGH
9-4	There are no mast arm mounted street name signs at the intersection.	Consideration be given to installing mast arm mounted street name signs.	X			X		
9-5	There are handicap ramps on all of the corners of the intersection but they lack the detectable warning surface and may not be ADA compatible.	Consideration be given to installing detectable warning surfaces on the handicap ramps and verify ADA compatibility.	X			X		
9-6	“DO NOT ENTER” and “ONE WAY” signs at the intersection are not installed on breakaway posts.	Reinstall signs on breakaway posts.	X			X		
9-7	An additional “ONE WAY” sign be installed on the northeast corner of the intersection as the sign on the southeast corner is not readily visible.	Install “ONE WAY” sign.	X			X

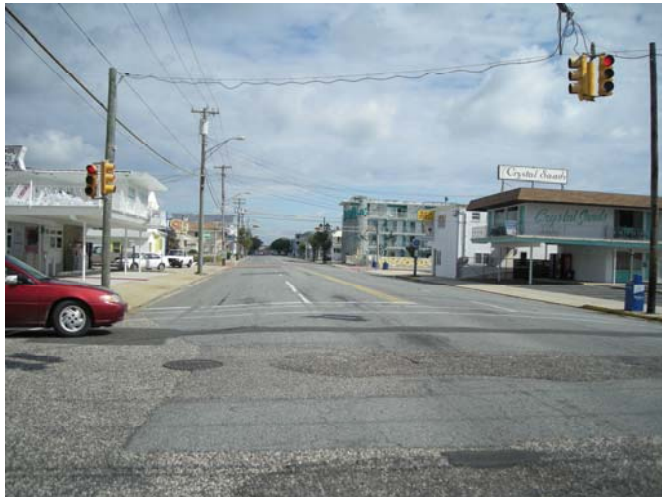
PICTURE 26:
ATLANTIC AVENUE AND HAND
AVENUE

SAFETY ISSUE		REMEDIAL ACTION	LEVEL OF EFFORT REQUIRED			POTENTIAL SAFETY BENEFIT		
			LOW	MEDIUM	HIGH	LOW	MEDIUM	HIGH
10. ATLANTIC AVENUE AND HAND AVENUE								
10-1	General comment- this is a cross type intersection with Atlantic Avenue extending in the north-south direction and Hand Avenue in the east-west direction. Hand Avenue is one way eastbound. The intersection is controlled by a fixed time traffic signal.							
10-2	The traffic signal design at this intersection consists of a span wire installation suspended from wood poles on the northeast and southwest corners of the intersection and pole mounted signals installed on wood poles on the southeast and northwest corners of the intersection. The signals suspended from the span wires results in a near left far right over- the- road display to the Atlantic Avenue approaches to the intersection and a near right far left display to the Hand Avenue westerly approach to the intersection. No indications are readily visible to pedestrians crossing several crosswalks at the intersection. All of the signal equipment is old. The signal controller for this intersection is mounted on a wood pole on the southwest corner of the intersection. The intersection has overhead electrical service.	Consideration be given to replacing the entire signal installation with new aluminum poles and pedestrian walk-don't walk signals.			X			X

10-3	There are handicap ramps on all of the corners of the intersection but they lack the detectable warning surface and may not be ADA compatible.	Consideration be given to installing detectable warning surfaces on the handicap ramps and verify ADA compatibility.	X			X		
10-4	There are no span wire mounted street name signs at the intersection.	Consideration be given to installing over the road street name signs on the span wire at the intersection.	X			X

SAFETY ISSUE		REMEDIAL ACTION	LEVEL OF EFFORT REQUIRED			POTENTIAL SAFETY BENEFIT		
			LOW	MEDIUM	HIGH	LOW	MEDIUM	HIGH
10-5	The pavement markings along the Hand Avenue westerly approach indicate that the left lane is reserved for left turns only and the right lane for through and right turning traffic. There are no lane use control signs along the approach.	Install the appropriate lane use control signs.	X			X		
10-6	“DO NOT ENTER” and “ONE WAY” signs at the intersection are not installed on breakaway posts.	Reinstall signs on breakaway posts.	X			X		
10-7	Crosswalks at the intersection do not align with the handicap ramps.	Re-install crosswalks to align with handicap ramp. This may require a second handicap ramp be installed on the southwest corner of the intersection.	X			X		
10-8	The painted left turn lane is less than 9 feet in width.	Evaluate the pavement markings to see if the lane width can be increased.	X			X

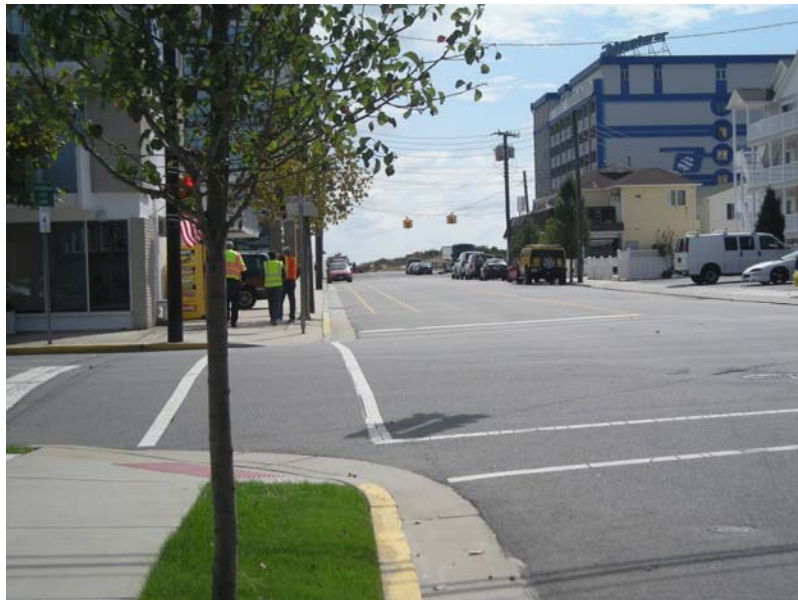
PICTURE 27:
ATLANTIC AVENUE AND CRESSE AVENUE

SAFETY ISSUE		REMEDIAL ACTION	LEVEL OF EFFORT REQUIRED			POTENTIAL SAFETY BENEFIT		
			LOW	MEDIUM	HIGH	LOW	MEDIUM	HIGH
11. ATLANTIC AVENUE AND CRESSE AVENUE								
11-1	General comment- this is a cross type intersection with Atlantic Avenue extending in the north-south direction and Cresse Avenue in the east-west direction. The intersection is controlled by a fixed time traffic signal.							
11-2	The traffic signal design at this intersection consists of a span wire installation suspended from wood poles on the southeast and northwest corners of the intersection and pole mounted signals installed on wood poles on the northeast and southwest corners of the intersection. The signals suspended from the span wires result in a near right far left over- the- road display to the Atlantic Avenue approaches to the intersection and a near left, far right display to the Cresse Avenue approaches to the intersection. County representative stated that pedestrian activity at this intersection is very substantial and warrants special attention. All of the signal equipment is old. The signal controller for this intersection is mounted on a wood pole on the southeast corner of the intersection. The intersection has overhead electrical service.	Consideration be given to replacing the entire signal installation with new aluminum poles and pedestrian walk-don't walk signals.			X			X

11-3	There are handicap ramps on all of the corners of the intersection. The ramps on the northwest and southeast have detectable warning surfaces but those on the other two corners do not and the ramps may not be ADA compatible.	Consideration be given to installing detectable warning surfaces on the handicap ramps and verify ADA compatibility.	X			X

SAFETY ISSUE		REMEDIAL ACTION	LEVEL OF EFFORT REQUIRED			POTENTIAL SAFETY BENEFIT		
			LOW	MEDIUM	HIGH	LOW	MEDIUM	HIGH
11-4	There are no span wire mounted street name signs at the intersection.	Consideration be given to installing over the road street name signs on the span wire at the intersection.	X			X		
11-5	Southbound Atlantic Avenue changes from two lanes to one lane at the intersections. There are no warning signs indicating the lane drop.	Install the appropriate transitional lane drop pavement markings and lane drop warning signs along the approach.	X			X		
11-6	The hinged "STOP" signs at the intersection are on non-breakaway posts.	Reinstall signs on breakaway posts.	X			X		
11-7	"Welcome to the Crest" sign on the southwest corner of the intersection is on non-breakaway post.	Reinstall sign on breakaway post.	X			X

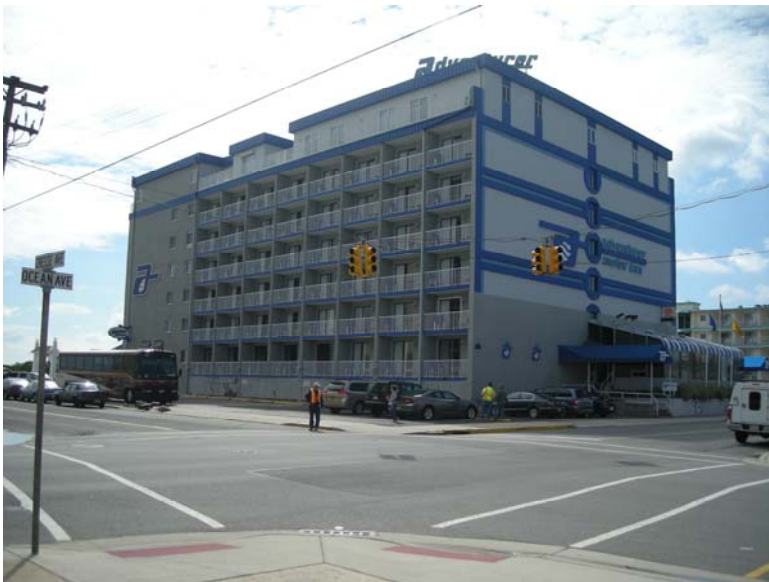
PICTURE 28:
OCEAN AVENUE AND CRESSE AVENUE

SAFETY ISSUE		REMEDIAL ACTION	LEVEL OF EFFORT REQUIRED			POTENTIAL SAFETY BENEFIT		
			LOW	MEDIUM	HIGH	LOW	MEDIUM	HIGH
12. OCEAN AVENUE AND CRESSE AVENUE								
12-1	General comment- this is a cross type intersection with Ocean Avenue extending in the north-south direction and Cresse Avenue in the east-west direction. The intersection is controlled by a fixed time traffic signal.							
12-2	The traffic signal design at this intersection consists of a span wire installation suspended from wood poles on the northeast and southwest corners of the intersection. The signals suspended from the span wires result in a near left, far right over- the- road display to the Ocean Avenue approaches to the intersection and a near right, far left display to the Cresse Avenue approaches to the intersection. No indications are readily visible to pedestrians crossing several crosswalks at the intersection. County representative stated that pedestrian activity at this intersection is very substantial and warrants special attention. All of the signal equipment is old. The signal controller for this intersection is mounted on a wood pole on the southwest corner of the intersection. The intersection has overhead electrical service.	Consideration be given to replacing the entire signal installation with new aluminum poles and pedestrian walk-don't walk signals.			X			X

12-3	There are handicap ramps on all of the corners of the intersection. The ramps on the northwest and southwest corner have detectable warning surfaces but those on the other two corners do not and the ramps may not be ADA compatible.	Consideration be given to installing detectable warning surfaces on the handicap ramps and verify ADA compatibility.	X			X

SAFETY ISSUE		REMEDIAL ACTION	LEVEL OF EFFORT REQUIRED			POTENTIAL SAFETY BENEFIT		
			LOW	MEDIUM	HIGH	LOW	MEDIUM	HIGH
12-4	There are no span wire mounted street name signs at the intersection.	Consideration be given to installing over the road street name signs on the span wire at the intersection.	X			X		
12-5	There is water standing along the curb on the northeast corner of the intersection.	Consideration be given to investigating what can be done to eliminate the standing water.			X	X		
12-6	Southeast and southwest corners of the intersection- inlets which are not bicycle safe.	Consideration be given to installing bicycle safe inlets grates.	X			X		
12-7	The hinged "STOP" signs at the intersection are on non-breakaway posts.	Reinstall signs on breakaway posts.	X			X

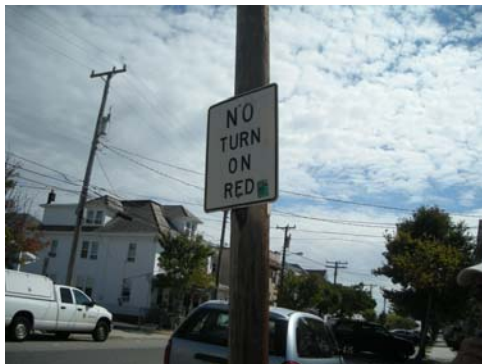
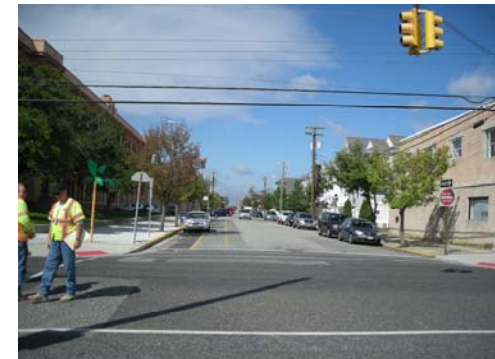
**PICTURE 29 & 30:
PACIFIC AVENUE AND BAKER
AVENUE**

SAFETY ISSUE		REMEDIAL ACTION	LEVEL OF EFFORT REQUIRED			POTENTIAL SAFETY BENEFIT		
			LOW	MEDIUM	HIGH	LOW	MEDIUM	HIGH
13. PACIFIC AVENUE AND BAKER AVENUE								
13-1	General comment- this is a cross type intersection with Pacific Avenue extending in the north-south direction and Baker Avenue in the east-west direction. Baker Avenue is one way eastbound. The intersection is controlled by a fixed time traffic signal.							
13-2	<p>The traffic signal design at this intersection consists of a span wire installation suspended from wood poles on the northwest and southeast corners of the intersection. The signals suspended from the span wires result in a near right far left over- the- road display to the Pacific Avenue approaches to the intersection and a near left far right display to the Baker Avenue westerly approach to the intersection. There is an over the roadway signal facing the Baker Avenue easterly approach to the intersection which has the potential to draw vehicles the wrong way down the one way street. No indications are readily visible to pedestrians crossing several crosswalks at the intersection. All of the signal equipment is old. The signal controller for this intersection is mounted on a wood pole on the northwest corner of the intersection. The intersection has overhead electrical service.</p> <p>County representative stated that pedestrian activity at this intersection is very substantial and warrants special attention.</p>	Consideration be given to replacing the entire signal installation with new aluminum poles and pedestrian walk-don't walk signals.			X			X

SAFETY ISSUE		REMEDIAL ACTION	LEVEL OF EFFORT REQUIRED			POTENTIAL SAFETY BENEFIT		
			LOW	MEDIUM	HIGH	LOW	MEDIUM	HIGH
13-3	There are no span wire mounted street name signs at the intersection.	Consideration be given to installing over the road street name signs on the span wire at the intersection.	X			X		
13-4	Wildwood high school is located on the southwest corner of the intersection. This is a school crossing that lacks the required school crossing signs.	Install the required school crossing and advance warning signs along all of the approaches to the intersection in the appropriate fluorescent yellow-green.	X				X	
13-5	“NO TURN ON RED” sign on the southeast corner of the intersection is installed on a wood pole and is worn.	Install new sign on a breakaway post.	X			X		
13-6	“ONE WAY” sign on the northeast corner of the intersection and ‘ONE WAY” and “DO NOT ENTER” signs on the northwest corner of the intersection are worn and installed on a non-breakaway posts.	Install new signs on breakaway posts.	X			X

13-7	It was felt that a “ONE WAY” and “DO NOT ENTER” sign should be installed on the southwest corner of the intersection.	Install new signs on southwest corner.	X			X		
13-8	The hinged “STOP” sign on the southwest corner of the intersection is not on a breakaway post.	Reinstall sign on breakaway post.	X			X

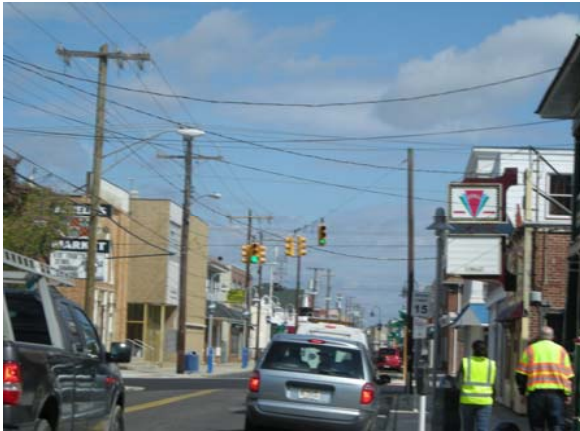
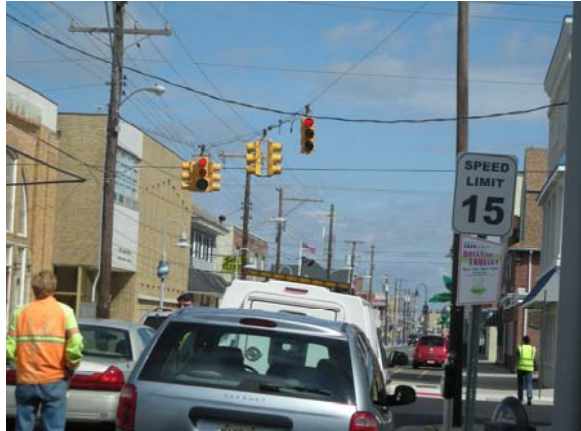
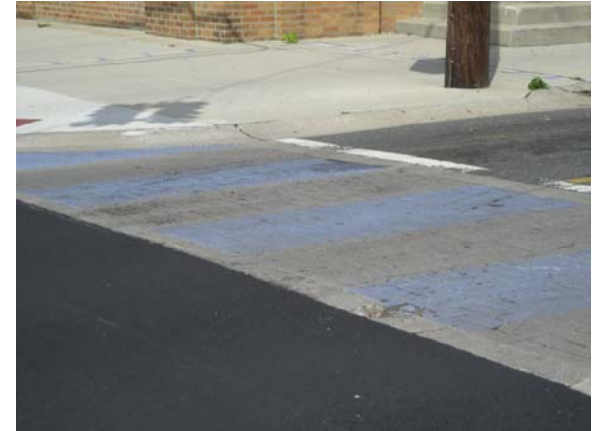
**PICTURE 31, 32 & 33:
PACIFIC AVENUE AND SPENCER AVENUE**

SAFETY ISSUE		REMEDIAL ACTION	LEVEL OF EFFORT REQUIRED			POTENTIAL SAFETY BENEFIT		
			LOW	MEDIUM	HIGH	LOW	MEDIUM	HIGH
14. PACIFIC AVENUE AND SPENCER AVENUE								
14-1	General comment- this is a cross type intersection with Pacific Avenue extending in the north-south direction and Baker Avenue in the east-west direction. The intersection is controlled by a fixed time traffic signal.							
14-2	The traffic signal design at this intersection consists of a span wire installation suspended from wood poles on the northwest and southeast corners of the intersection. The signals suspended from the span wires result in a near right, far left over- the- road display to the Pacific Avenue approaches to the intersection and a near left, far right display to the Spencer Avenue approaches to the intersection. No indications are readily visible to pedestrians crossing several crosswalks at the intersection. All of the signal equipment is old. There is a mix of 8” and 12” indications. The signal controller for this intersection is mounted on a wood pole on the northwest corner of the intersection. The intersection has overhead electrical service. There are handicap ramps on all of the corners of the intersection. All of the ramps have detectable warning surfaces	Consideration be given to replacing the entire signal installation with new aluminum poles and pedestrian walk-don’t walk signals. Verify ADA ramp compatibility.			X			X

14-3	There are no span wire mounted street name signs at the intersection.	Consideration be given to installing over the road street name signs on the span wire at the intersection.	X			X

SAFETY ISSUE		REMEDIAL ACTION	LEVEL OF EFFORT REQUIRED			POTENTIAL SAFETY BENEFIT		
			LOW	MEDIUM	HIGH	LOW	MEDIUM	HIGH
14-4	Intersection appears to have recently been resurfaced so there are no painted crosswalks or stop lines.	Install painted crosswalks and stop lines at intersection.	X				X	
14-5	There is a “15 MPH” speed limit sign facing northbound traffic.	Remove “15 MPH” speed limit sign.	X			X

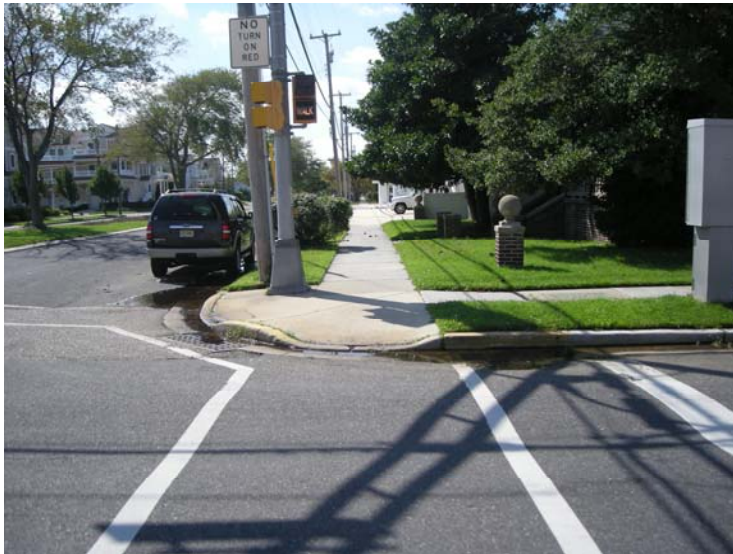
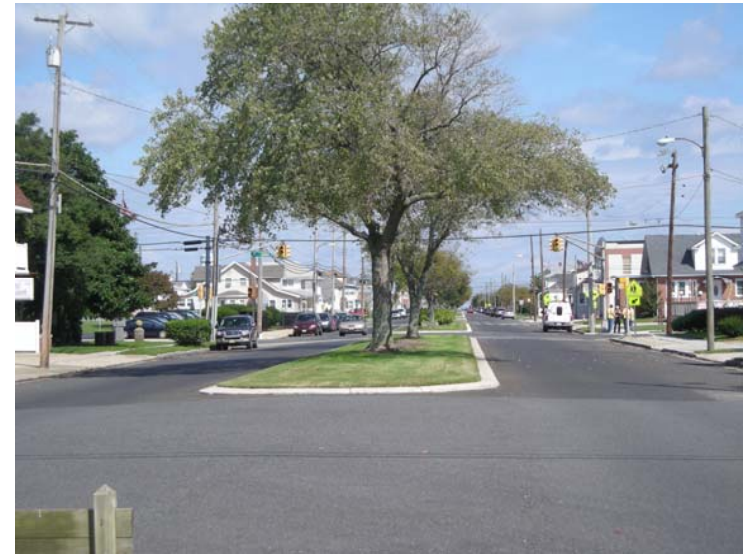
**PICTURE 34 & 35:
CENTRAL AVENUE AND
16TH AVENUE**

SAFETY ISSUE		REMEDIAL ACTION	LEVEL OF EFFORT REQUIRED			POTENTIAL SAFETY BENEFIT		
			LOW	MEDIUM	HIGH	LOW	MEDIUM	HIGH
15. CENTRAL AVENUE AND 16TH AVENUE								
15-1	General comment- this is a cross type intersection with Central Avenue extending in the north-south direction and 16th Avenue in the east-west direction. The intersection is controlled by a semi- vehicle and pedestrian actuated traffic signal.							
15-2	The traffic signal design at this intersection consists of a four pole layout with mast arms with four way signal heads installed on the northeast and southwest corners of the intersection along with walk-don't walk signals on the same poles. There are walk-don't walk signals on the poles on the southeast and northwest corners of the intersection. There are pedestrian push buttons on all four corners of the intersection. Central Avenue is a wide divided roadway with one over the roadway signal head on each side of the landscaped divider creating a near left far right signal display to the Central Avenue approaches. Due to the width of Central Avenue it is felt that an additional far right signal should be installed for both of the Central Avenue approaches. This may require installing additional mast arms at the intersection. The signals facing the 16 th Avenue approaches are in a near right far left display. The signal controller for this intersection is on the northeast corner of the intersection	Consideration be given to revising the signal design to provide two far right signals for both of the Central Avenue approaches to the intersection.		X				X

15-5	There are no “KEEP RIGHT” signs on the center median of Central Avenue	Install missing signs.	X			X		
15-6	There are old style (non-compliant with the current MUTCD) school crossing warning signs with diagonal plate on the southeast and northwest corners of the intersection facing the Central Avenue approaches to the intersection.	Replace the old type signs and plates with new signs and plates.	X			X		
15-7	There is an advance school crossing warning sign along the northbound Central Avenue approach just north of 17 th Avenue. However the sign is damaged and lacks the required “AHEAD” plate.	Replace with new sign and plate.	X			X

SAFETY ISSUE		REMEDIAL ACTION	LEVEL OF EFFORT REQUIRED			POTENTIAL SAFETY BENEFIT		
			LOW	MEDIUM	HIGH	LOW	MEDIUM	HIGH
15-8	There is no painted centerline along the 16 th Avenue westerly approach to the intersection.	Install missing painted centerline.	X			X		
15-9	There is an inlet grate that is not bicycle safe on the northwest corner of the intersection.	Replace with bicycle safe inlet grate.	X			X
