South Jersey Transportation Planning Organization

2005 Road Safety Audit

**Richwood Road (CR 609), Swedesboro Road (CR 666), Monroeville
Road (CR 604)
Upper Pittsgrove Township, Salem County**

Introduction

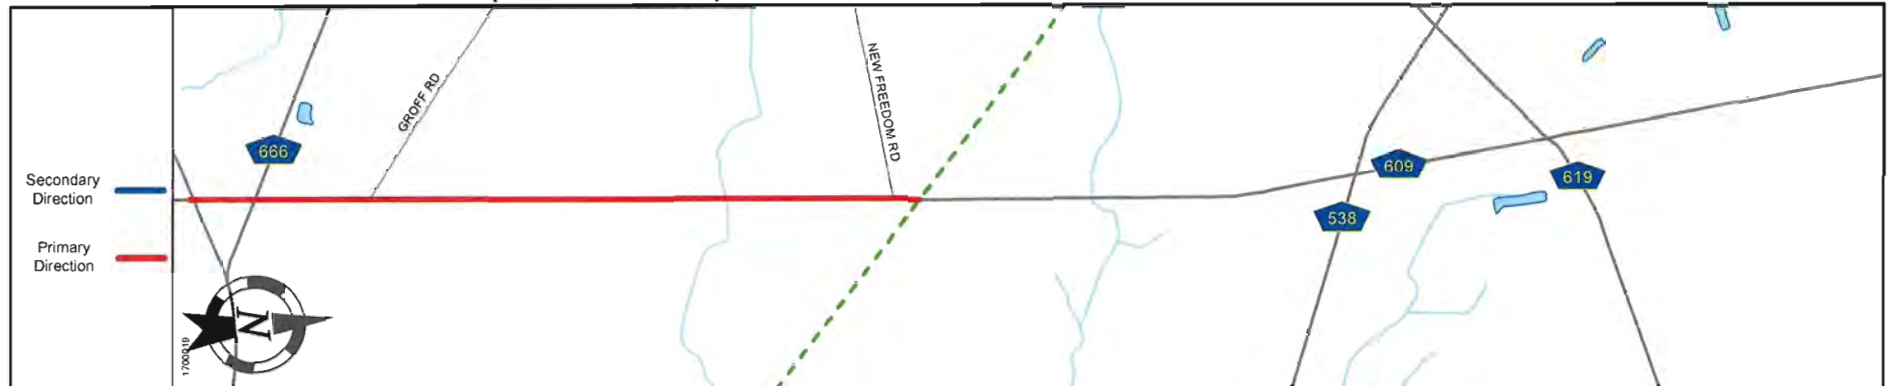
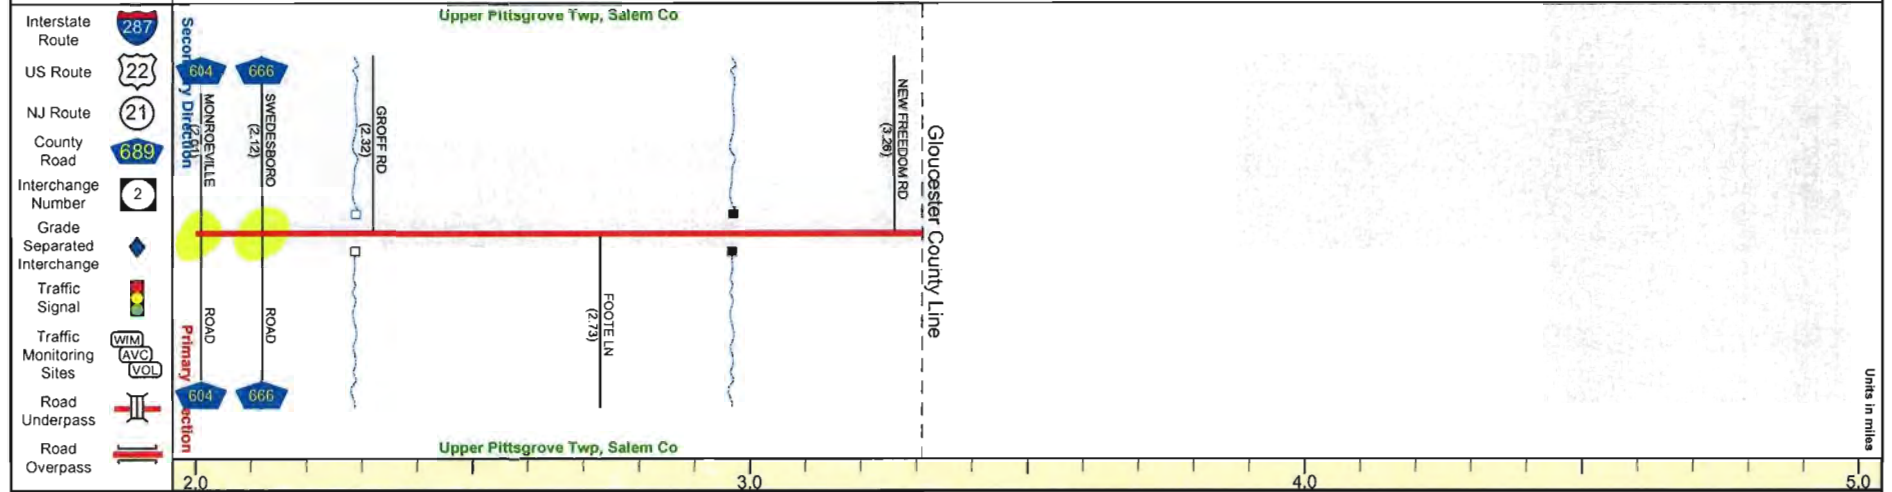
SALEM COUNTY 609 (South to North)

Mile Posts: 2.000 - 3.310

Street Name	Richwood Road	
Jurisdiction	County	
Functional Class	Rural Minor Collector	
Federal Aid - NHS Sy	Non-Federal Aid	
Control Section		
Speed Limit	45	
Number of Lanes	2	
Med. Type	None	
Med. Width	0	
Pavement	21	
Shoulder	1	
Traffic Volume		
Traffic Sta. ID		
Structure No.	CULVERT	CULVERT
Enlarged Views

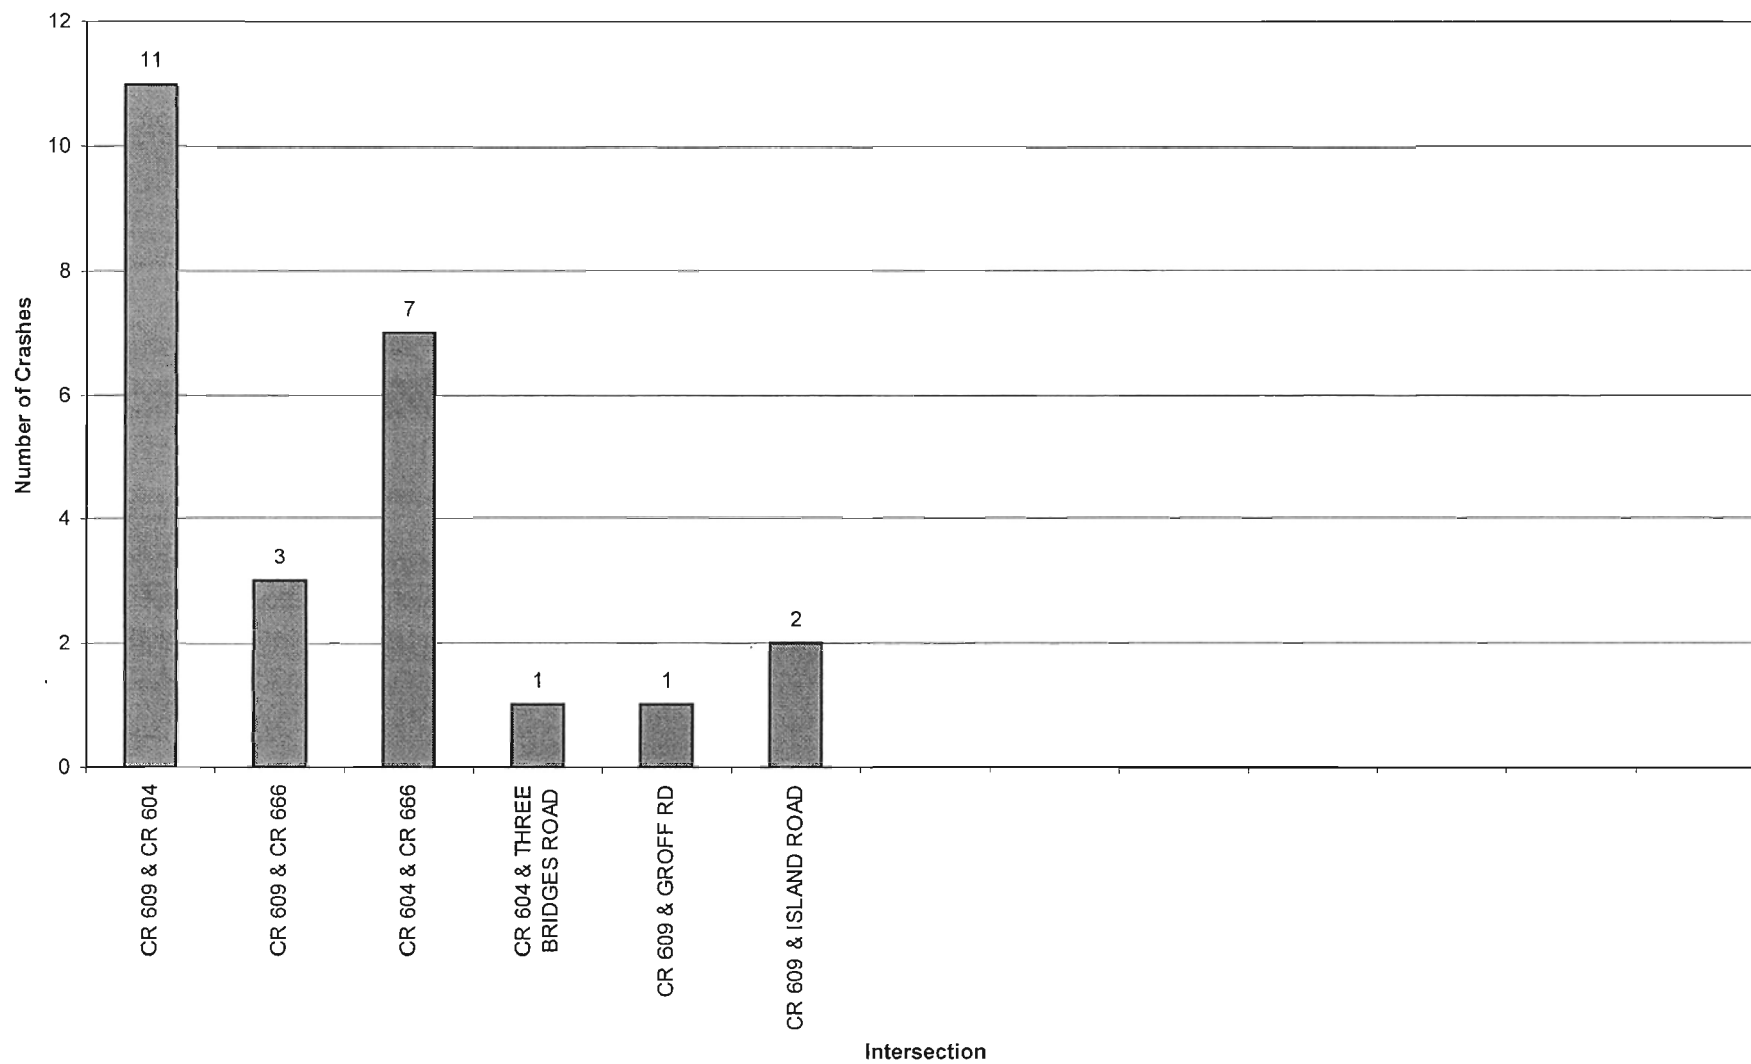
CR 609, CR 666, CR 604
Crash Type

Fourteen (14) right-angle type crashes – Ten (10) at the CR 609 and CR 604 intersection and three (3) at the intersection of CR 609 and CR 666. Local officials also conveyed to the team that a fatal right-angle type crash occurred at the intersection of CR 609 and CR 604 in 2003. Also, one of the team members had a right-angle type crash at the intersection in 2003.

Four (4) fixed-object crashes – all along CR 604 between CR 666 and Three Bridges Road. There is evidence (tire tracks) of single-vehicle run-off-the-road type crashes involving vehicles westbound on CR 604 occurring on RT 666 just west of the CR 604 intersection.

Seven (7) other type crashes – including four (4) that struck deer and one (1) that struck a dog.
