# ***South Jersey Transportation Planning Organization***

## **2005 Road Safety Audit**

**Hook Road (CR 551)  
Pennsville Township, Carney's Point Township, Salem County**

June 14, 2005

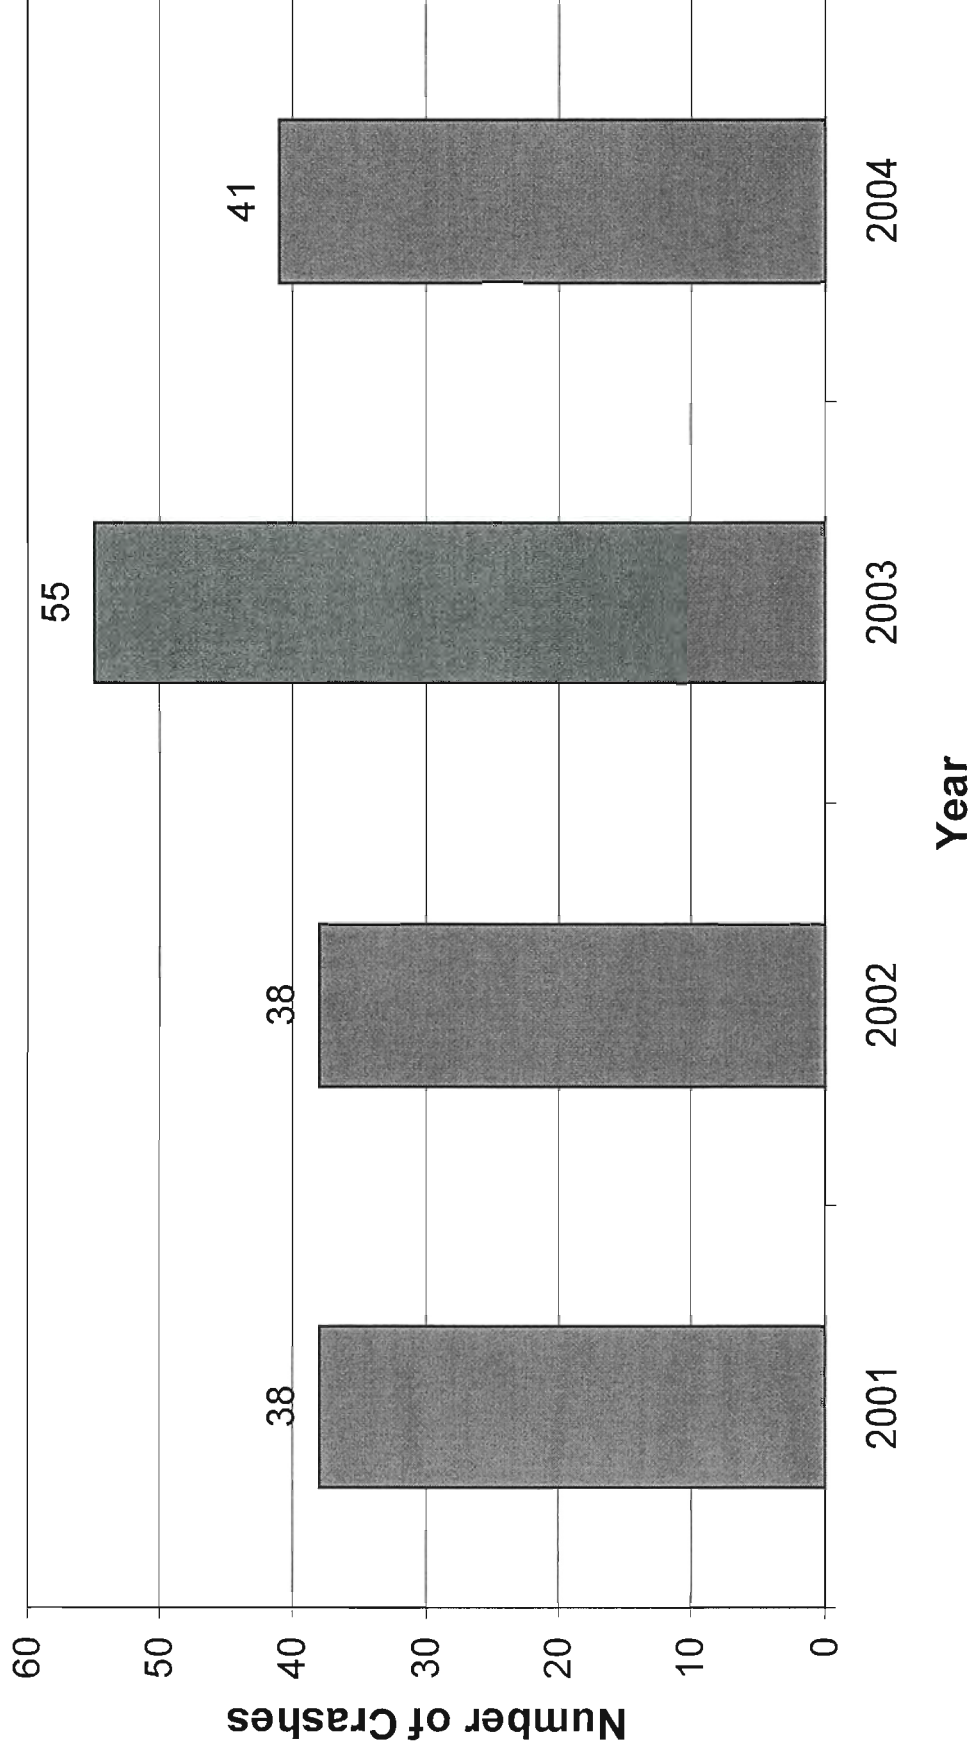
# Hook Road 4 Year Trend

SJTPO received and forwarded to ORA the crash reports from the Pennsville Township Police Department for the years 2001, 2002, and 2003. On May 5, 2005, Sgt. Chatin provided crash data for the year 2004. Summary sheets were prepared for each of the four years, as well as a summary sheet for the four-year period. For the four-year period, a total of 172 crashes were plotted for the study section of road. Thirty-eight (38) crashes occurred in 2001, 38 in 2002, 55 in 2003 and 41 in 2004.

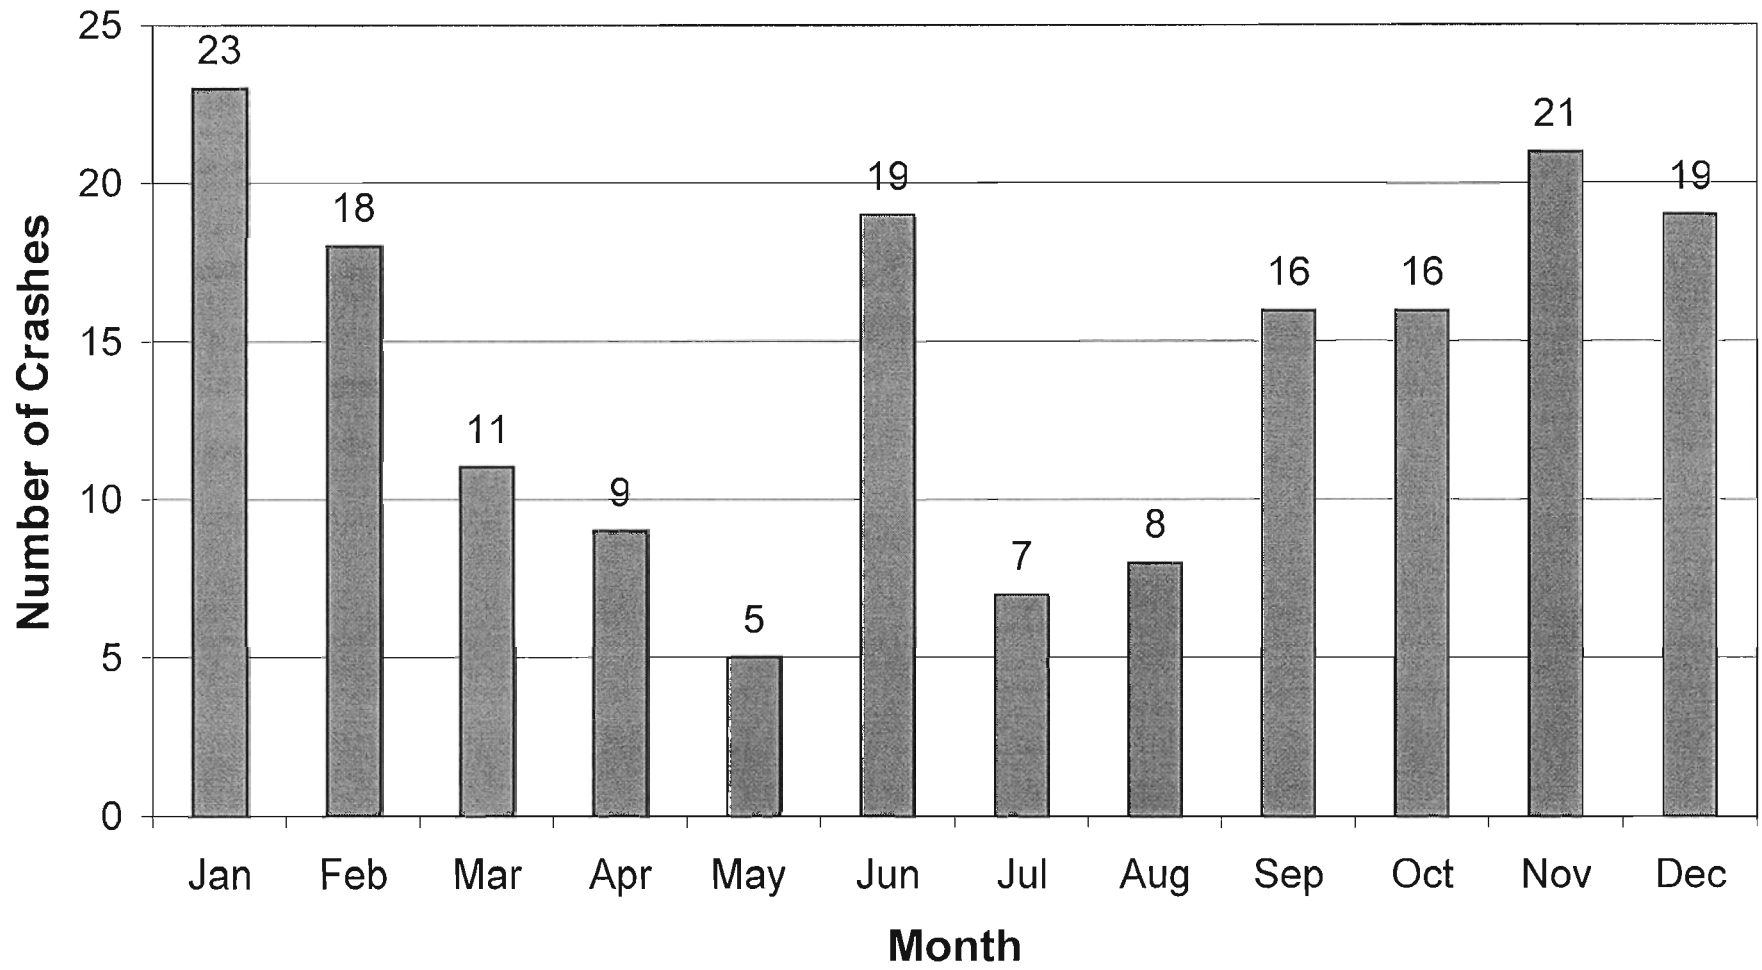
## Hook Road Crash Occurrence by Month

- ♦ The critical months for crashes were January and November. It is surprising to see that the number of crashes in July and August were significantly lower than the number of crashes in other months when the locals officials stated that the route is used by traffic going to and from the recreational shore area.

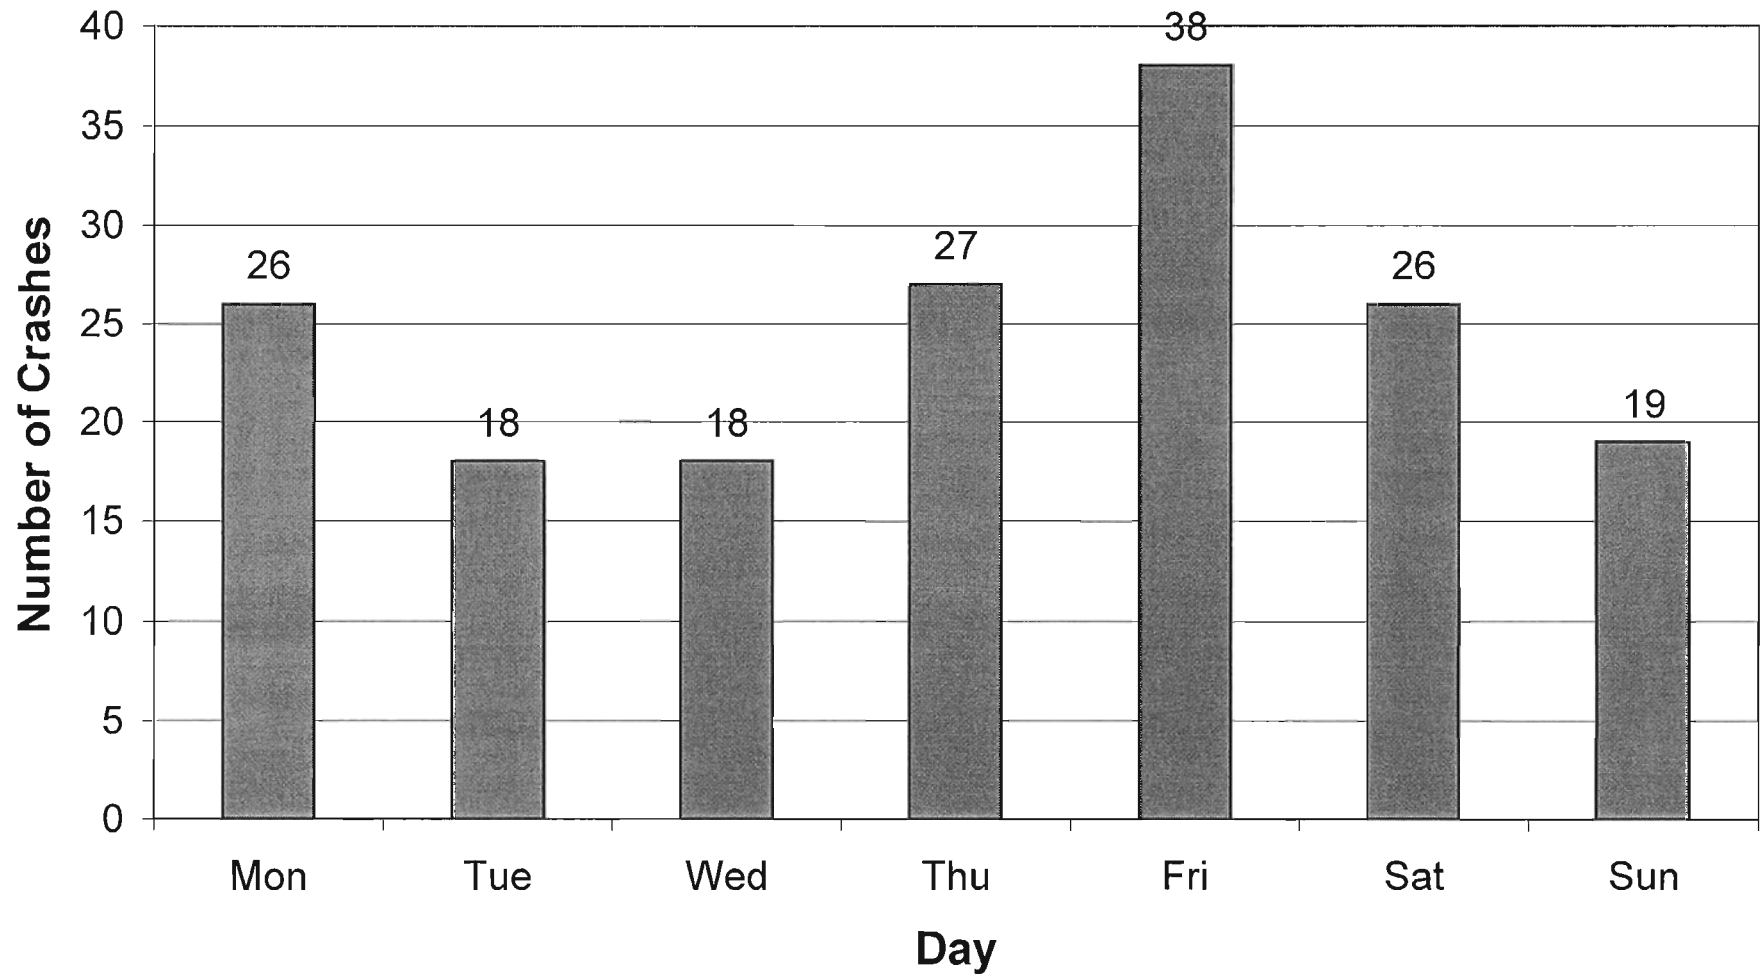
## Hook Road Crash Occurrence by Day of Week

- ♦ The highest frequency of crashes occurred on Fridays.
- ♦ The highest frequency of crashes occurred between 3:00-4:00 PM.
- ♦ The percentage of crashes during hours of darkness (35%) is higher than the statewide average for county roads (approximately 28%). The roadway is generally well lit and the pavement markings and signing are in good condition.

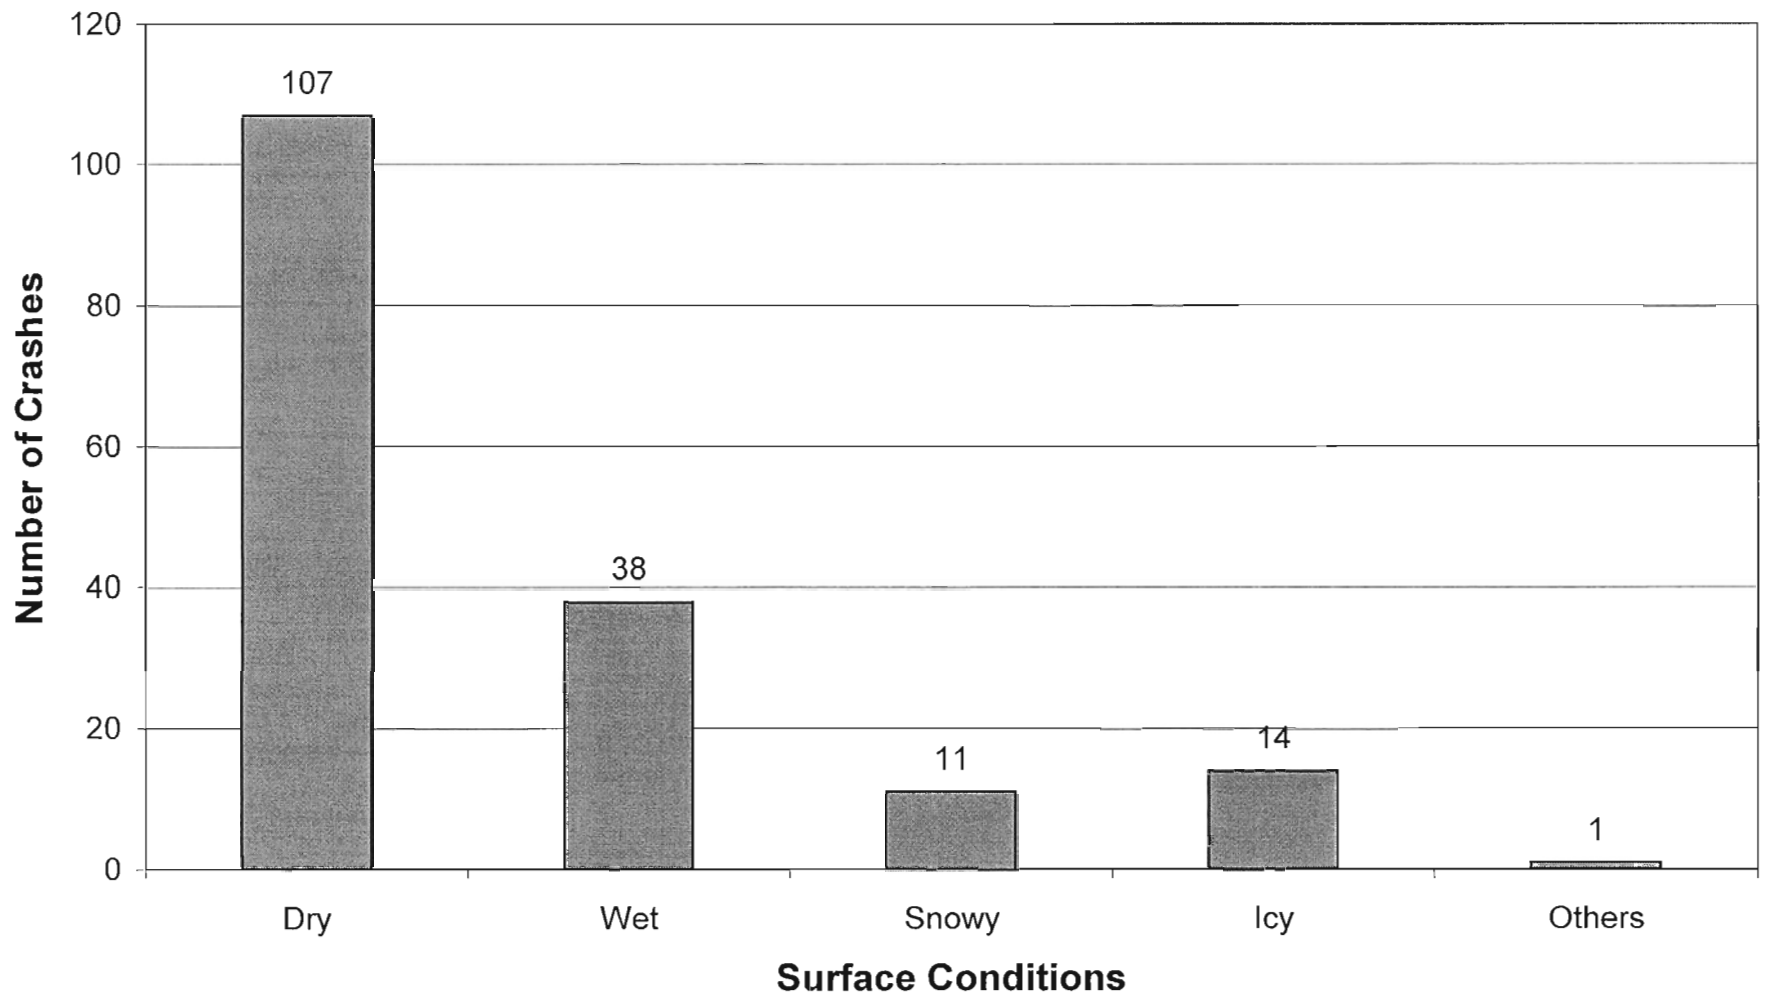
# Hook Road Crash Occurrence by Surface Conditions

- ♦ The percentage of crashes for wet surface conditions (22%) is consistent with the statewide average for county roads (approximately 21%). The percentage of crashes with snowy or icy surface conditions (14%) is higher than the statewide average for county roads (approximately 6.9%). It was ascertained during the audit that the county is now installing snow fence in open areas along the road during the winter months to control snow drifting.

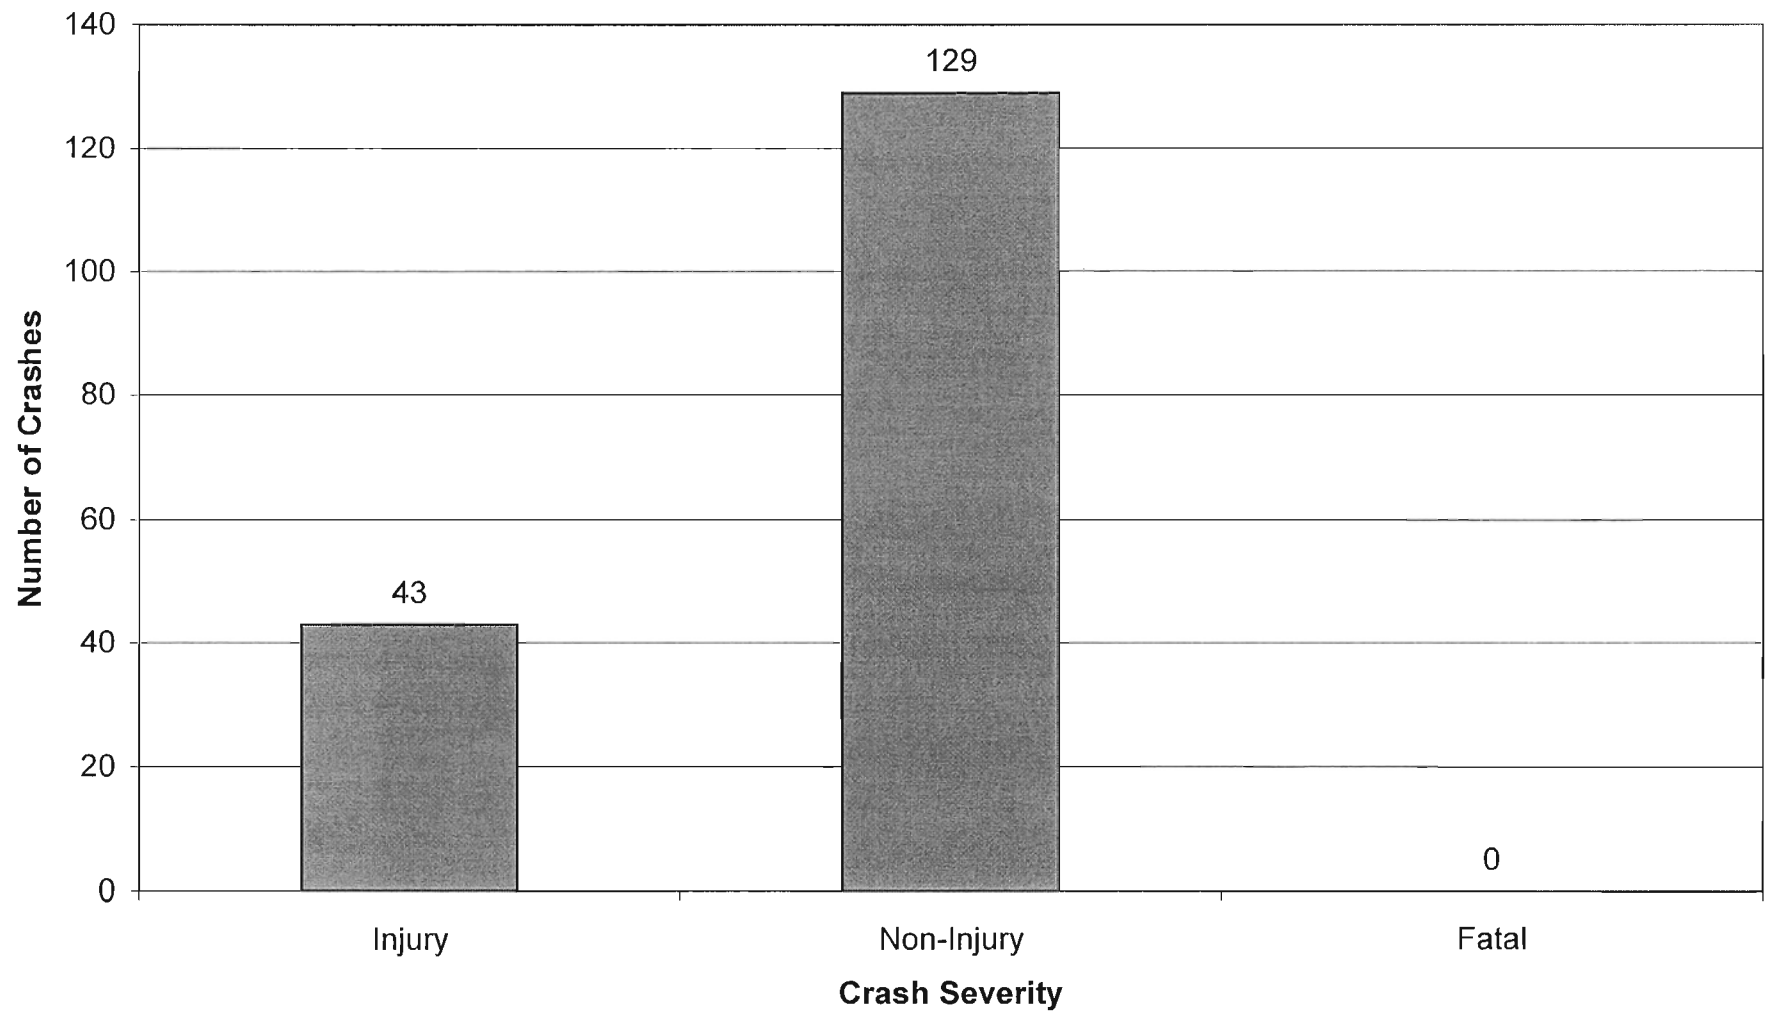
# Hook Road Crash Severity

**0-fatal crashes**

**43- injury crashes**

**129-non-injury crashes**

- ♦ The percentage of crashes with injuries (25%) is lower than the statewide average for county roads (approximately 30%).
- ♦ The percentage of same directional crashes (29%) is consistent with the statewide average for county roads (approximately 29%).

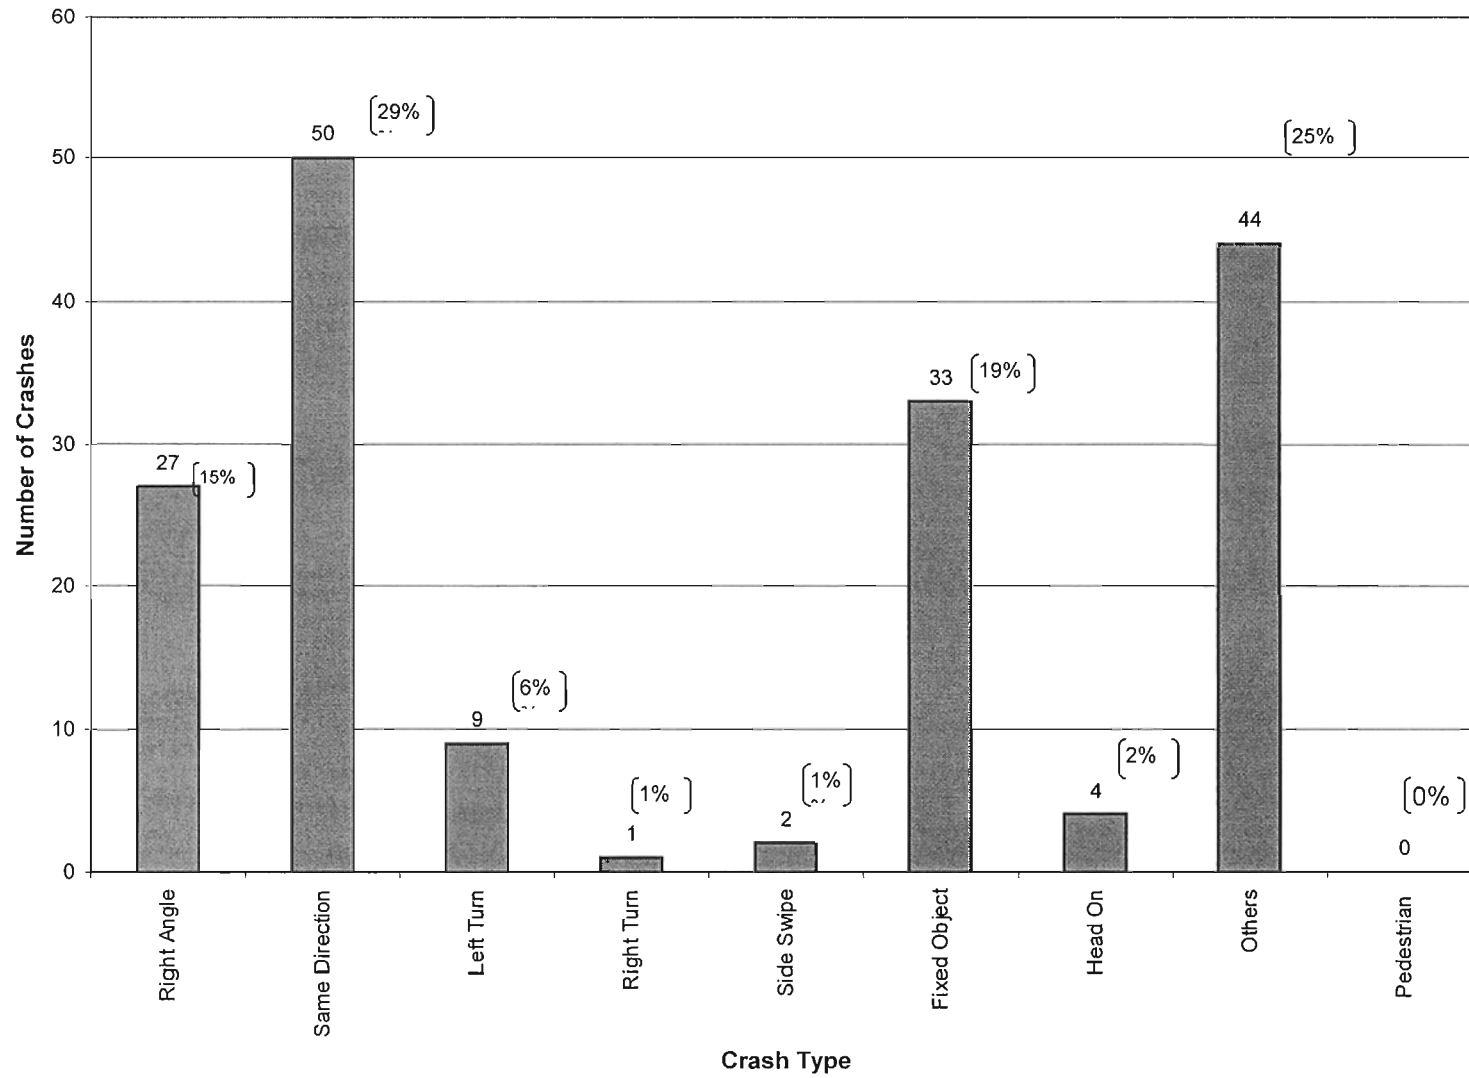
# Hook Road Crash Type

**27 – right-angle type crashes** – five (5) at the Sunoco Gas Station driveway, three (3) at RT 49, two (2) at Mahoney Road, five (5) at Pittsfield Road, four (4) at Churchtown Road. No other concentrations.

**50 – same-direction type crashes** – five (5) at the Sunoco gas station driveway, 14 at Rt 49, four (4) at Churchtown Road. No other concentrations.

**33 – fixed-object type crashes** – No concentration.

**4 – head on type crashes** – No concentrations.

**2 – side swipe type crash.**

**9 – left-turn type crashes** – No concentrations.

**44 – other type crashes, including 24 struck deer.**
