South Jersey Transportation Planning Organization

2006 Road Safety Audit

**Jimmie Leeds Road (CR 561 & 633)
Galloway Township,
Atlantic County**

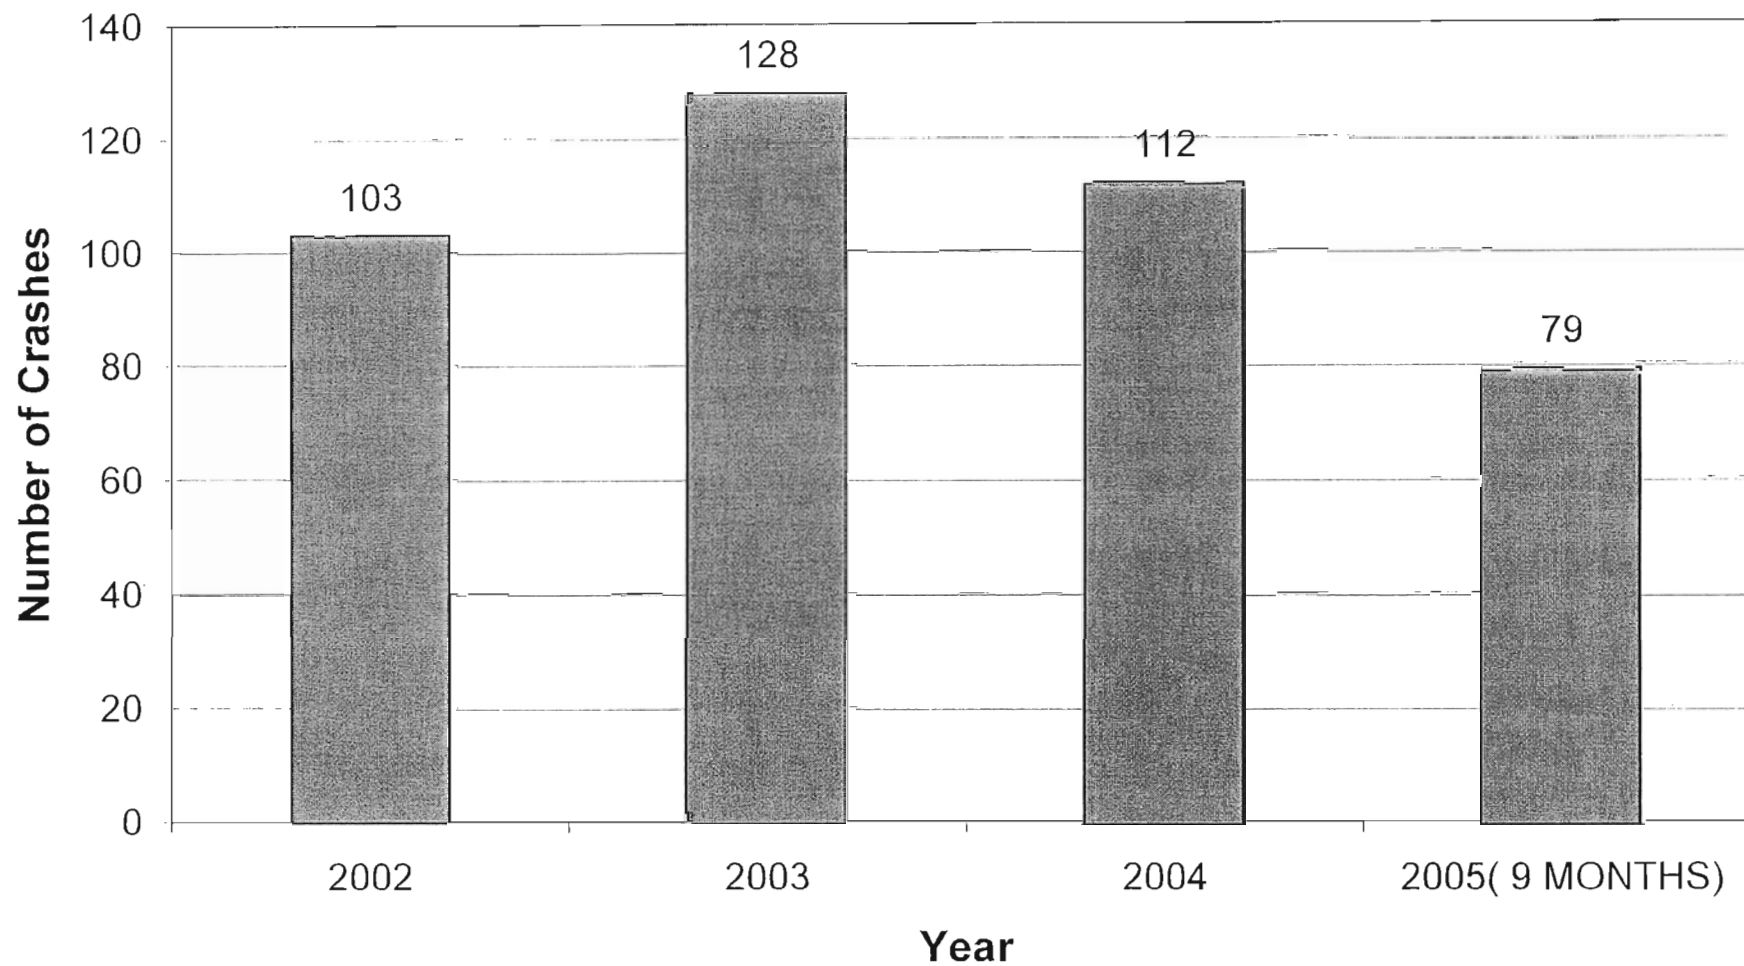
4 Year Trend

Jimmie Leeds Rd (CR 561 & 633)

three (103) crashes occurred in 2002, 128 in 2003, 112 in 2004, and 79 in 2005 (nine months).

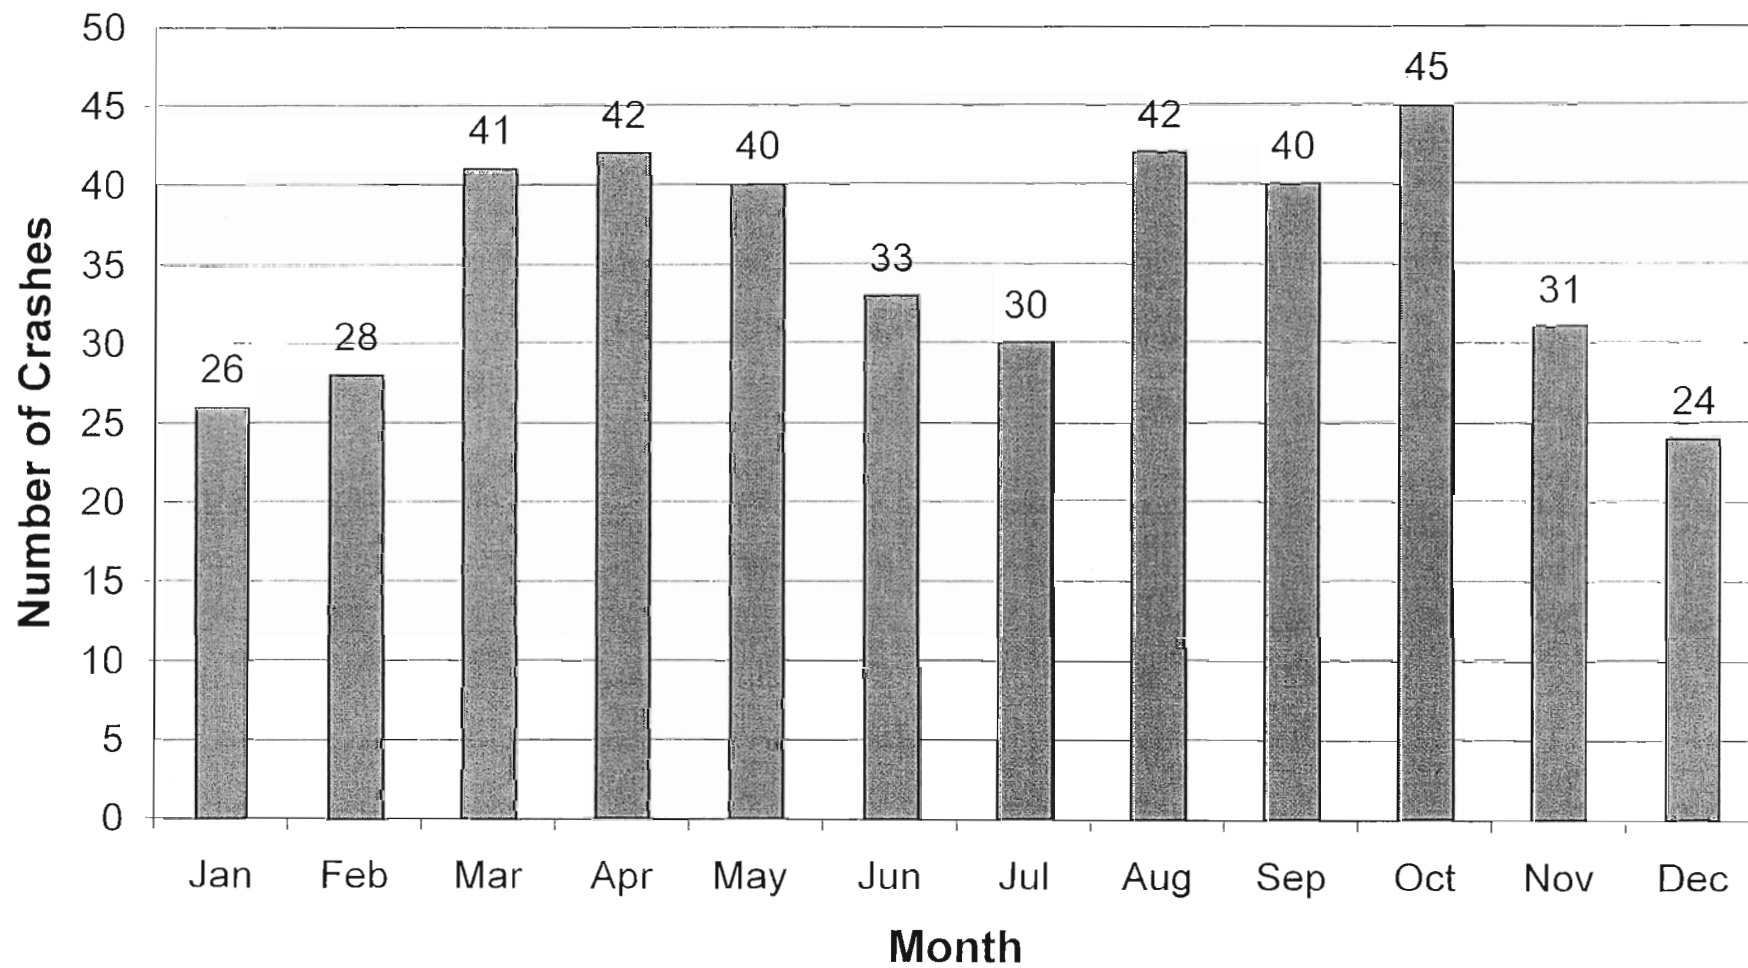
Jimmie Leeds Rd (CR 561 & 633) **Crash Occurrence by Month**

- ♦ The month with the highest number of crashes was October. The month with the least number of crashes was December. Note – October, November and December crashes for 2005 were not provided.

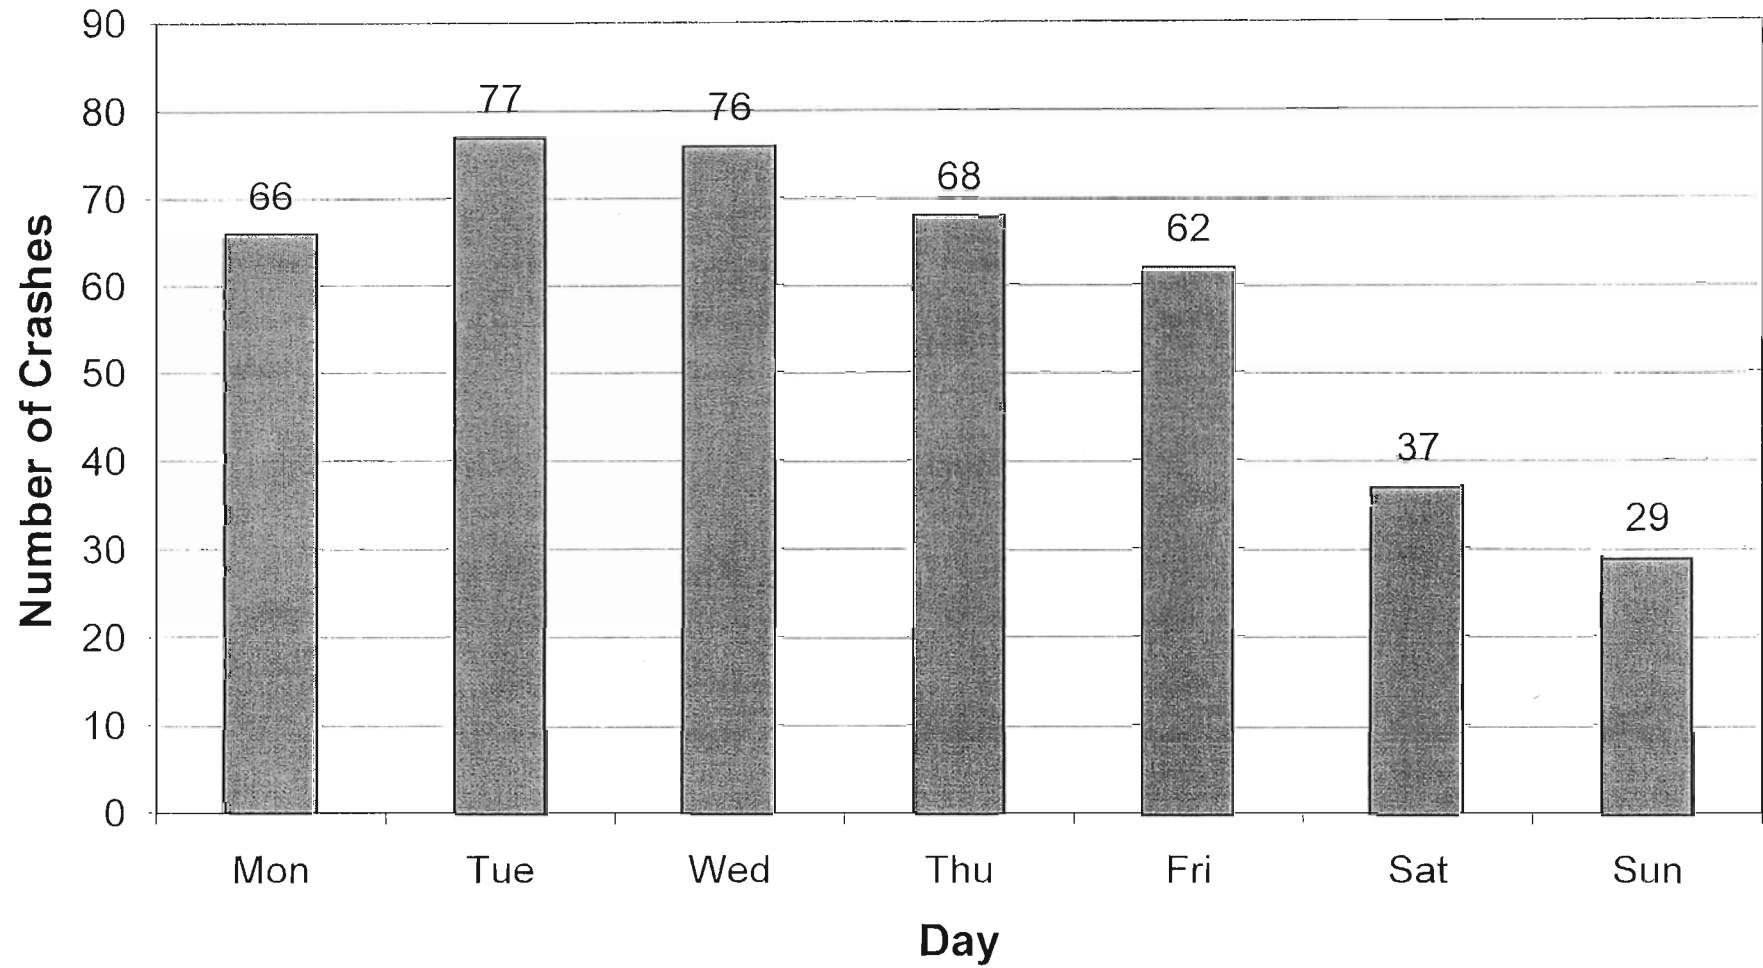
Jimmie Leeds Rd (CR 561 & 633) **Crash Occurrence by Day of Week**

- ♦ The highest frequency of crashes occurred on Tuesday and Wednesday. The least number of crashes occurred on Saturday and Sunday. (Road is a major commuter route.)

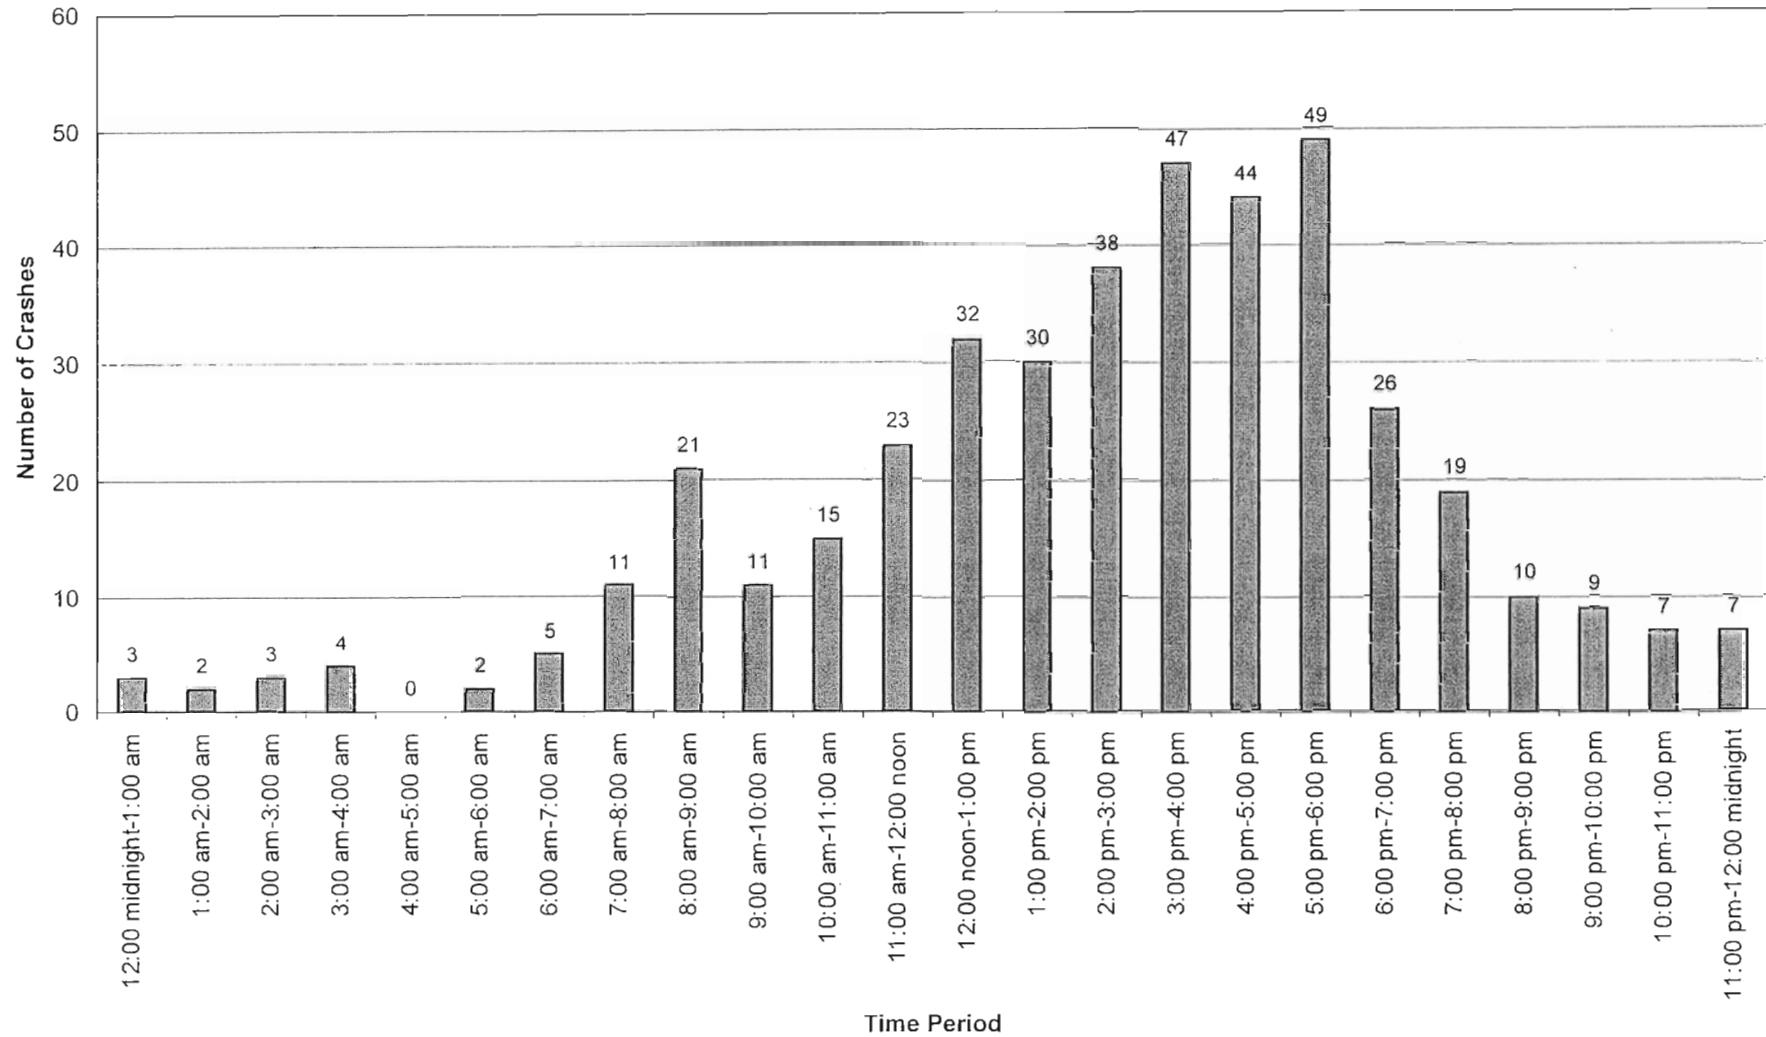
Jimmie Leeds Rd (CR 561 & 633)
Crash Occurrence by Time of Day

- ♦ The highest frequency of crashes occurred between 3:00-6:00 PM. (Peak commuting period.)
- ♦ The percentage of crashes during hours of darkness (20%) is less than the statewide average for county roads (approximately 30%).

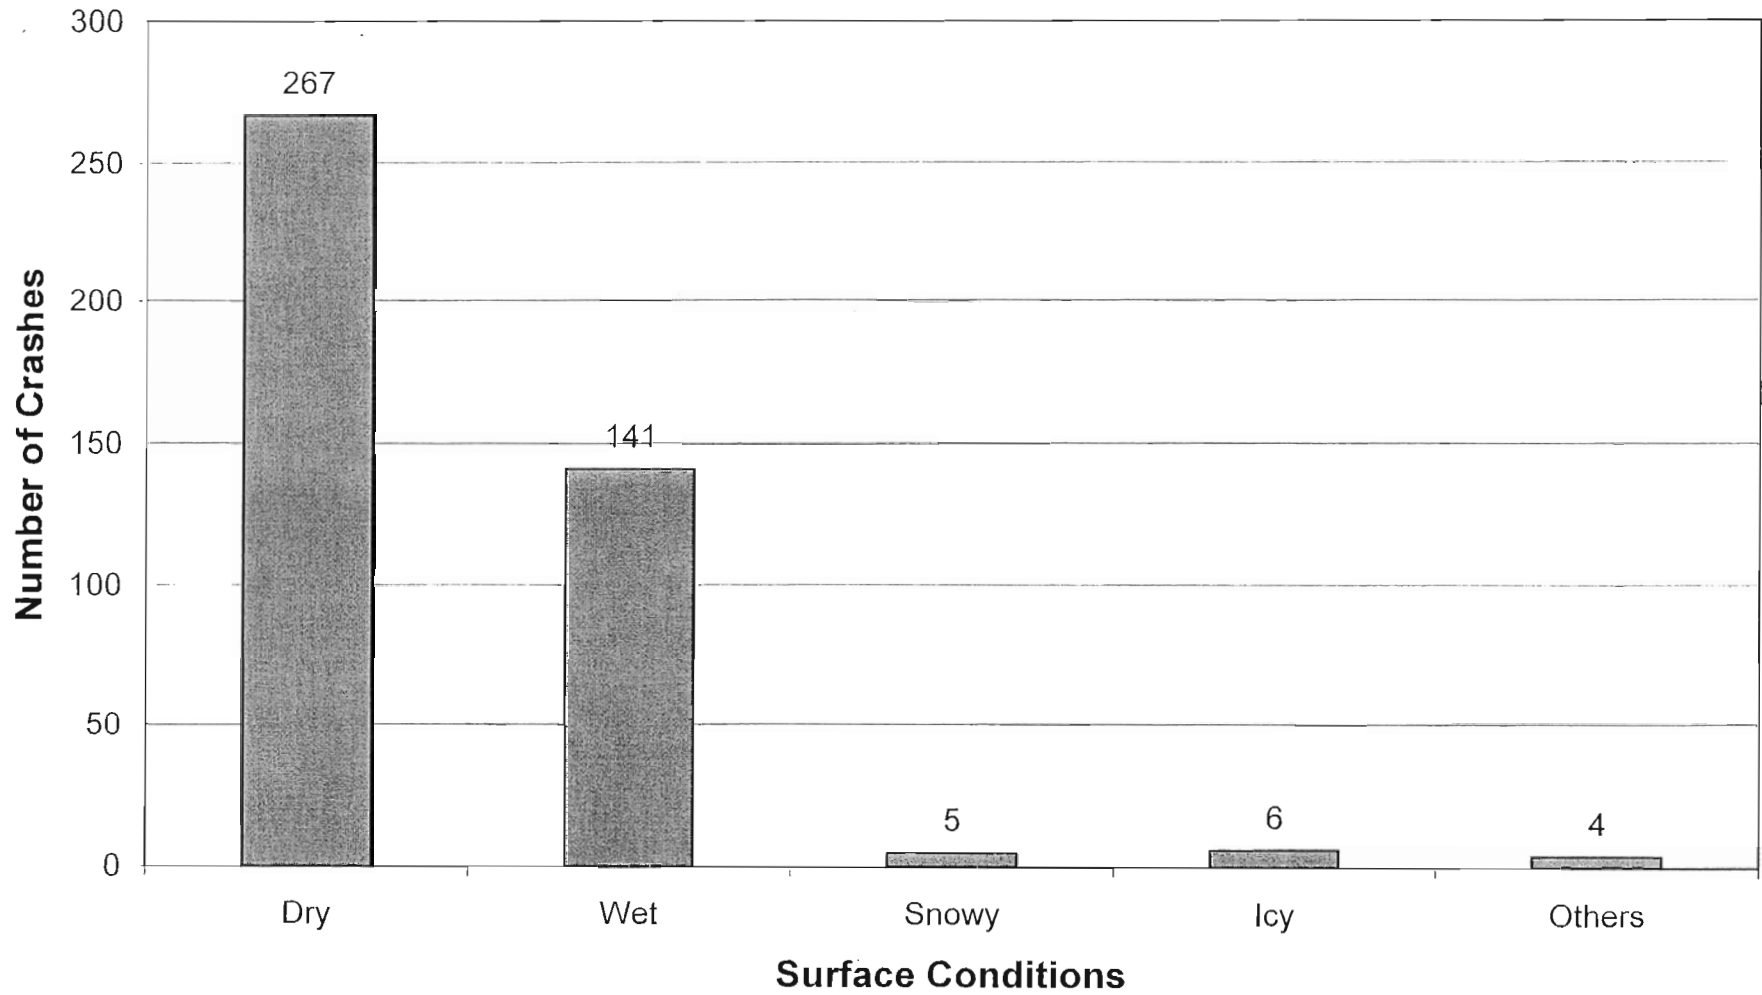
Jimmie Leeds Rd (CR 561 & 633)
Crash Occurrence by Surface Conditions

- ♦ The percentage of crashes for wet surface conditions (33%) is greater than the statewide average for county roads (approximately 24%). (possible indication of a slippery road surface)

- ♦ The percentage of crashes with snowy or icy surface conditions (3%) is consistent with the statewide average for county roads (approximately 5%).
- ♦ The percentage of crashes with injuries (26%) is consistent with the statewide average for county roads (approximately 30%).

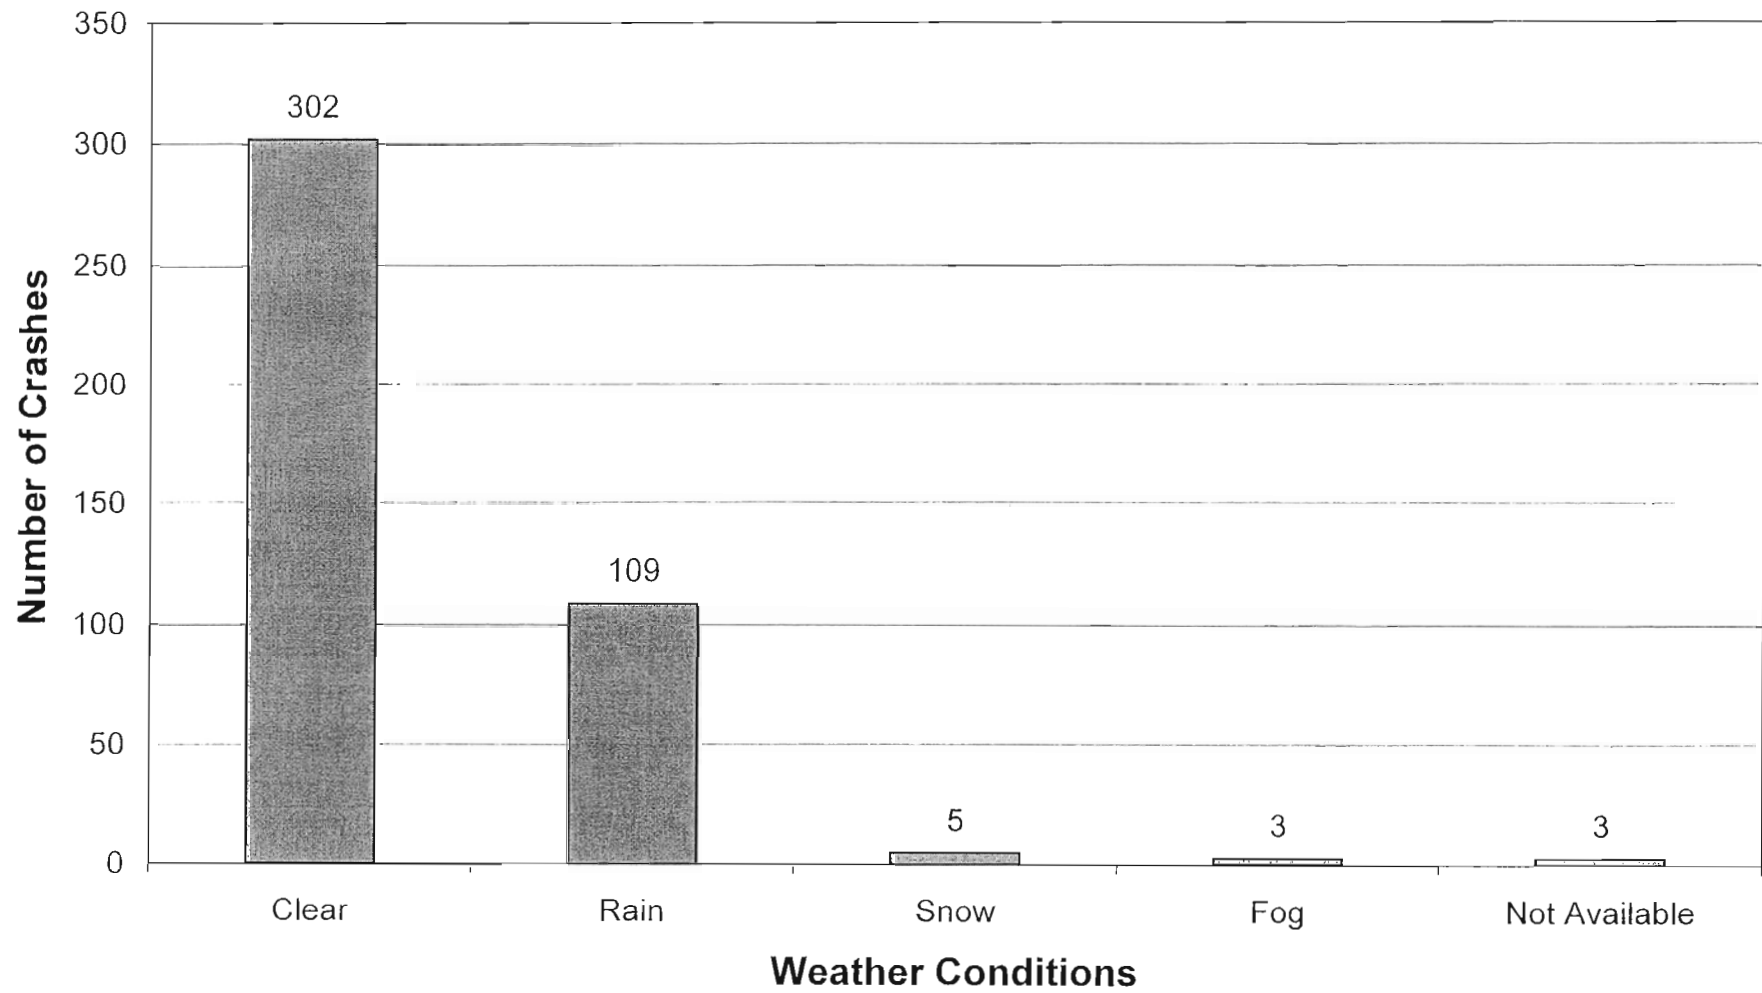
Jimmie Leeds Rd (CR 561 & 633)
Crash Occurrence by Weather Conditions

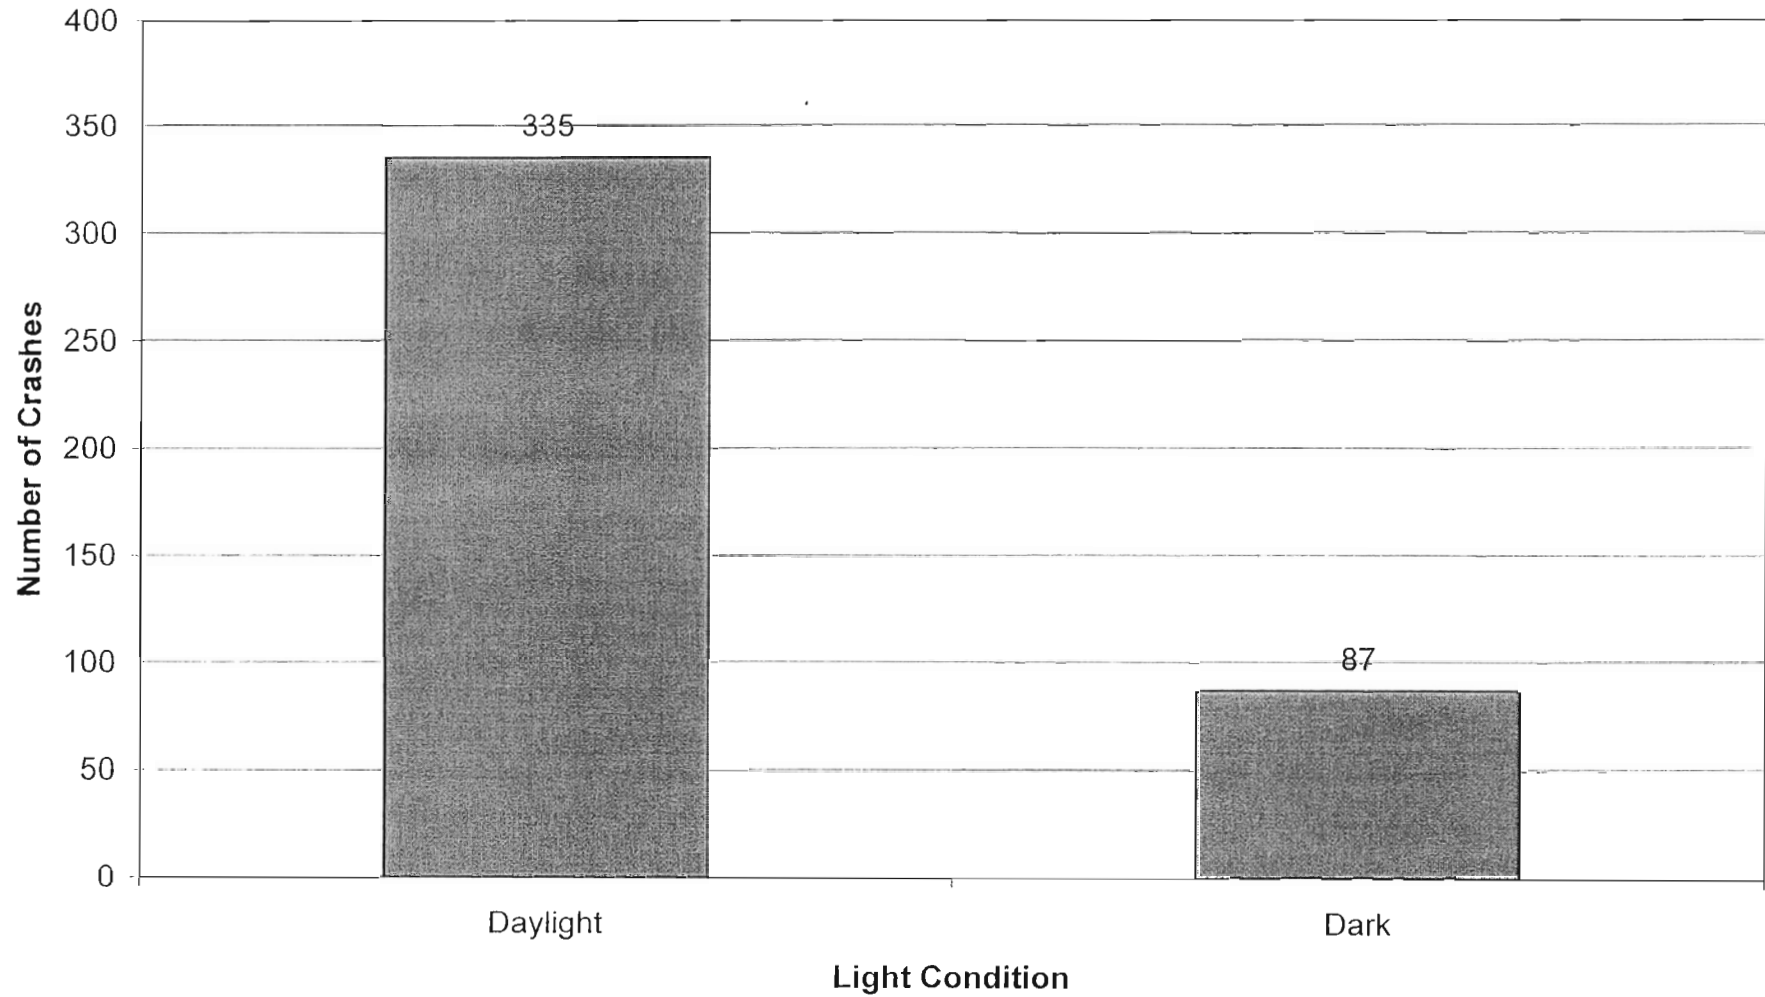
Jimmie Leeds Rd (CR 561 & 633)
Crash Occurrence by Light Condition

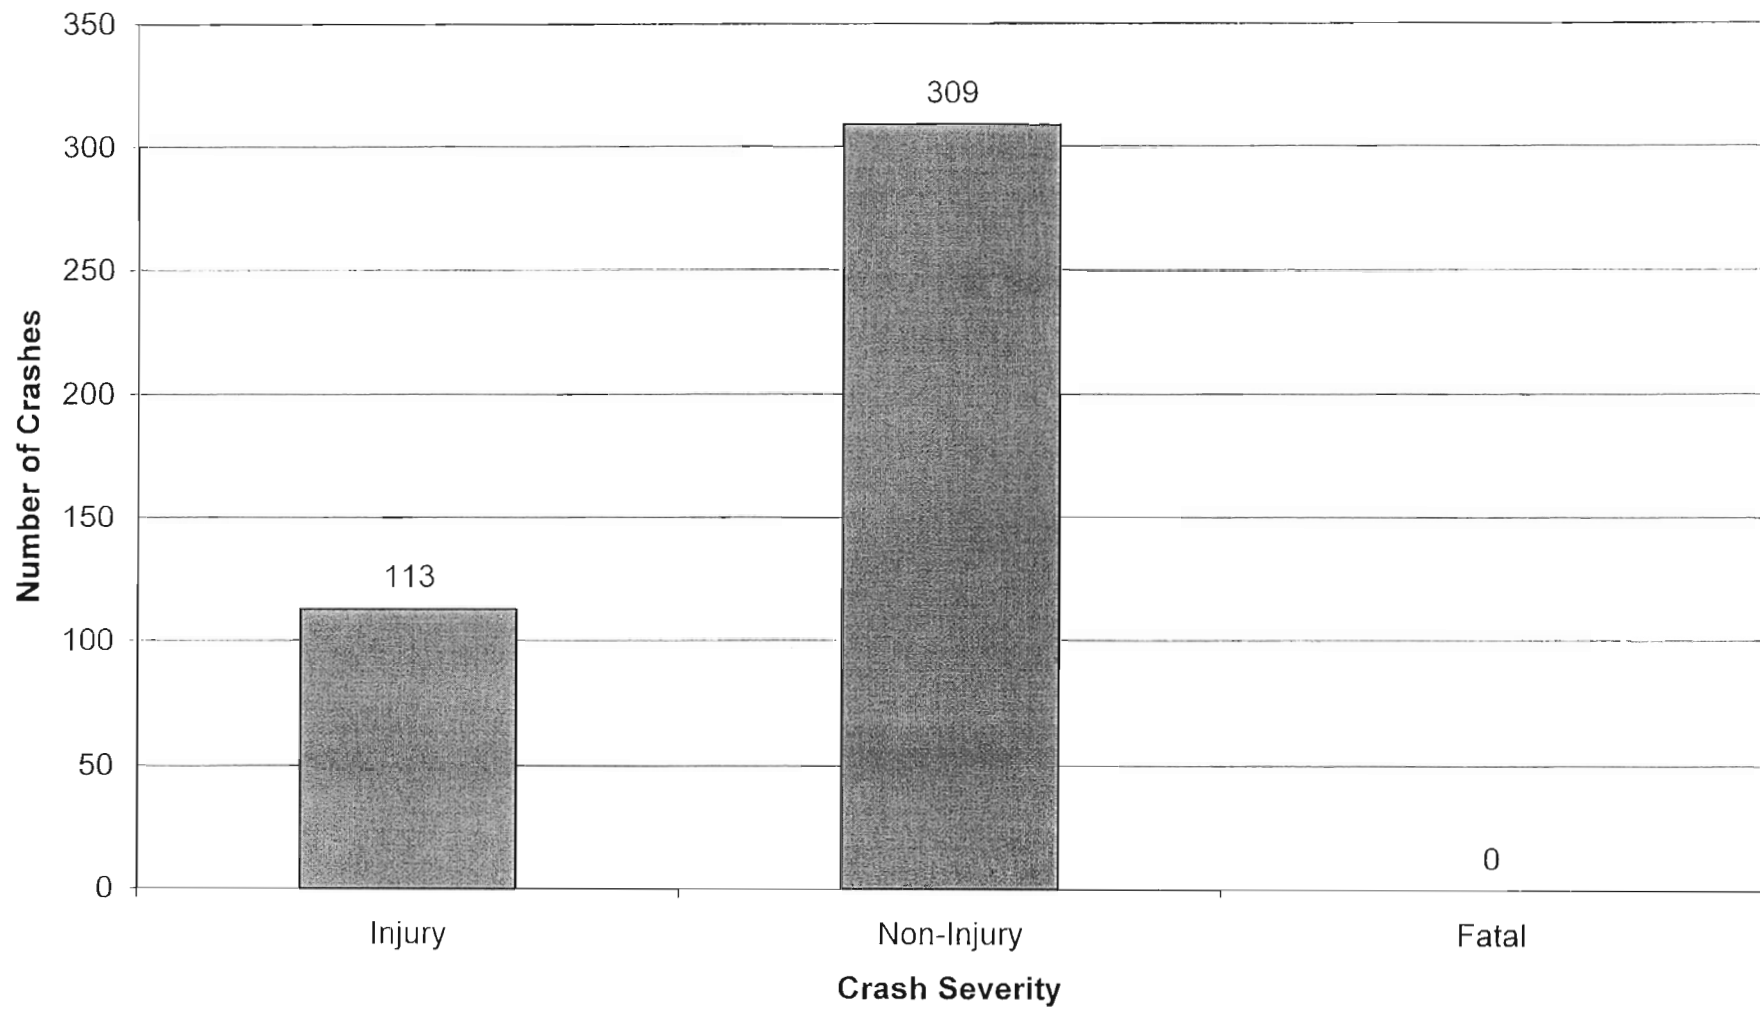
Jimmie Leeds Rd (CR 561 & 633)
Crash Severity

0 – fatal crashes

113 – injury crashes

309 - non-injury crashes

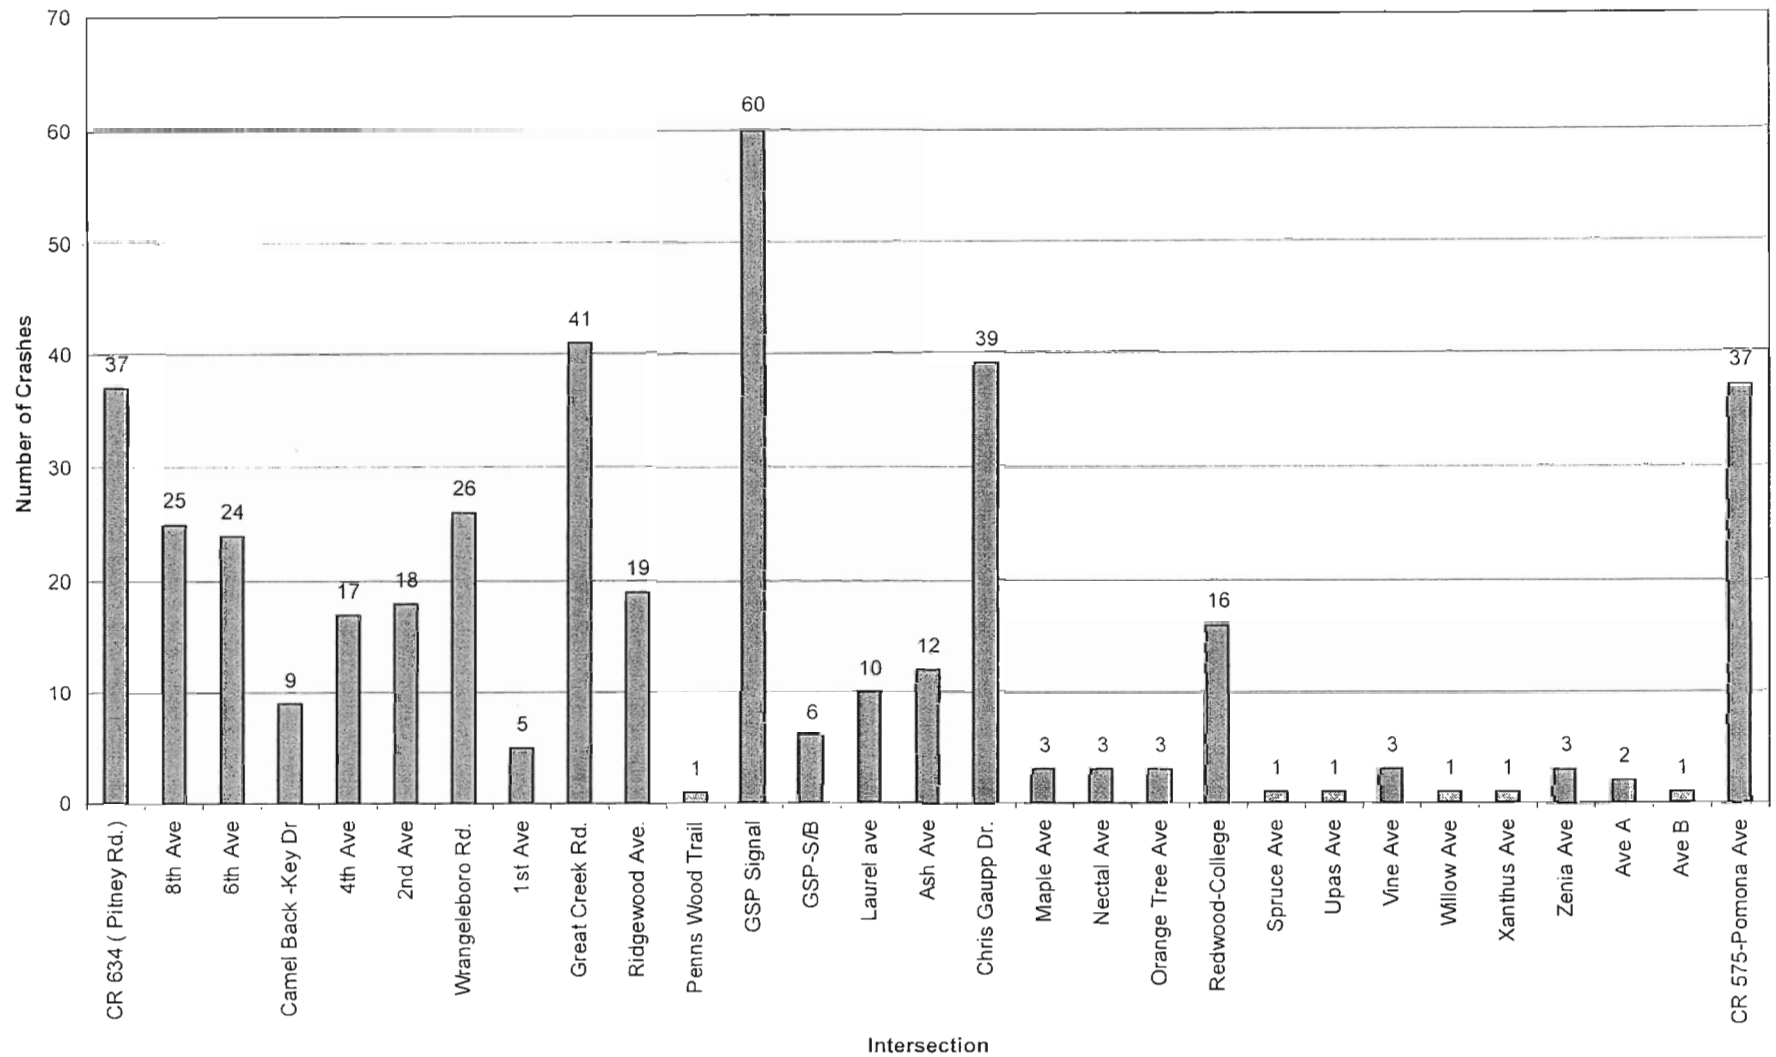
Jimmie Leeds Rd (CR 561 & 633)
Spot Location of Crashes (Proximity to Nearest Intersection)

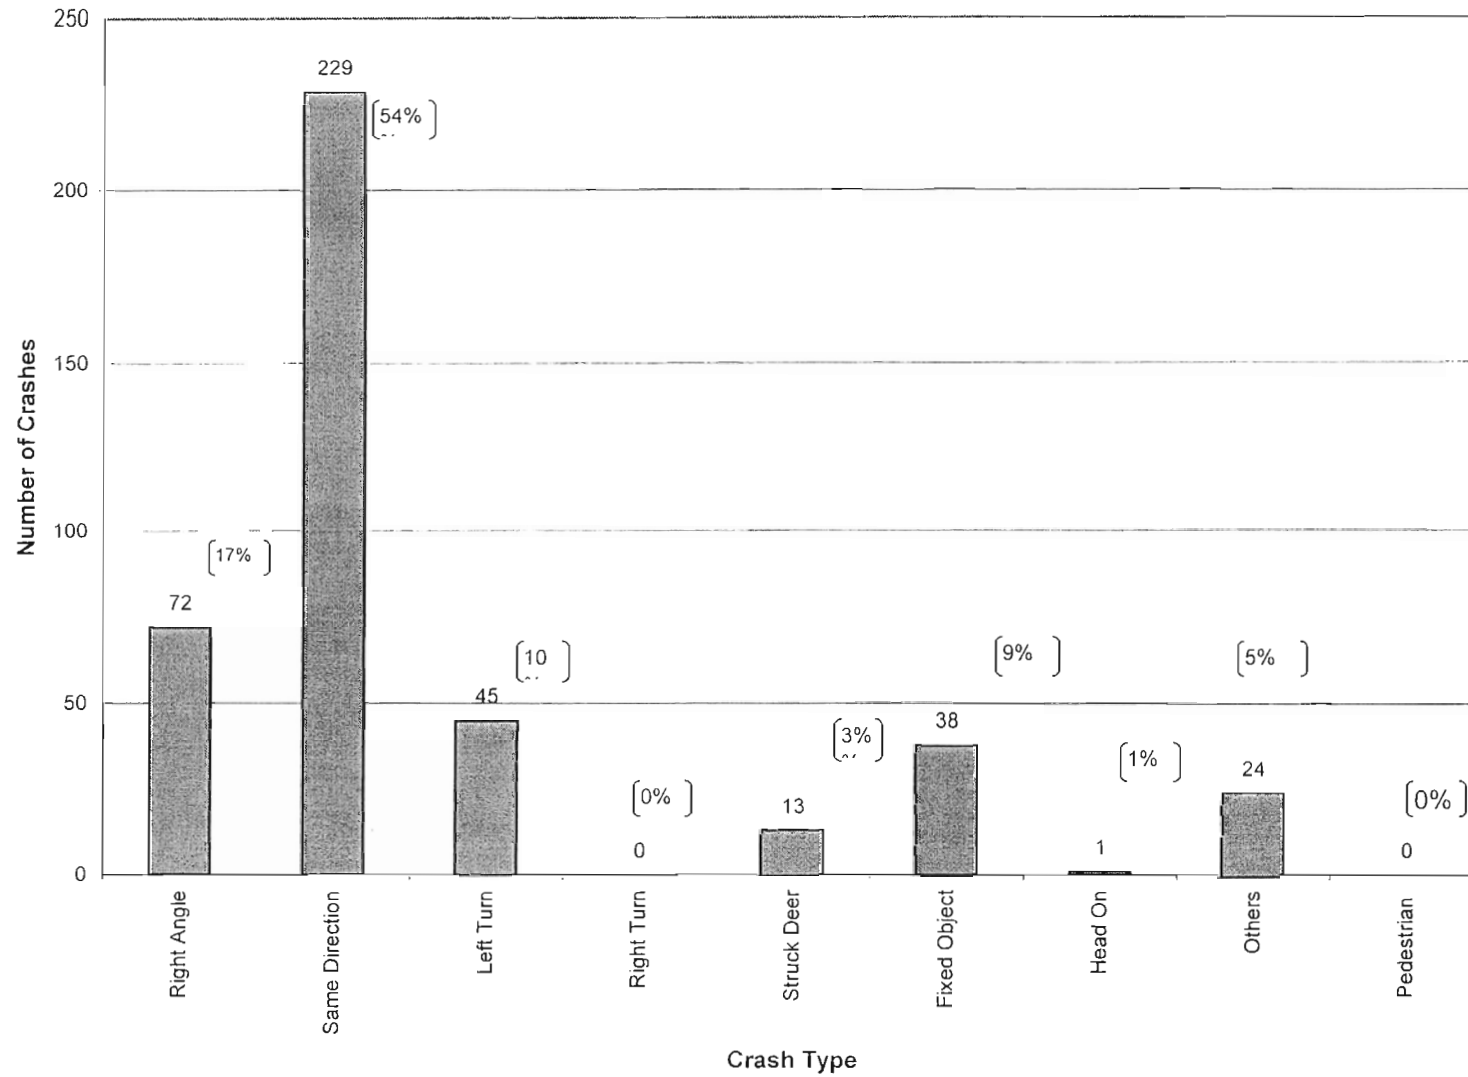
Jimmie Leeds Rd (CR 561 & 633)
Crash Type

72 – right-angle type crashes – Four at Pitney Road, three at the driveway to WAWA, three at the driveway to Downtown Plaza, three at 8th Avenue, four at 2nd Avenue, five at Chris Gaupp Drive, six at Redwood Avenue-College Entrance, and six at Pomona Road. There were no other concentrations.

229 – same-direction type crashes – Twenty-five (25) at Pitney Road, seven at 8th Avenue, five at the municipal complex driveway, three at Camel Back-Key, eight at 4th Avenue, eight at 2nd Avenue, 17 at Wrangleboro Road, 18 at Great Creek Road, eight at Ridgewood Avenue, 46 at the GSP signal, six at southbound GSP, four at Laurel Avenue, 25 at Chris Gaupp Dr., five at Redwood-College entrance, and 22 at Pomona Road. There were no other concentrations.

45 – left-turn type crashes – Five at Pitney Road, and nine at the GSP signal. There were no other concentrations.

38 – fixed-object type crashes – Five at 4th Avenue, four in the vicinity of 2nd Avenue, and four at Chris Gaupp Drive. There were no other concentrations.

1 – head on type crash – at Willow Avenue.

13 – struck animal - Five in the vicinity of Ash Avenue. There were no other concentrations.

24 – other type crashes – There were no concentrations.
