South Jersey Transportation Planning Organization

2006 Road Safety Audit

**Broad Street (CR 607)
Penns Grove Borough/Carney's Point Township
Salem County**

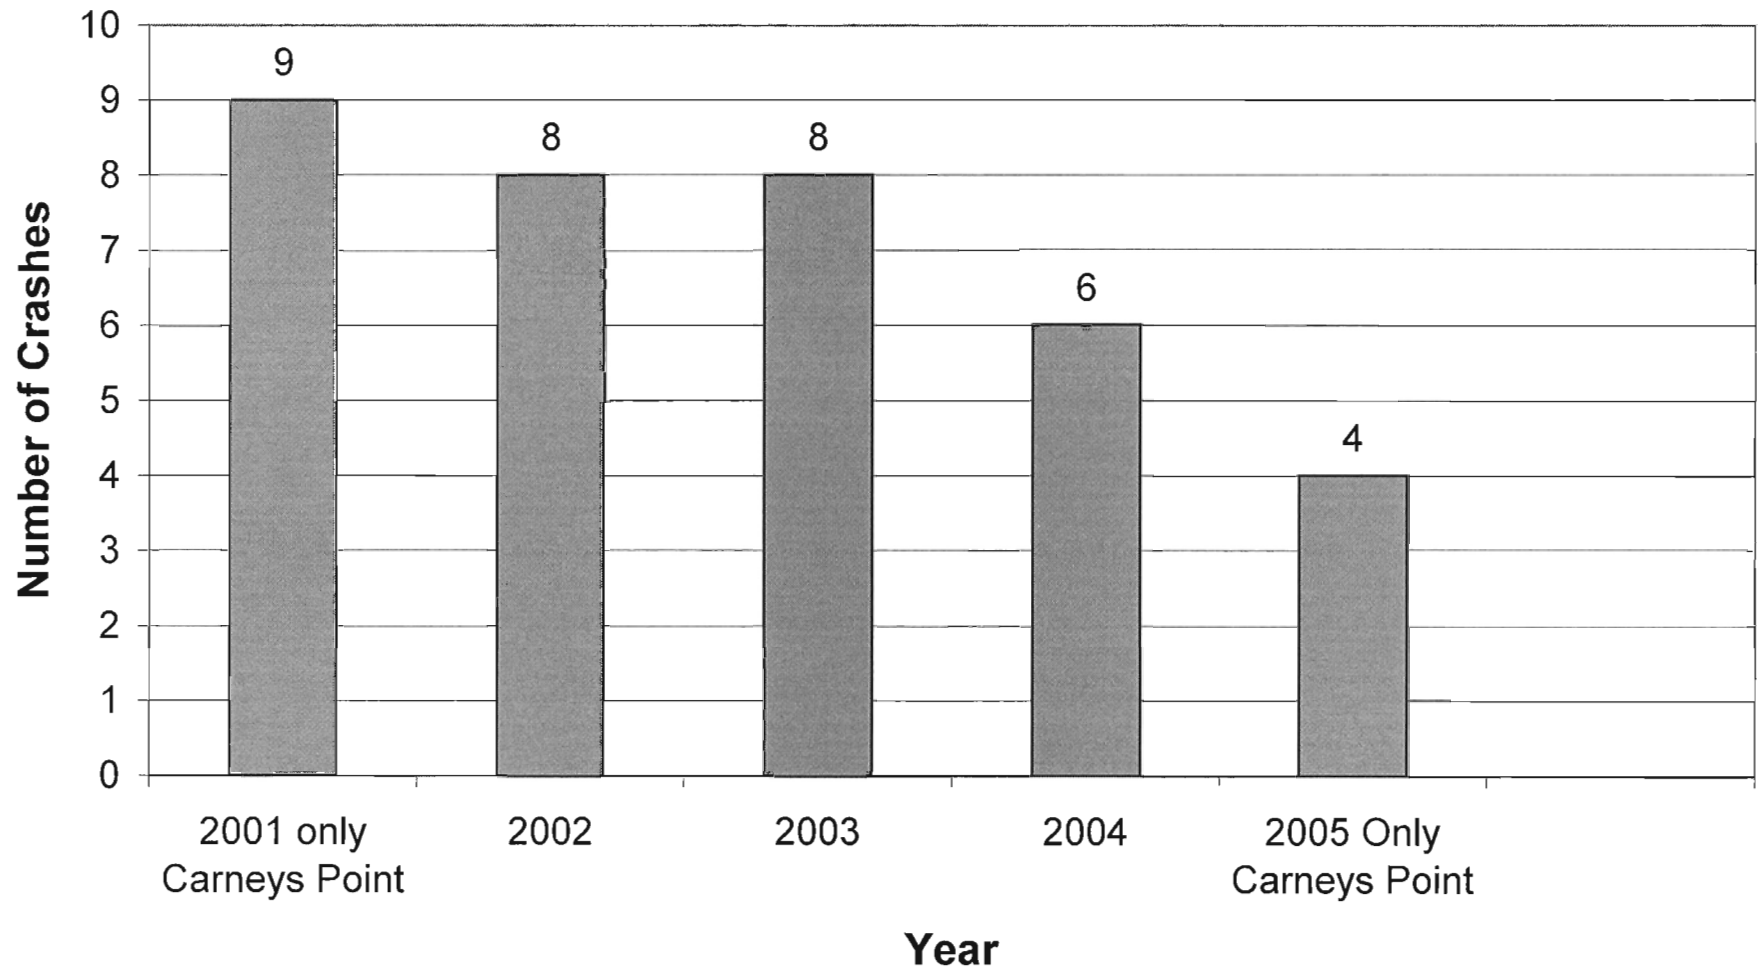
South Broad Street (CR 607) 5 Year Trend

section of road. Eleven (11) crashes occurred in Penns Grove Borough and 24 occurred in Carneys Point Township. Nine (9) crashes occurred in 2001 (Penns Grove only), eight (8) in 2002, eight (8) in 2003, six (6) in 2004 and four (4) in the first nine months of 2005 (Penns Grove only).

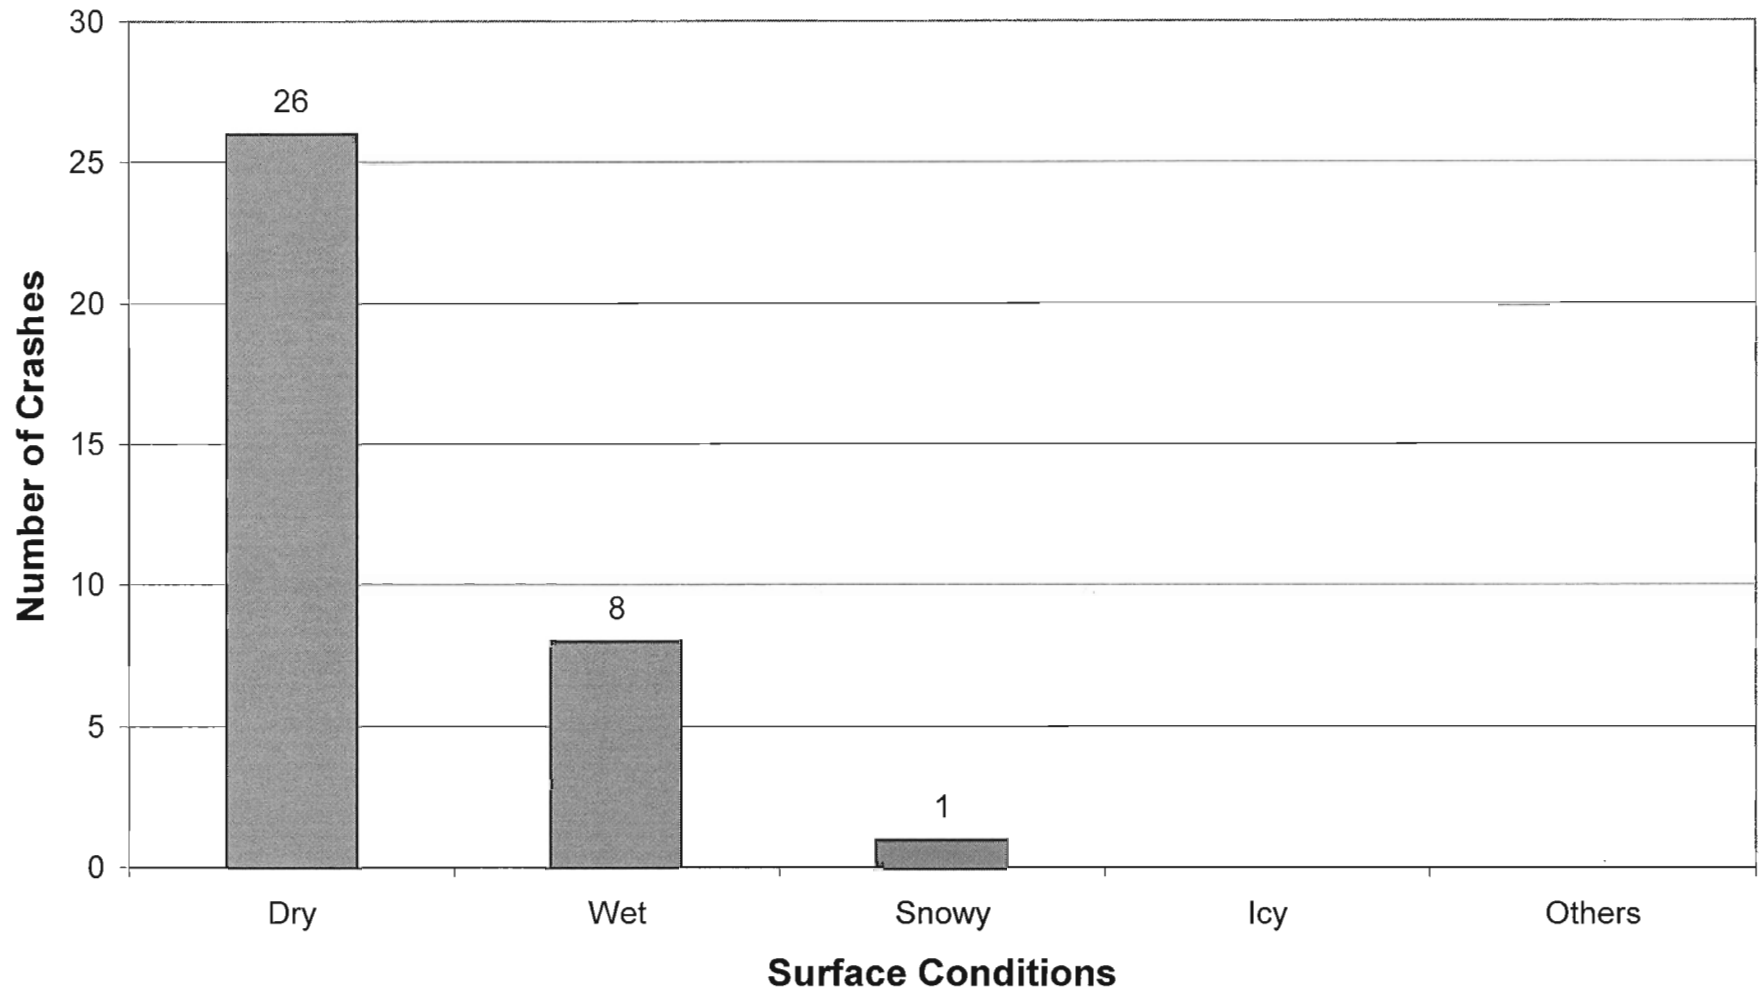
**South Broad Street (CR 607)
Crash Occurrence by Surface Conditions**

statewide average for county roads (approximately 24%). The percentage of crashes with snowy or icy surface conditions (6%) is consistent with the statewide average for county roads (approximately 5%).
