South Jersey Transportation Planning Organization

2011-12 Road Safety Assessment

**New Jersey Avenue (CR 621)
Wildwood Crest Borough
Wildwood City
Cape May County**

April 25, 2012

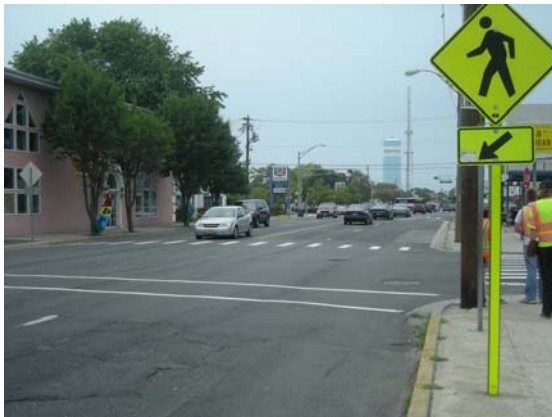
SAFETY ISSUE	REMEDIAL ACTION	LEVEL OF EFFORT REQUIRED			POTENTIAL SAFETY BENEFIT		
			LOW	MEDIUM	HIGH	LOW	MEDIUM	HIGH
1	General comment - there are some handicapped ramps along the roadway but most do not appear to be in compliance with ADA standards. Other locations lack them entirely. Many lack the detectable warning surfaces. (Pictures 1& 2)	Consideration be given to installing ADA compatible ramps along the roadway in conjunction future roadway projects.			X			X

**PICTURE 1:
NO CURB RAMP AT CROSSWALK AT
HEATHER ROAD**

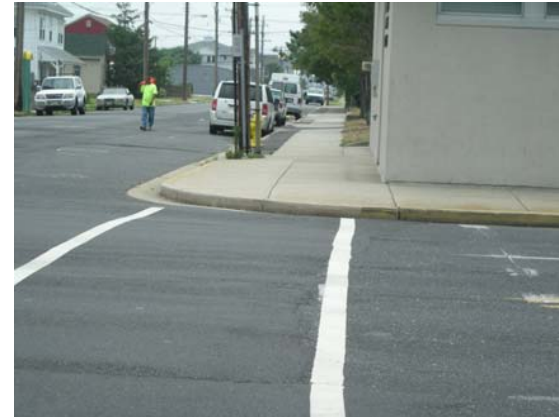
**PICTURE 2:
NO CURB RAMP AT CROSSWALK AT
GARFIELD AVENUE**

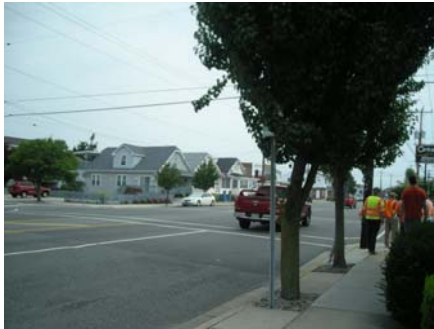
SAFETY ISSUE	REMEDIAL ACTION	LEVEL OF EFFORT REQUIRED			POTENTIAL SAFETY BENEFIT		
		LOW	MEDIUM	HIGH	LOW	MEDIUM	HIGH
2 General comment - Sign installations. Many of the signs along the road are installed as “bendaway” rather than “breakaway.” Many installed as “breakaway” are installed incorrectly with the stub too far out of the ground or on the wrong side of the post. It was noted that many of the signalized intersections have hinged “STOP” signs on the side street approaches to New Jersey Ave. It was stated by the local team members that these signs are used to supplement the stop condition when the signals are operated in the flashing mode in the off season or during power outages which we were told occur with some frequency. (Pictures 3&4)	Consideration should be given to inventorying the method of sign installation along the entire road and taking steps to properly install all signs as “breakaway” in accordance with the most current NJDOT standards and the MUTCD.			X		X

**PICTURE 3:
20 MINUTE PARKING SIGN IN
TREE SOUTH OF CROCUS ROAD
NON-BREAKAWAY POST**

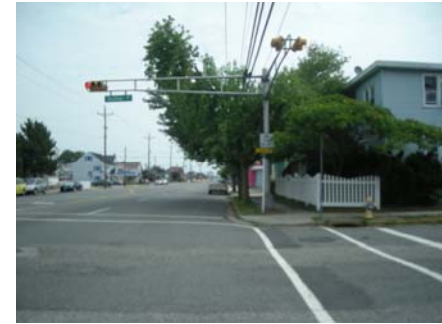
**PICTURE 4:
NON-BREAKAWAY SIGN AT
LINCOLN AVENUE**

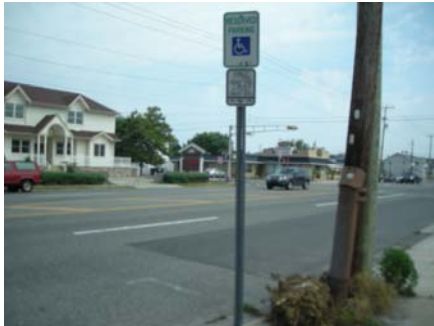
**PICTURE 5:
RESERVED PARKING SIGN POST
NON-BREAKAWAY, SOUTH OF
PALM ROAD**

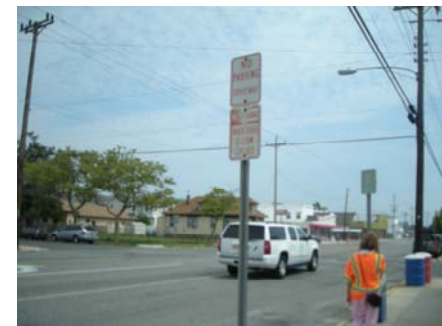
**PICTURE 6:
NO PARKING SIGNS WORN
AND ON NON-BREAKAWAY
POST, NORTH OF
COLUMBINE ROAD**

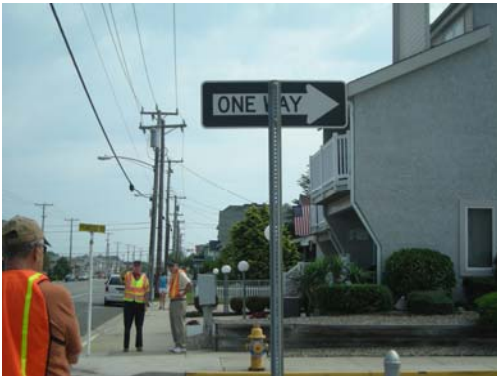
7	General Comment- many of the one way roads are signed with a single double sided "ONE WAY" signs on a sign post instead of the standard installation of two "ONE WAY" signs with one installed on either side of the sign post. (Pictures 7 & 8)	Revise all installations to standard method of signing.	X			X

**PICTURE 7:
ONE (1) ONE-WAY SIGN
MOUNTED INSTEAD OF BACK-
TO-BACK MOUNT, NON-
BREAKAWAY POST AT
PRIMROSE AVENUE**

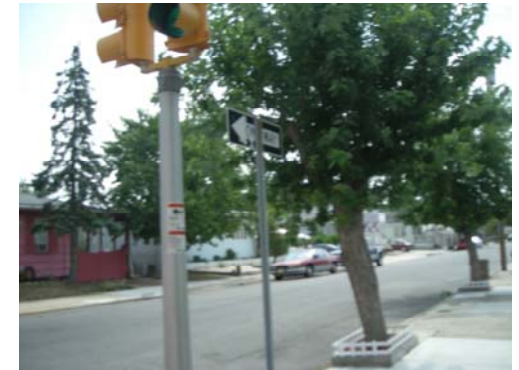
**PICTURE 8:
ONE WAY SIGN OBSCURED
BY TREE LINE AT
ROSEMARY ROAD**

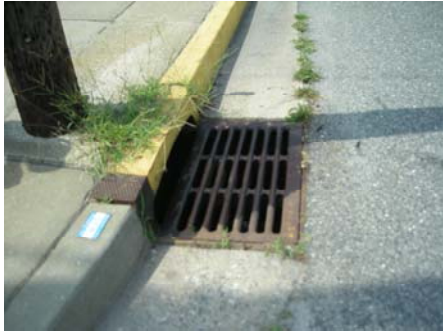
SAFETY ISSUE	REMEDIAL ACTION	LEVEL OF EFFORT REQUIRED			POTENTIAL SAFETY BENEFIT		
			LOW	MEDIUM	HIGH	LOW	MEDIUM	HIGH
10	<p>The following location had inlets located within the crosswalk-handicap ramp area:</p> <p>Rambler Road-southeast corner.</p>	<p>Consideration be given to investigating what can be done to either relocate the inlets out of the handicapped area or to revise the handicapped area to eliminate the conflict.</p>		X		X		
11	<p>Inlet grates which are not bicycle safe were noted at the following locations.</p> <p>Two on the southeast corner and two on the northeast corner of Fern Road.</p>

<p>PICTURE 9: INLET GRATE NOT BICYCLE SAFE GRATE, SOUTHEAST CORNER OF FERN ROAD</p> <p>Two on the southeast corner and two on the northeast corner of Columbine Road.</p> <p>Northeast and southeast corners of Magnolia Avenue.</p> <p>Northeast and southeast corners of Poplar Avenue.</p> <p>Northeast corner of Jupiter Avenue.</p>	<p>Consideration be given to replacing all of the inlet grates with bicycle safe grates.</p>		X				X

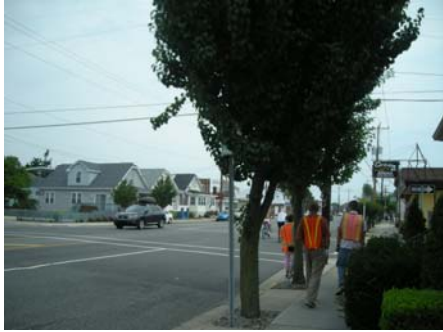
<p>PICTURE 10: 20 MINUTE PARKING SIGN IN TREE SOUTH OF CROCUS ROAD</p>

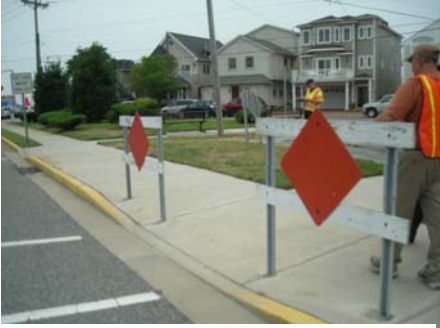
SAFETY ISSUE	REMEDIAL ACTION	LEVEL OF EFFORT REQUIRED			POTENTIAL SAFETY BENEFIT		
			LOW	MEDIUM	HIGH	LOW	MEDIUM	HIGH
12	<p>Continued-</p> <p>“ONE WAY” sign on the northwest corner of Palm Road.</p> <p>Worn “DO NOT ENTER” sign on the southwest corner of Palm Road.</p> <p>Worn “STOP” sign on the southwest corner of Lotus Road.</p> <p>“ONE WAY” sign on the northwest corner of Myrtle Road.</p> <p>Worn truck route assembly and worn County route marker assembly signs just south of Myrtle Road.</p> <p>Opposite Primrose Road- four posts with white colored boards. Posts most likely installed when west side of road was reconfigured. Remove the posts and attachments.</p>

<p>PICTURE 11: NON-MUTCD COMPLIANT BARRICADE @ PRIMROSE AVENUE</p>			X		X

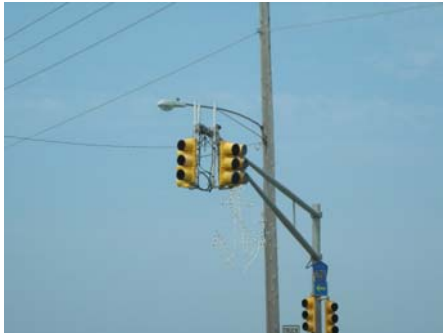
SAFETY ISSUE	REMEDIAL ACTION	LEVEL OF EFFORT REQUIRED			POTENTIAL SAFETY BENEFIT		
			LOW	MEDIUM	HIGH	LOW	MEDIUM	HIGH
13	<p>Rambler Road-Park Boulevard</p> <p>General comment-The traffic signal at this intersection consist of a four pole layout with pole mounted vehicular indications used to control pedestrians. This installation does not appear to conform to the current MUTCD. (Picture 12)</p> <p>There are painted crosswalks across the Rambler Road approach and the New Jersey Avenue (CR 621) southerly approach to the intersection but none across either the Park Boulevard approach or the New Jersey Avenue (CR 621) northerly approach to the intersection.</p>

<p>PICTURE 12: SIGNAL CLUSTER AT RAMBLER ROAD, SW CORNER</p>	<p>Consideration be given to upgrading the signal design to bring it into conformance with the current MUTCD. This would probably require the installation of additional foundations and signal poles</p> <p>Consideration be given to installing a crosswalk across either or both the Park Boulevard approach and New Jersey Avenue (CR 621) northerly approach. If only one new crosswalk is installed, install the necessary pedestrian prohibition crossing signs directing pedestrians to the crosswalks at the intersection should be installed. In conjunction with the installation of the crosswalk the necessary WALK_DONT WALK pedestrian indications should also be installed.</p>			X			X

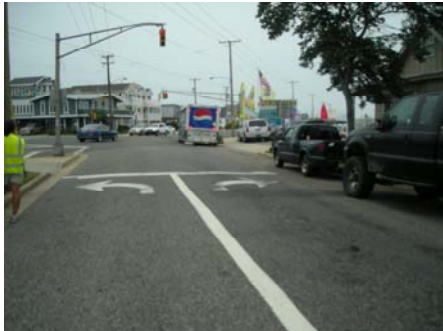
SAFETY ISSUE	REMEDIAL ACTION	LEVEL OF EFFORT REQUIRED			POTENTIAL SAFETY BENEFIT		
			LOW	MEDIUM	HIGH	LOW	MEDIUM	HIGH
13	<p>Rambler Road-Park Boulevard Continued- The Park Boulevard approach to the intersection has an exclusive green interval but has only three section signal heads with red ball, yellow ball and green ball sections displayed. The current MUTCD requires this interval to also display a green left turn arrow.</p> <p>The painted arrows and “ONLY” pavement markings on the Park Blvd. approach do not reflect the two left turn movements that can be made from the approach , one onto Rambler Road and the other onto northbound New Jersey Avenue (CR 621). (Picture 13)</p> <p>There are no lane use control signs reflecting the lane usage control pavement marking noted above.</p>	<p>Consideration be given to upgrading the signal design to bring it into conformance with the current MUTCD.</p> <p>Consideration be given to revising the pavement markings to reflect the two left turn movements.</p> <p>Consideration be given to installing the necessary lane use control sign along the Park Boulevard approach.</p>			X			X

<p>PICTURE 13: ARROW PAVEMENT MARKINGS ON PARK BLVD. APPROACH</p>	X				X

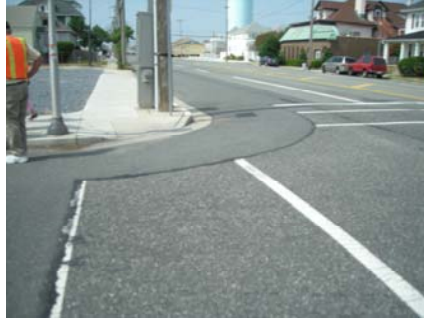
SAFETY ISSUE	REMEDIAL ACTION	LEVEL OF EFFORT REQUIRED			POTENTIAL SAFETY BENEFIT		
			LOW	MEDIUM	HIGH	LOW	MEDIUM	HIGH
14	<p>Palm Road- General comment- the traffic signal at this intersection consists of a four pole layout with pedestrian indications. The signal appears to meet the minimum requirements of the MUTCD. The pedestrian signal heads are weather beaten.</p> <p>No mast arm mounted street name signs exist at the intersection.</p> <p>Southeast corner of the intersection was repaved and the crosswalks on that corner were not repainted. (Picture 14)</p> <p>“DO NOT ENTER” sign installed on the pedestal pole on the northwest corner of the intersection is worn.</p> <p>“DO NOT ENTER” sign on the southwest corner of the intersection is worn.</p> <p>An empty non-breakaway sign post is on the northeast corner of the intersection.</p>

<p>Consideration be given to installing mast arm mounted street name signs at the intersection.</p> <p>Re-install crosswalks.</p> <p>Install new sign.</p> <p>Install new sign.</p> <p>Remove sign post.</p> <p>PICTURE 14: CROSSWALK NOT EXTENDING TO CURB AT SOUTHEAST CORNER OF PALM ROAD</p>

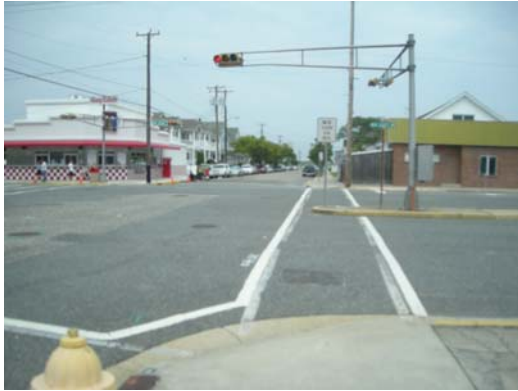
SAFETY ISSUE	REMEDIAL ACTION	LEVEL OF EFFORT REQUIRED			POTENTIAL SAFETY BENEFIT		
			LOW	MEDIUM	HIGH	LOW	MEDIUM	HIGH
19	<p>Sweet Briar Road Signalized intersection</p> <p>General comment- the signal design at this intersection consists of a two pole layout with two mast arms on each pole.</p> <p>There is a service road just east of the New Jersey Avenue (CR 621) easterly curb line. There are no signal indications on the far side of the service road to define the stop line along the Sweet Briar Road easterly approach which is located on the far side of the service road. The installation lacks pedestrian indications. Some pedestrian movements at the intersection lack a readily visible indication. The signal at the intersection does not conform to MUTCD requirements and will require a new installation to bring it into conformance. (Pictures 15 & 16)</p>	<p>Consideration be given to installing a complete new signal installation at the intersection.</p>			X			X

**PICTURE 15:
CROSSWALK ACROSS NEW JERSEY
AVENUE AT SWEET BRIAR ROAD**

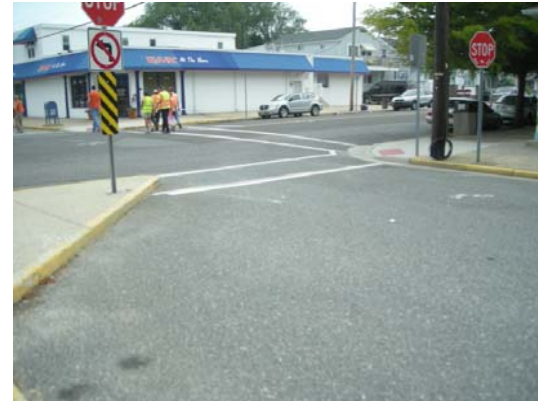
**PICTURE 16:
END OF SERVICE ROAD AT SWEET BRIAR
ROAD**

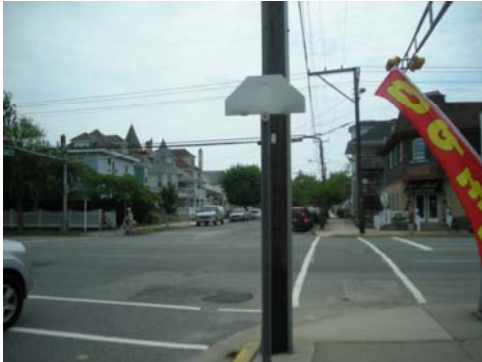
SAFETY ISSUE	REMEDIAL ACTION	LEVEL OF EFFORT REQUIRED			POTENTIAL SAFETY BENEFIT		
			LOW	MEDIUM	HIGH	LOW	MEDIUM	HIGH
22	<p>Heather Road- Signalized intersection General comment- the signal design at this intersection consist of a two pole layout with two mast arms on each pole. Signal does not appear to meet the current standards of MUTCD.</p> <p>There are no WALK-DONT WALK pedestrian indications at the intersection. Some pedestrian movements at the intersection lack a readily visible indication.</p> <p>Right turn on red is prohibited from the northbound New Jersey Avenue (CR 621) approach to the intersection. The need for the prohibition was questioned by some members of the team.</p>	<p>Consideration be given to upgrading the signal design to include pedestrian indications.</p> <p>Consideration be given to evaluation the need to retain the existing right turn on red prohibition for the northbound New Jersey Avenue (CR 621) approach to the intersection.</p>			X		X

<div style="margin-left: 20px;"> <p>PICTURE 17: FOLDING STOP SIGN USED WITH SIGNAL AT HEATHER ROAD</p> </div> </div>								
23	<p>Northbound side- Lavender Road easterly approach to the intersection- partially blacked out stop line approximately 10 feet east of the existing stop line.</p>	<p>Consideration be given to removing the partially blacked out stop line.</p>	X				X

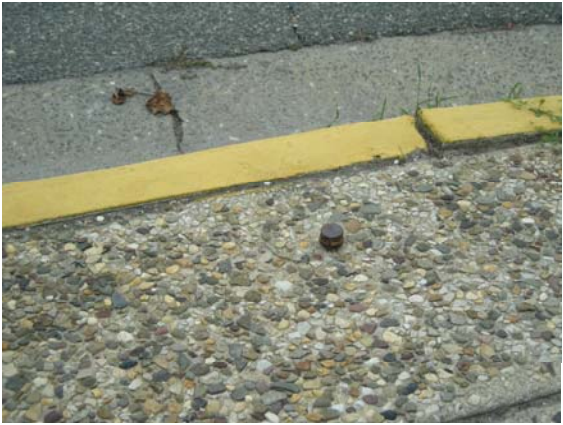
<div style="margin-left: 20px;"> <p>PICTURE 18: TRIPPING HAZARD AT LOTUS ROAD NORTHWEST CORNER</p> </div> </div>								
26	Southbound side-Lotus Road westerly approach to the intersection- stop line has been paved over.	Re-install stop line.	X			X		
27	Young Avenue- Signalized intersection General comment: County officials informed team members that Young Avenue intersection is being re-designed. Therefore it was not assessed.

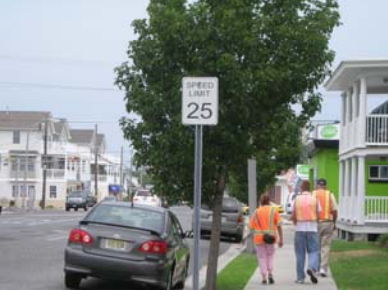
SAFETY ISSUE	REMEDIAL ACTION	LEVEL OF EFFORT REQUIRED			POTENTIAL SAFETY BENEFIT				
		LOW	MEDIUM	HIGH	LOW	MEDIUM	HIGH		
37	Northbound side north of Poplar Road- "SPEED LIMIT 25" sign is worn and appears to be home made. (Picture 19)	Replace with new sign.	X			X

<p>PICTURE 19: NON-MUTCD COMPLIANT SPEED LIMIT SIGN NORTH OF POPLAR AVENUE</p>

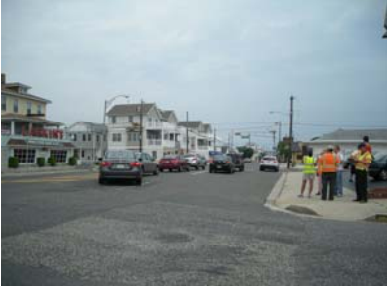
<p>PICTURE 20: STACKING PROBLEM BETWEEN SIGNALS SOUTH OF 26TH AVENUE</p>							
38	<p>26th Street - Signalized intersection General comment- signal layout at intersection consist of one pole with two mast arms on the northeast corner of the intersection and two poles on the southwest corner of the intersection each with one mast arm. Signal does not appear to meet the current standard of the MUTCD. (Picture 20)</p> <p>There are no WALK-DONT WALK pedestrian indications at the intersection. Some pedestrian movements at the intersection lack a readily visible indication.</p> <p>Team members observed traffic backup between signals south of 26th Avenue.</p> <p>"NO TURN ON RED" sign installed on the traffic signal pole on the northeast corner of the intersection is worn.</p> <p>Northbound pavement markings and signing do not address the lane drop.</p>	<p>Consideration be given to upgrading the signal installation to include pedestrian indications across all corners of the intersection.</p> <p>Consideration be given to evaluating the signal timing to alleviate backup.</p> <p>Replace with new sign.</p> <p>Study to develop new signing and pavement markings.</p>				X	X		X
