ATLANTIC AVENUE

ROAD SAFETY AUDIT

Atlantic City, New Jersey

REPORT

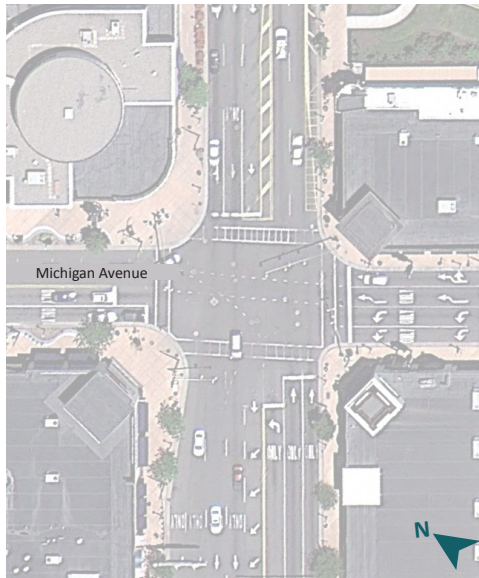
Figure 5

Michigan Avenue and Atlantic Avenue

- North leg. Two northbound (NB) lanes. Two southbound (SB) lanes: one left-turn-only lane and one right-turn-only lane. Left turn lane is set 25 feet from intersection. Trees, vegetation on either side of street.
- South leg. Four NB lanes: two left-turn-only lanes, one through lane (crossing Atlantic Avenue at an angle) and one through/right-turn lane. Parking garage on west side of street 100 feet south of intersection.
- East leg. Three westbound (WB) lanes: two through lanes and one through/right-turn lane. Seven foot median in center. Two eastbound (EB) lanes. Prohibited parking area marked by paint starting 15 feet from intersection and extending eastward.
- West leg. Three EB lanes: two through lanes and one left-turn only set 30 feet back from intersection. Four WB lanes.

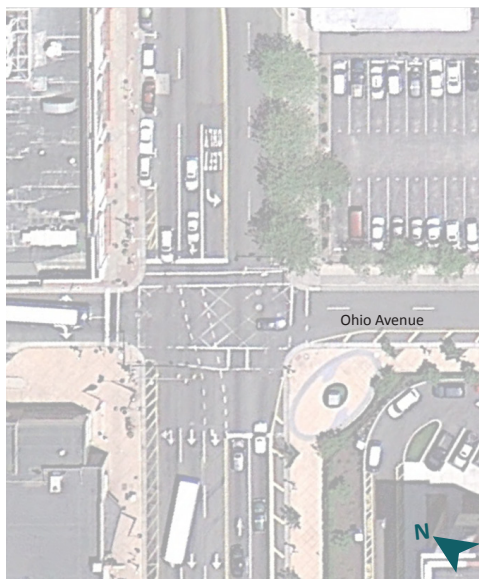
Figure 6

Ohio Avenue and Atlantic Avenue

- North leg. Two SB lanes: one through/left-turn lane and one through/right-turn lane.
- South leg. Two SB lanes. Paint marking prohibited parking begins 15 feet south of intersection.
- East leg. Three WB lanes: two through lanes (angled and dotted guide lines through intersection) and one left-turn only lane. Painted prohibited parking area at WB curb but permitted parking (except in loading areas and bus stops) beyond as leg extends eastward.
- West leg. Three EB lanes. A painted curbside lane on the EB approach keeps it clear for emergency vehicles. The stop bar for the EB approach is 40 feet back from the intersection.

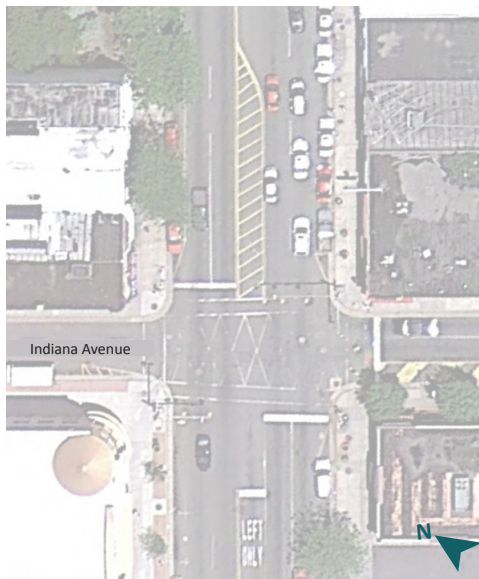
Figure 7

Indiana Avenue and Atlantic Avenue

- North leg. Two receiving NB lanes. Painted hatch-lines to prohibit corner parking but permitted after.
- South leg. Two NB lanes. A third lane farthest to the west prohibits parking, and travel and is reserved for emergency vehicles. Left lane for through-traffic only. Right lane is through/right-turn.
- East leg. Two WB lanes: one through and one through/right-turn lane. Seven-foot median in center. Two receiving eastbound (EB) lanes. Painted hatch-lines prohibit corner parking but permitted after (except in loading/bus zones).
- West leg. Two EB lanes: one left-turn only (45 feet back from intersection), two through lanes. Two receiving lanes. Painted hatch-lines to prohibit corner parking but permitted (except in loading/bus zones) after. Active driveway entrances on south curb.

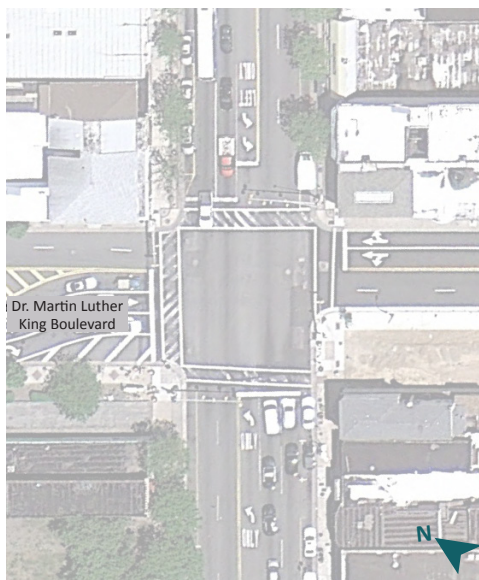
Figure 8

Dr. Martin Luther King Boulevard and Atlantic Avenue

- North leg (70-foot cross-section). Two SB lanes: one right-turn only, one through and one through/left-turn. Lanes are S-shaped to line up with receiving lanes across intersection. Hatched lane near west curb. Two receiving NB lanes.
- South leg (40-foot cross-section). Two NB lanes: one through/left-turn and one through/right-turn, two receiving SB lanes.
- East leg. Three WB lanes: two through and one left-turn only (35 feet back from intersection). Painted hatch-lines to prohibit corner parking but permitted (except in loading/bus zones) after.
- West leg. Three EB lanes: one left-turn only, two through lanes. Two receiving lanes. Painted hatch-lines to prohibit corner parking but permitted (except in loading/bus zones) after. Active driveway entrances on south curb.

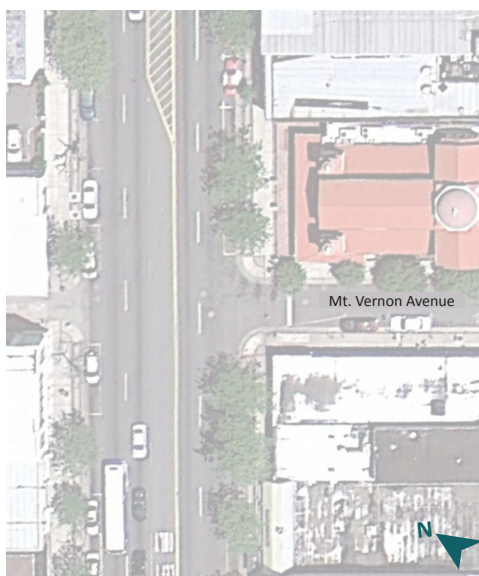
Figure 9

Mt. Vernon Avenue and Atlantic Avenue

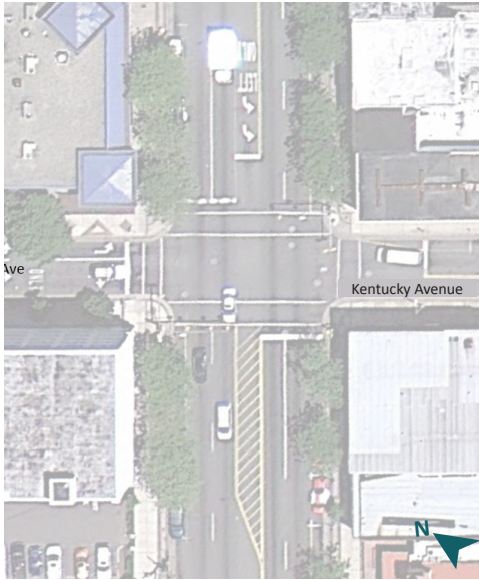
Figure 10

Kentucky Avenue and Atlantic Avenue

- North leg. Two SB lanes: one through/left-turn lane and one through/right-turn lane. Starting 100 feet back from intersection, there are three lanes SB.
- South leg. One NB lane (left/through/right) with stop bar approximately 30 feet back from intersection. Parking permitted long east curb. One receiving SB lane.
- East leg. Three WB lanes: two through lanes and one left-turn lane. Two EB lanes. Painted hatch-lines to prohibit corner parking but permitted (except in loading/bus zones) after. East of the intersection 115 feet, there is a pair of driveway entrances to access the strip mall parking lot.
- West leg. Two through EB lanes and two receiving WB lanes. Curbside parking permitted except for loading and bus zones.

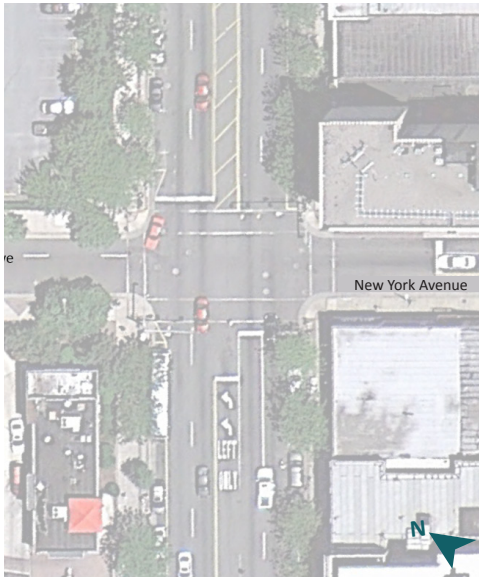
Figure 11

New York Avenue and Atlantic Avenue

- North leg. Two receiving NB through-lanes with parking along west curb.
- South leg. Two NB through-lanes with the stop bar set 60 feet back from intersection. One receiving SB lane.
- East leg. Two WB through-lanes and two receiving EB lanes with hatched 12-foot painted median. Painted angle line to prohibit corner parking but permitted after (except in loading/bus zone on SE corner.)
- West leg. Two EB through-lanes and one left-turn-only lane with the stop bar set 35 feet from intersection. Two receiving WB lanes. Painted angle line to prohibit corner parking but permitted after (except in loading/bus zone on NW corner.)

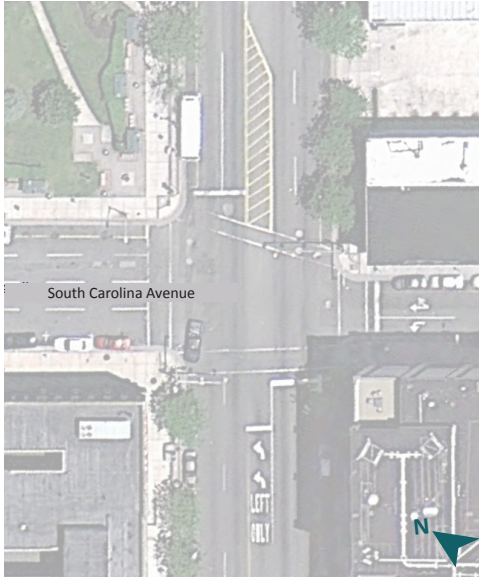
Figure 13

South Carolina Avenue and Atlantic Avenue

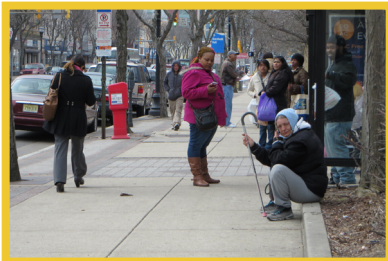
Another very active bus stop where it was observed that the bus stuck into the travel lane.

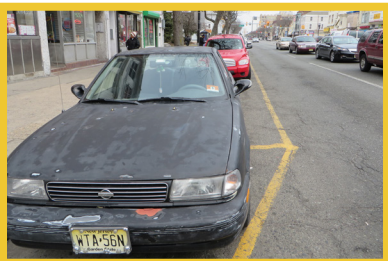
Many vehicles along Atlantic Avenue were observed to be parking in loading zones (like above), parking at intersections, or double-parked. This problem was particularly noted at the NE corner of Indiana Avenue in front of Gem Liquor. Crash reports showed 10 Struck Parked Vehicle crashes at this location.

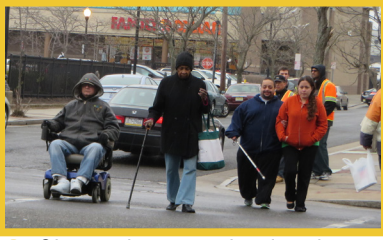
- 36 Observed many pedestrians in need of ADA-compliant facilities.

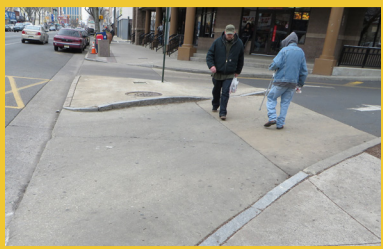
Misaligned curb, crosswalk marking at strip mall entrance.

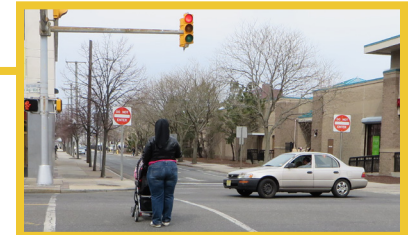
Jaywalking and crossing against the signal were frequently observed along the entire corridor.

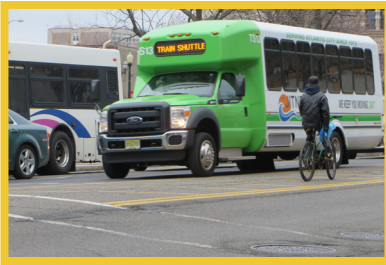
Heavy bus traffic contributes to heavier and more hectic traffic operations.

Antiquated 8-inch signal heads are located along many of the minor street approaches.

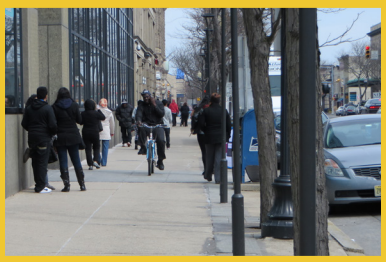
Many human services are located along Atlantic Avenue between Tennessee Avenue and South Carolina Avenue, such as the public library. RSA team members commented that vehicles drop off passengers to utilize these services and double park or park illegally to do so.

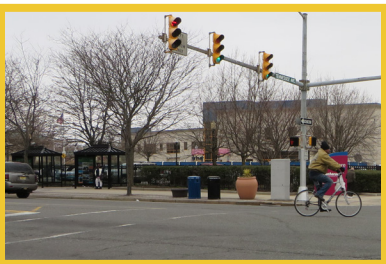
Three pedestrian crashes occurred here in the crosswalk, two of which involved left-turning vehicles when pedestrians had the right of way. Crosswalks were very faded.

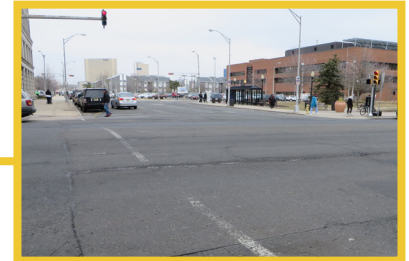
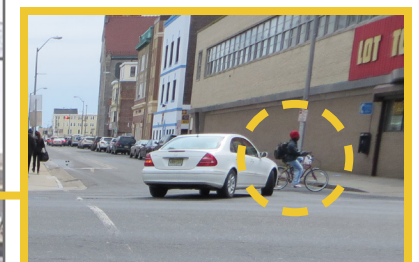
Cyclists traveling along sidewalks at higher-than-walking speed may not be seen by left-turning vehicles.

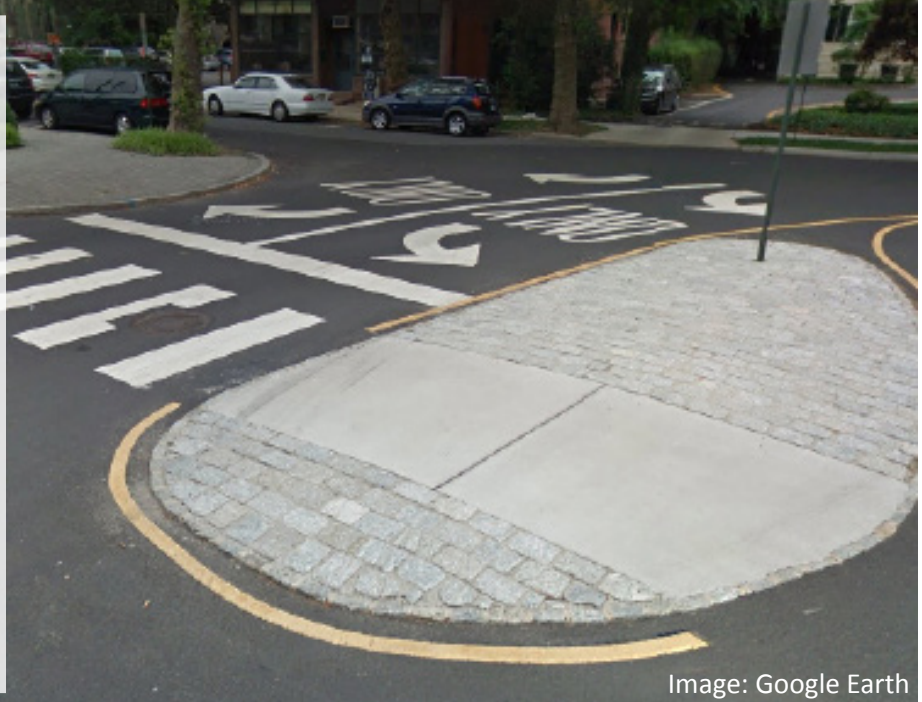
A commonly expressed concern with refuge islands is that they will impede emergency vehicles from full use of the center lane. One way to circumvent this concern is to consider the use of a mountable curb such as the one above in Princeton, New Jersey.

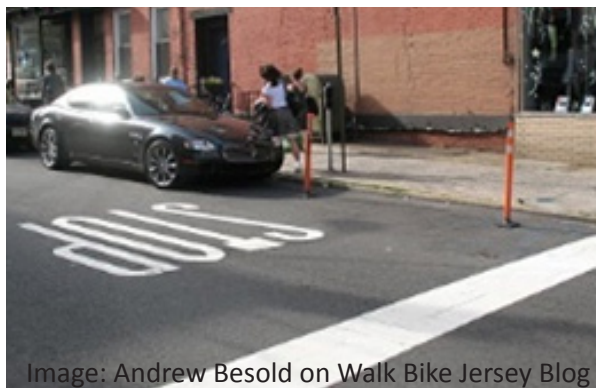
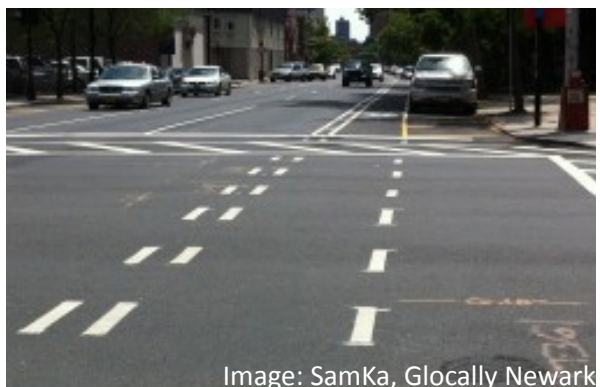
LEFT: A green, textured buffered bike lane in Newark, New Jersey alongside a metered parking lane

BOTTOM: Skipped lines indicate that the bike lane extends through the intersection

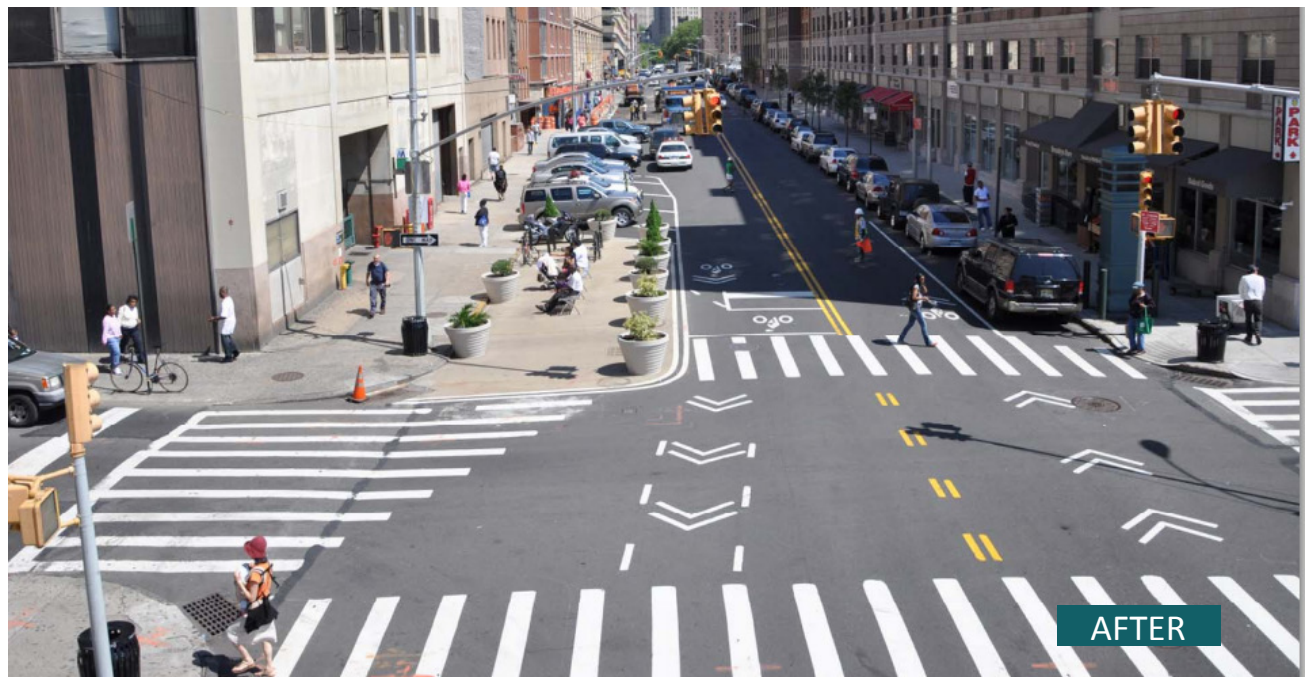
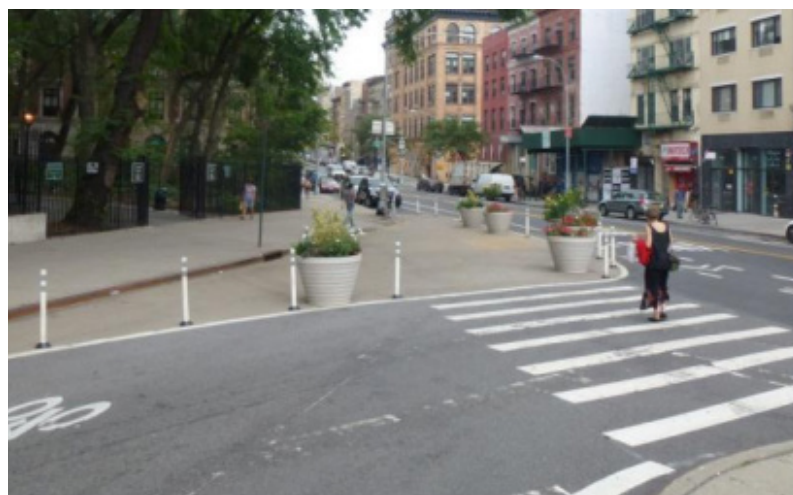
Painted bulb-outs or curb extensions are a quick, inexpensive way to provide safer pedestrian accommodations. They may also be augmented with landscaping elements like planters, benches, bike racks, or garbage receptacles. Notice that the image above also features ergonomic crosswalks that reflect pedestrian desire lines, high visibility crosswalks, and a parking area that does not interject onto sidewalk space.

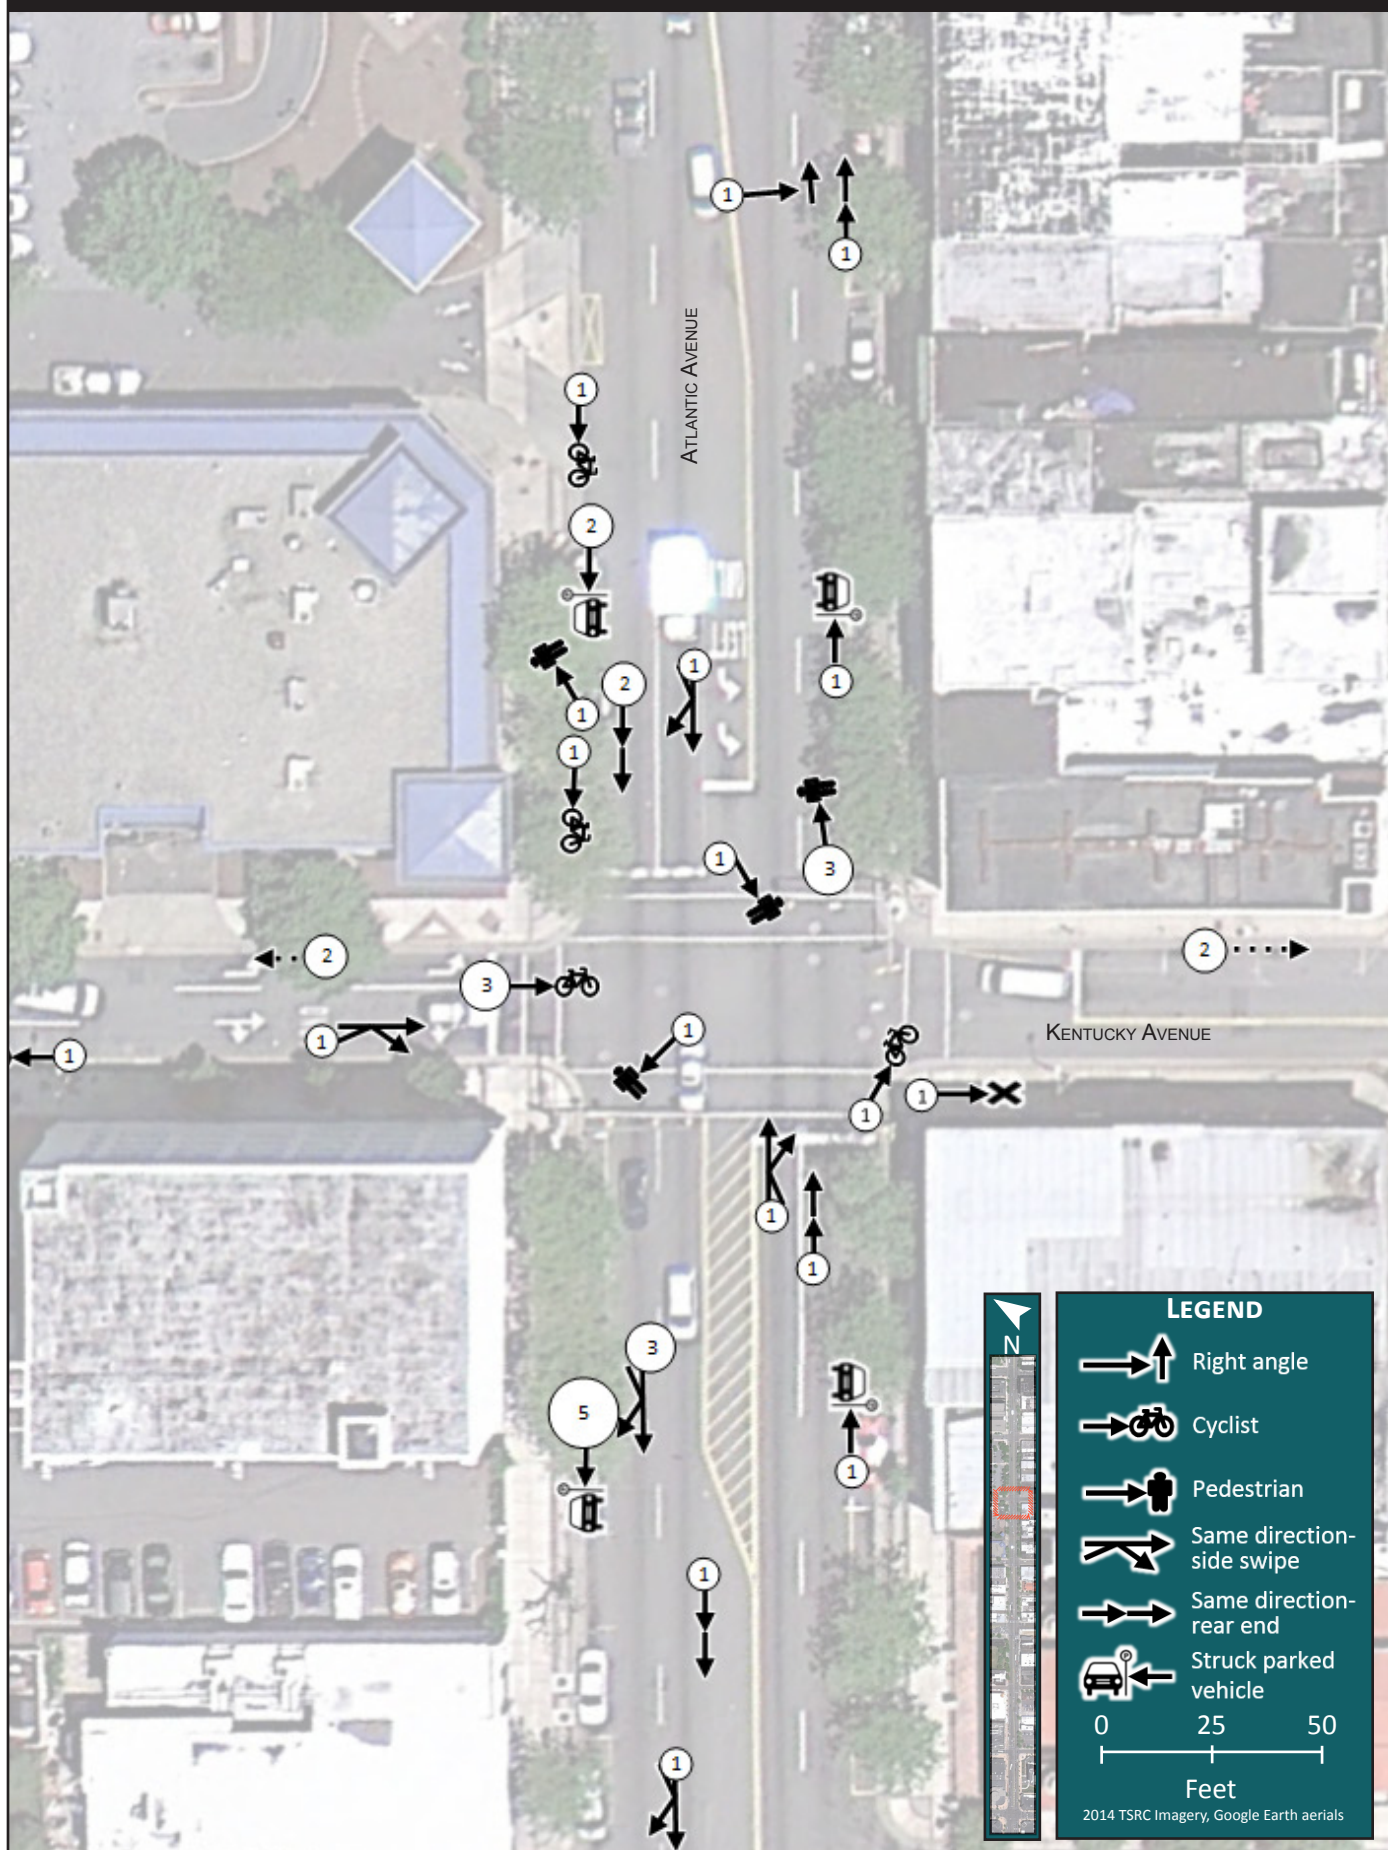
KENTUCKY AVENUE

Crash Type	#
Same Direction - Rear End	5
Same Direction - Side Swipe	7
Right Angle	-
Opposite Direction - Head On/Angular	-
Opposite Direction - Side Swipe	-
Struck Parked Vehicle	9
Left Turn/U-turn	-
Backing	3
Encroachment	-
Overtaken	-
Fixed Object	1
Animal	-
Pedestrian	5
Pedalcyclist	7
Non-fixed Object	0
Railcar - Vehicle	-
Other	-
Total	37
