South Jersey Transportation Planning Organization

2007 Road Safety Audit

**Buck Road (CR 553)
Pittsgrove Township, Upper Pittsgrove Township
Salem County**

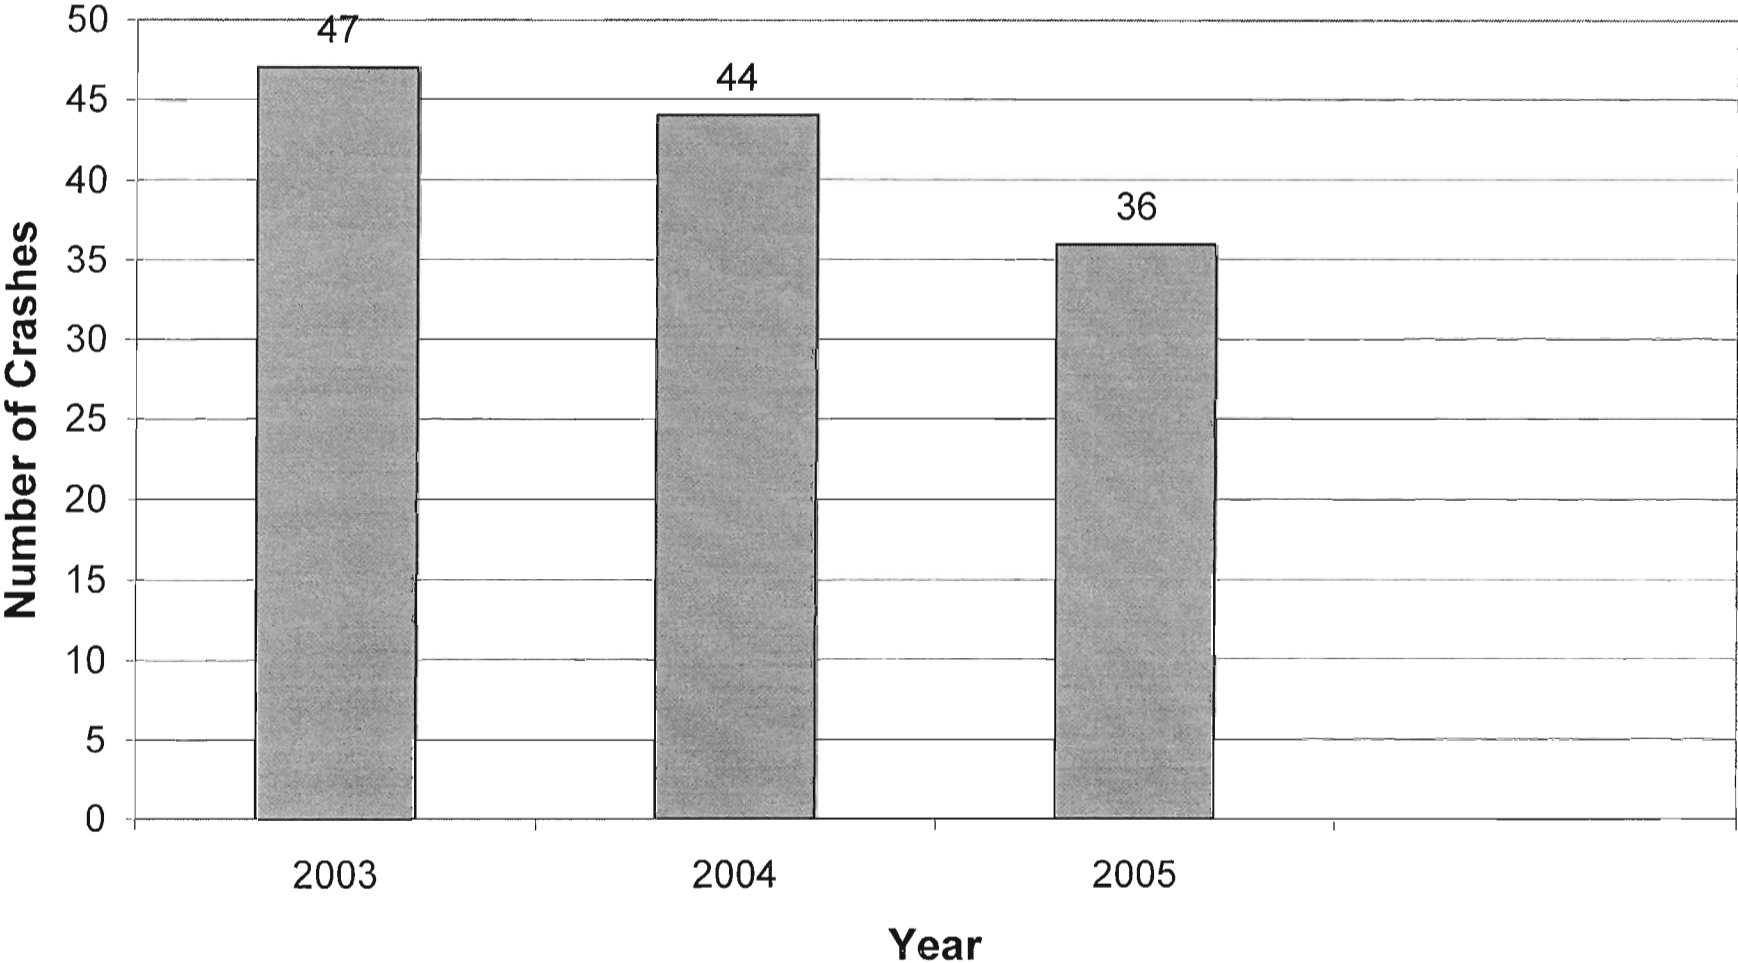
Buck Road (CR 553)
3 Year Trend

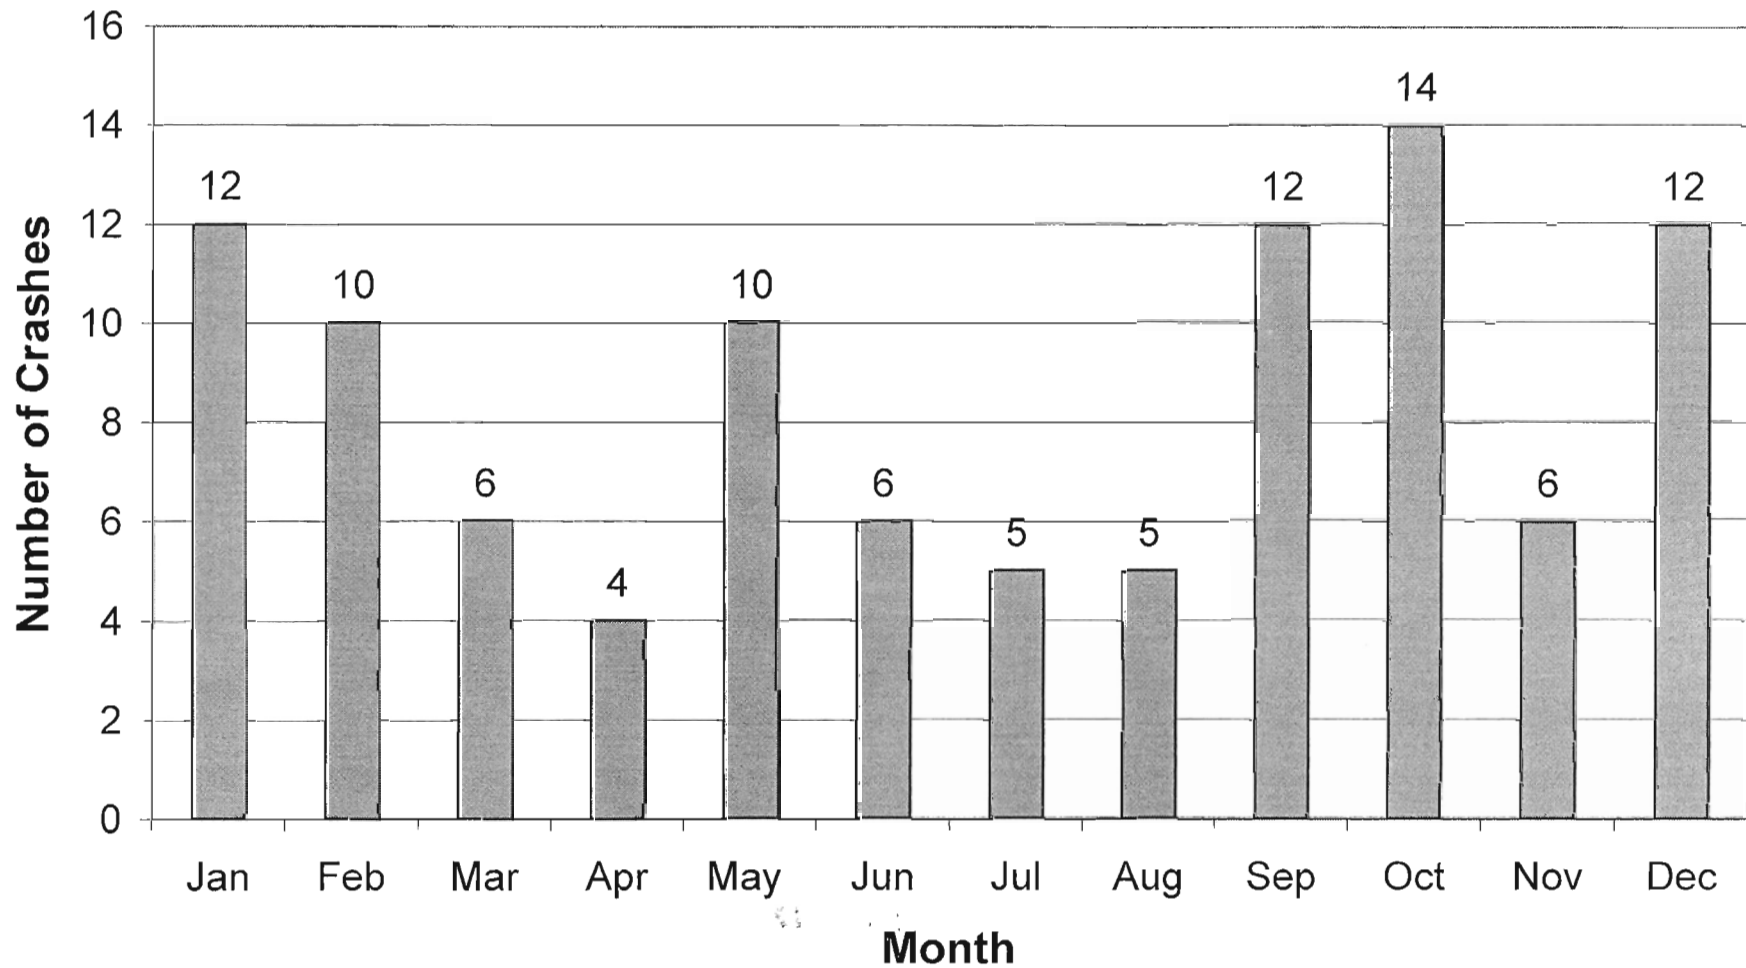
Buck Road (CR 553)

Crash Occurrence by Month

- ♦ The month with the most crashes (14) was October.
- ♦ The day of the week with the most crashes (27) was Friday.
- ♦ The highest frequency of crashes (12) occurred between 6AM-7AM.
- ♦ The percentage of crashes during hours of darkness (34%) is consistent with the statewide average for county roads (approximately 30%).
- ♦ The percentage of crashes for wet surface conditions (17 %) is slightly less than the statewide average for county roads (approximately 24%).
- ♦ The percentage of crashes for snowy or icy surface conditions (19 %) is almost five times higher than the statewide average for county roads (approximately 5%).
- ♦ The percentage of crashes with injuries (27%) is consistent with the statewide

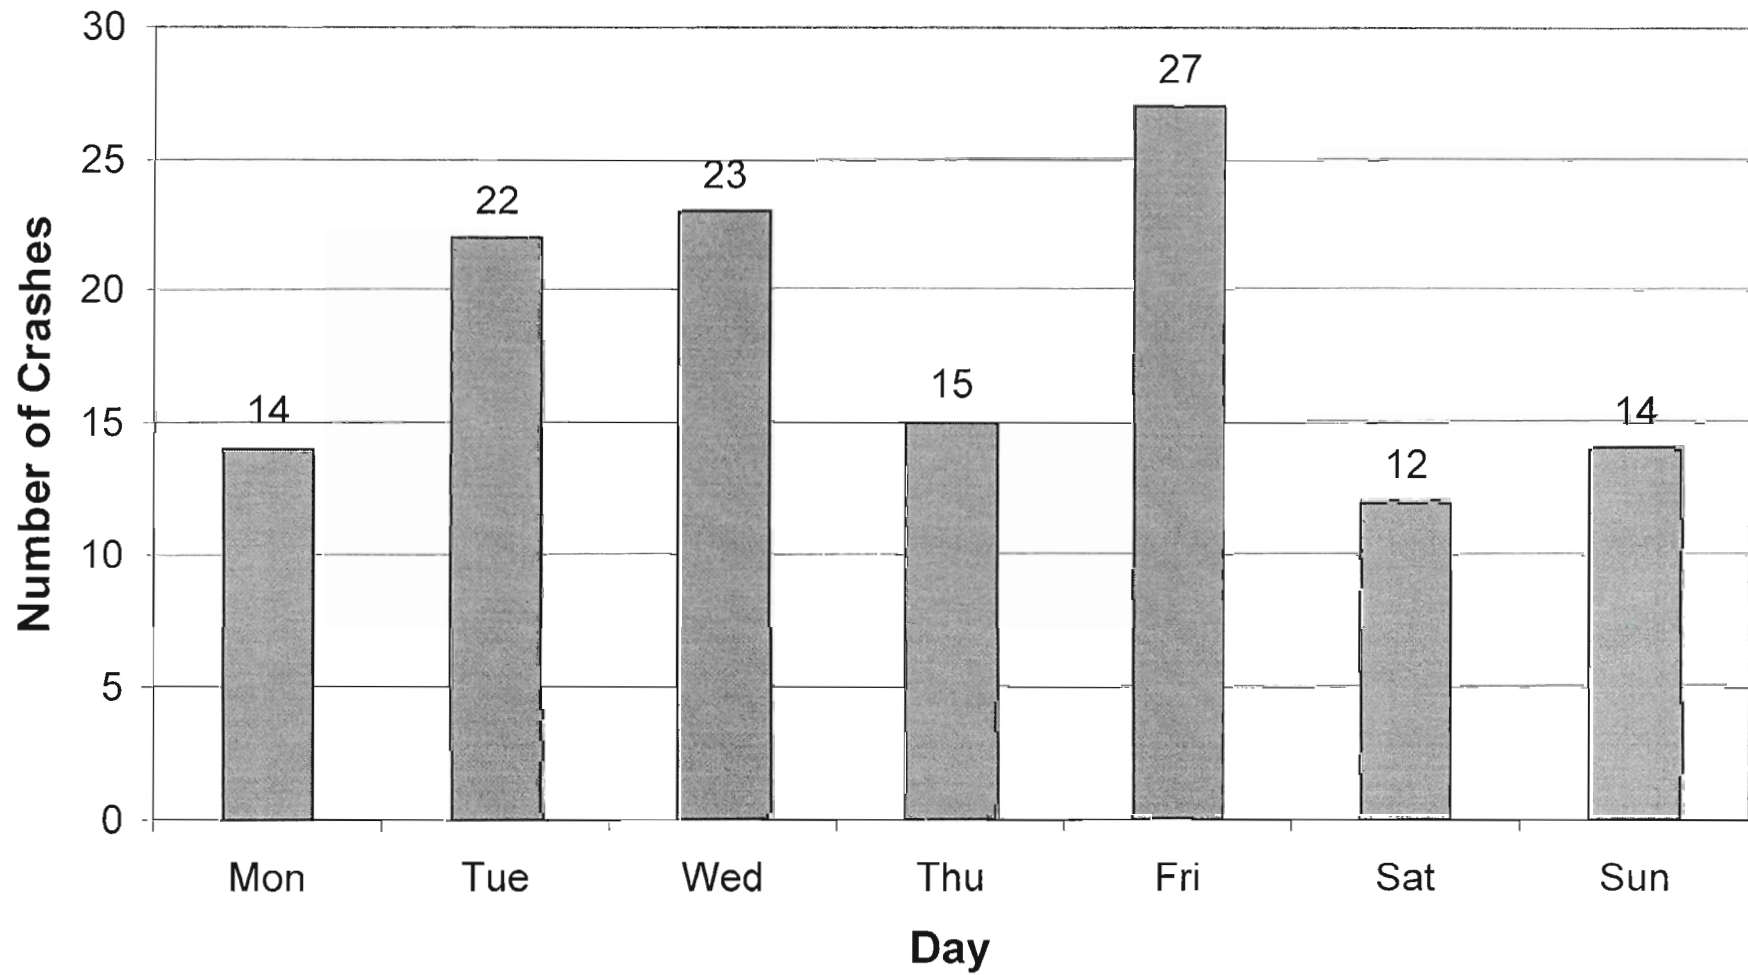
Buck Road (CR 553)
Crash Occurrence by Day of Week

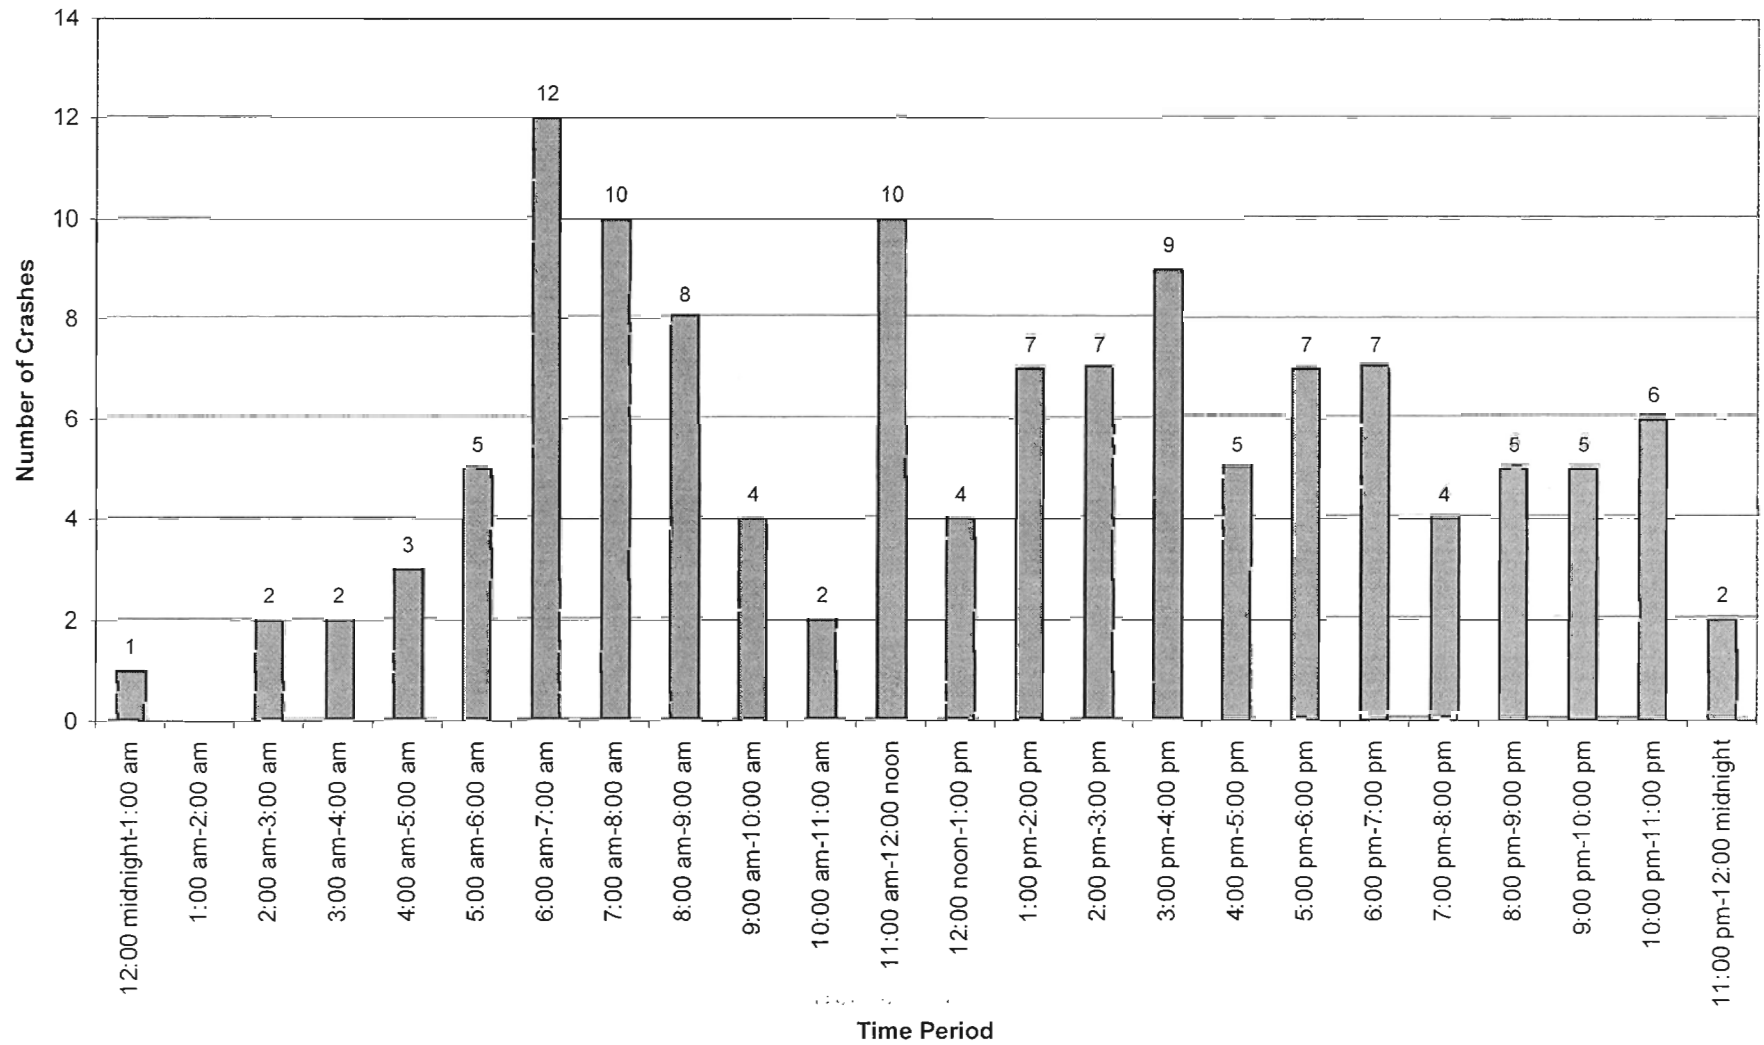
Buck Road (CR 553)
Crash Occurrence by Time of Day

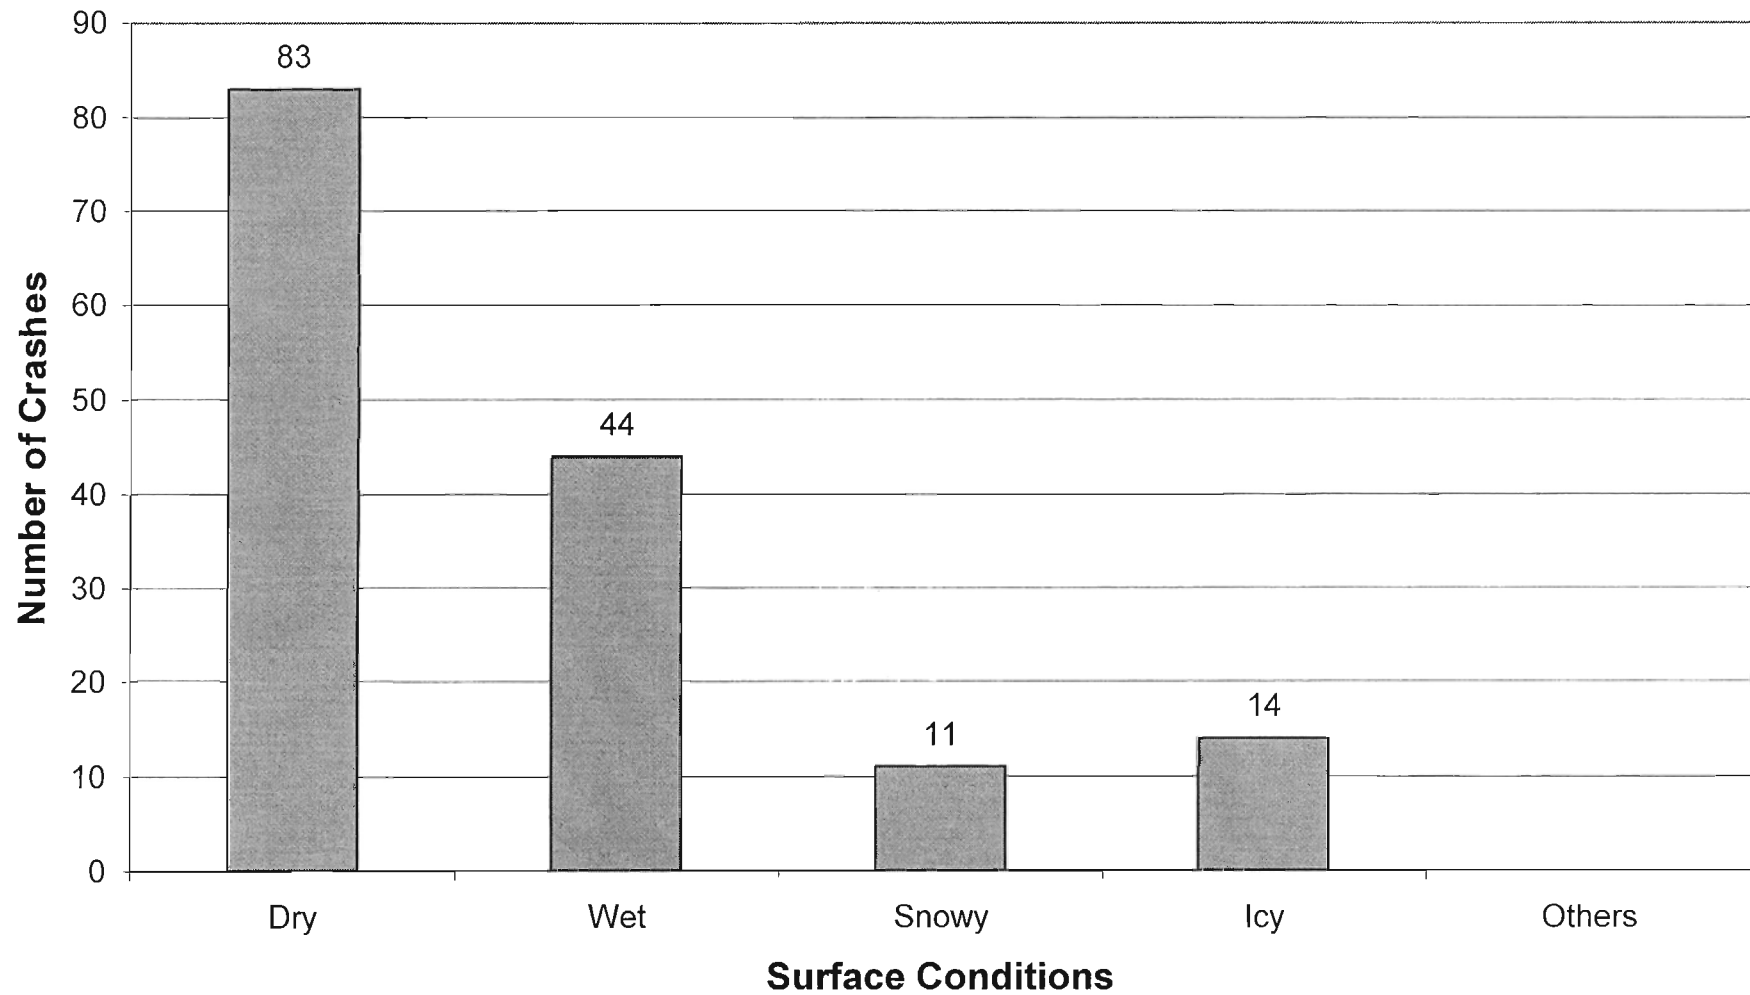
Buck Road (CR 553)
Crash Occurrence by Surface Conditions

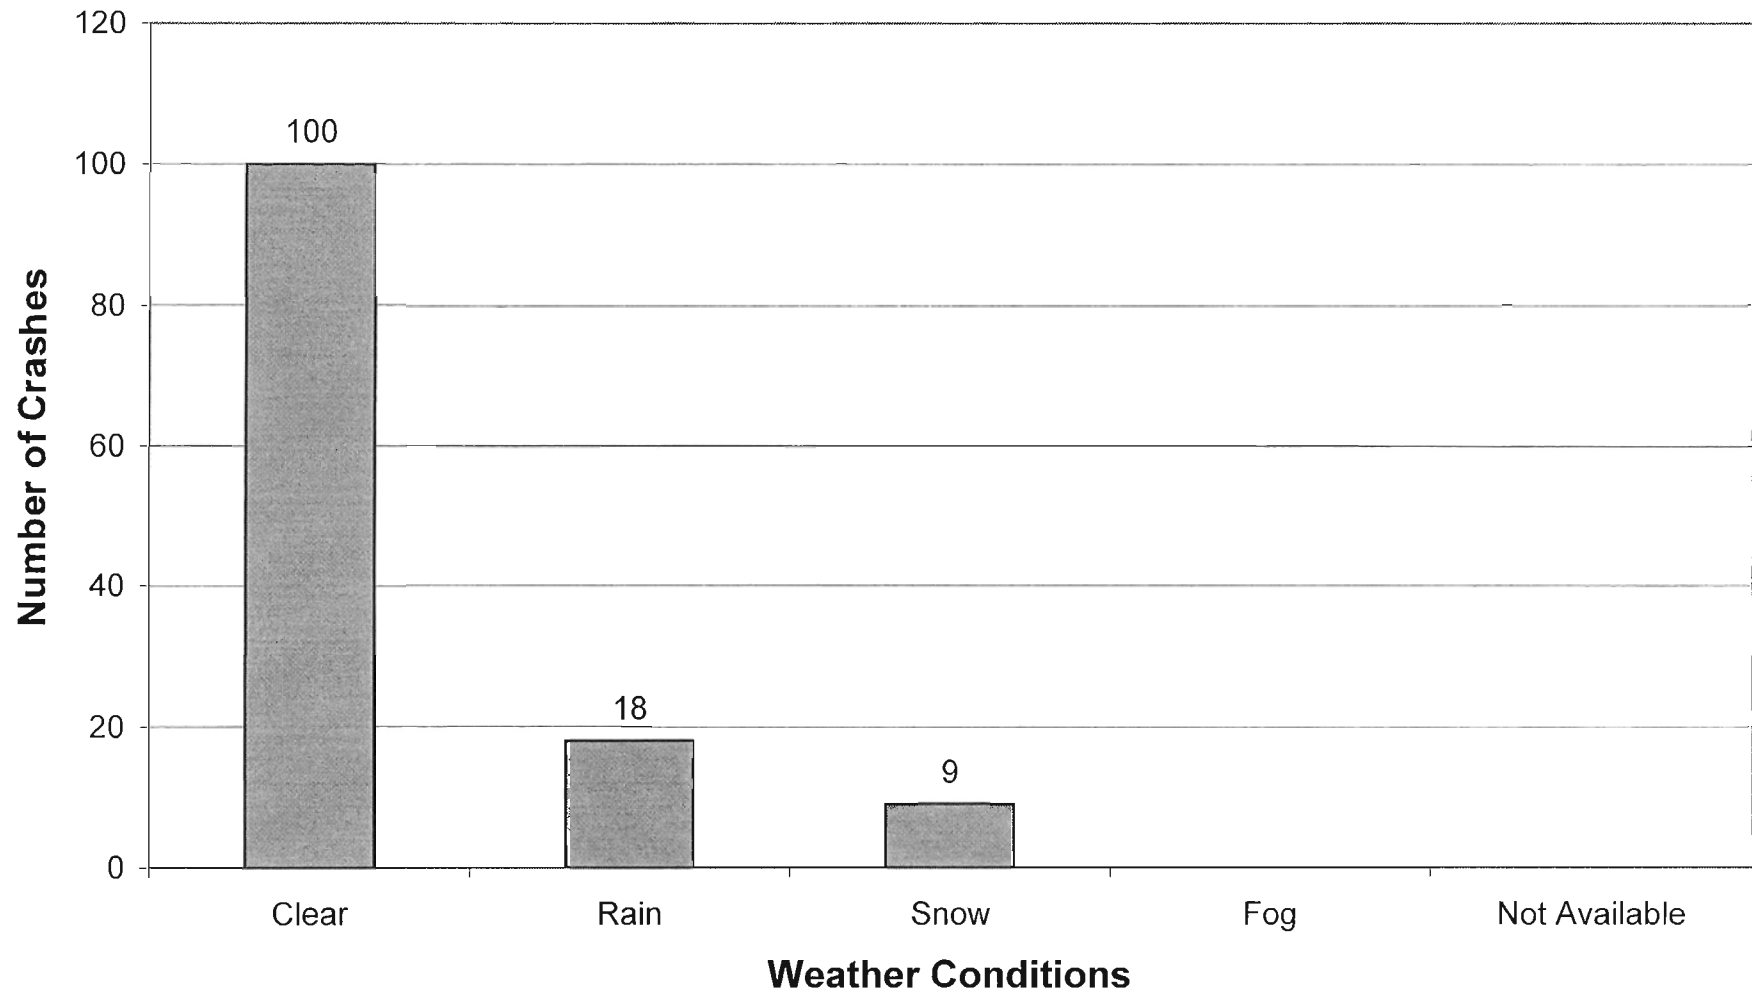
Buck Road (CR 553)
Crash Occurrence by Weather Conditions

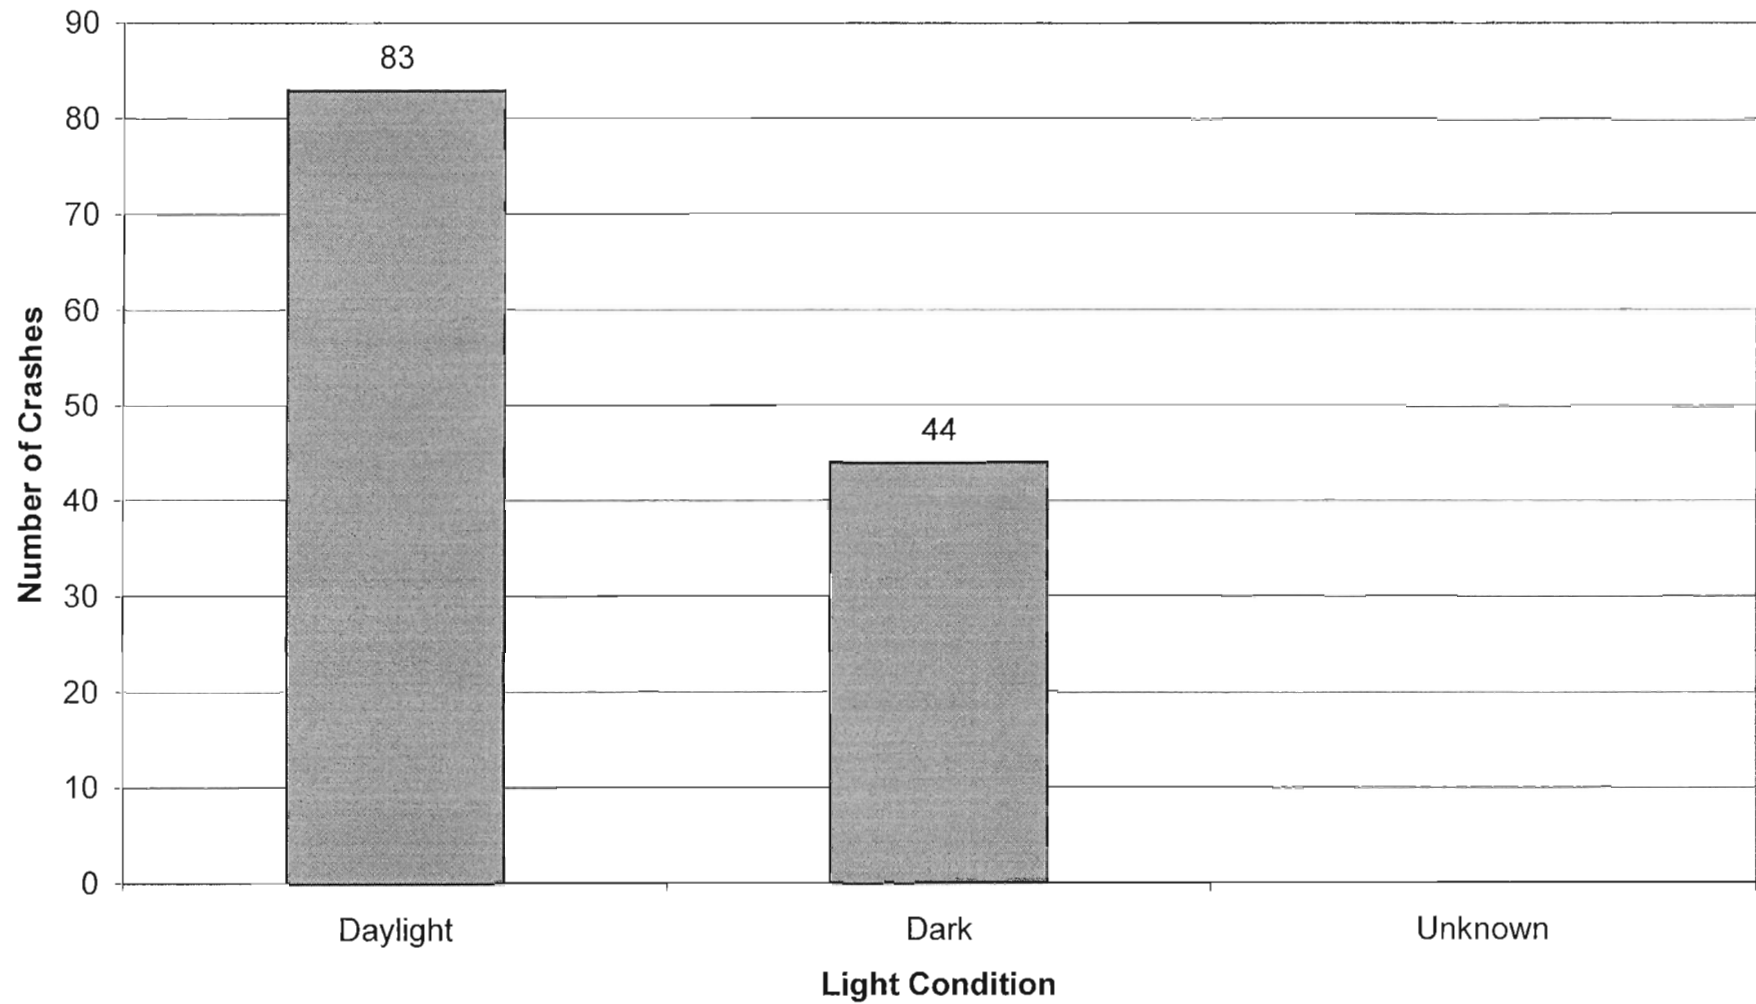
Buck Road (CR 553)
Crash Occurrence by Light Condition

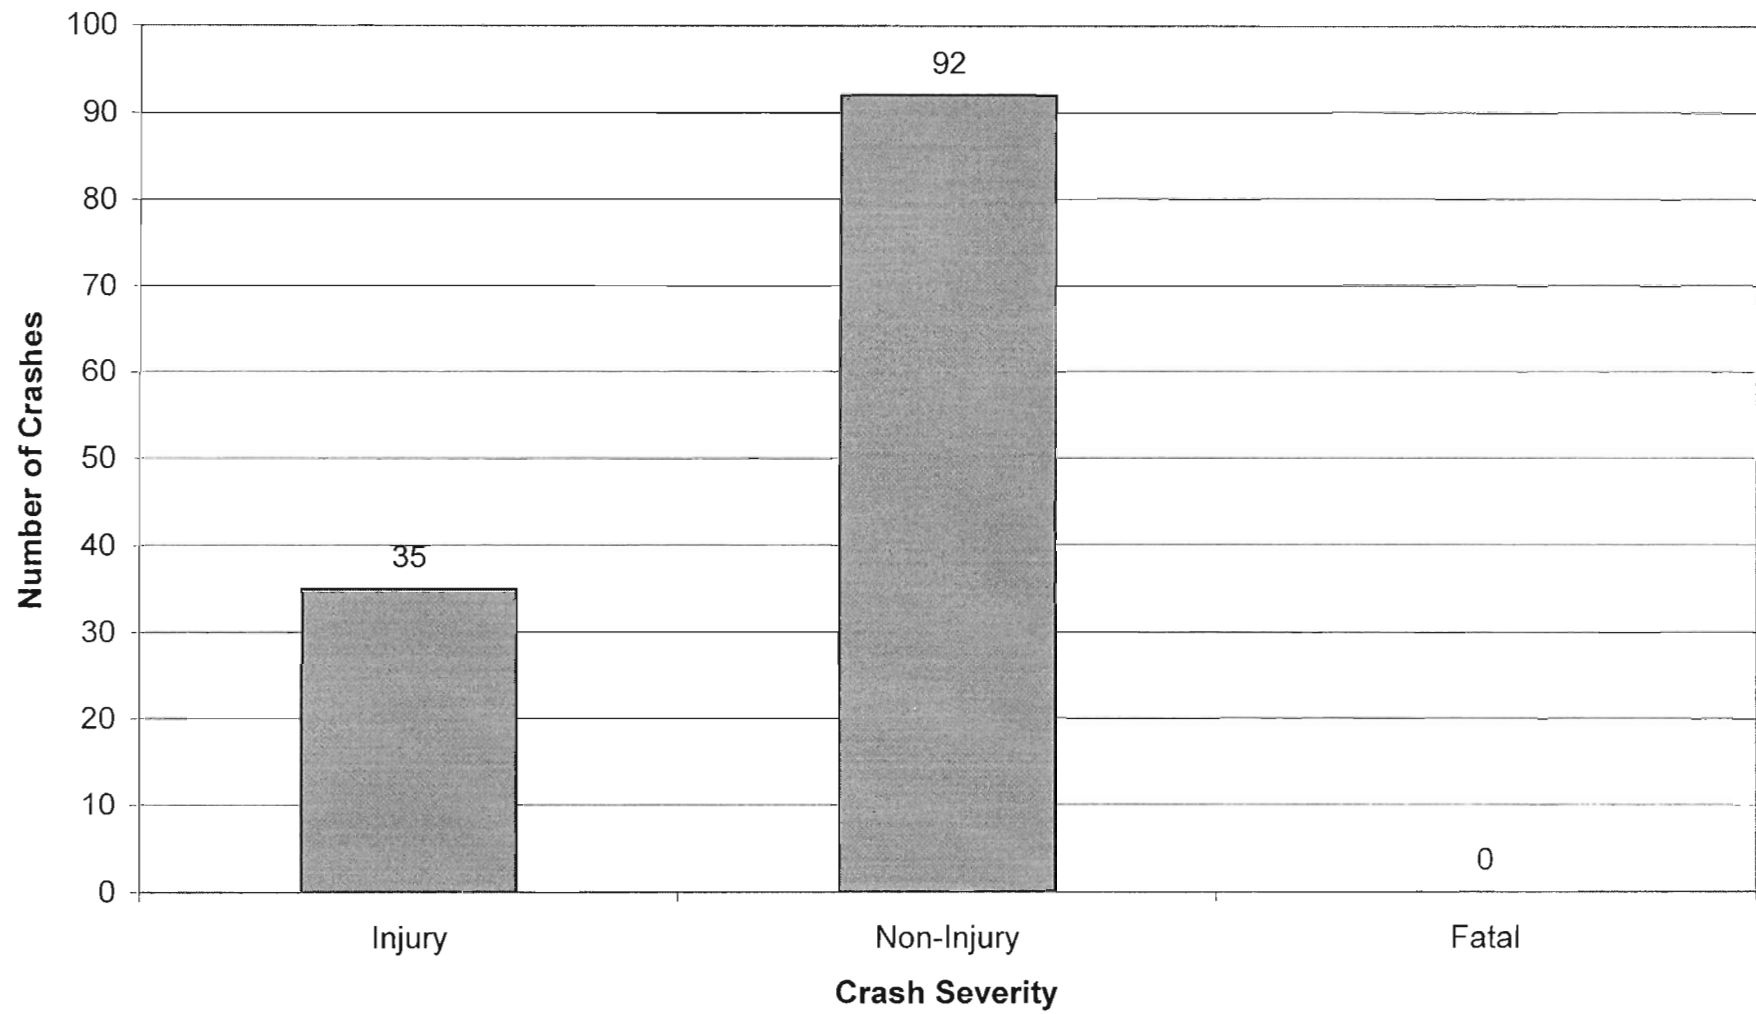
Buck Road (CR 553)
Crash Severity

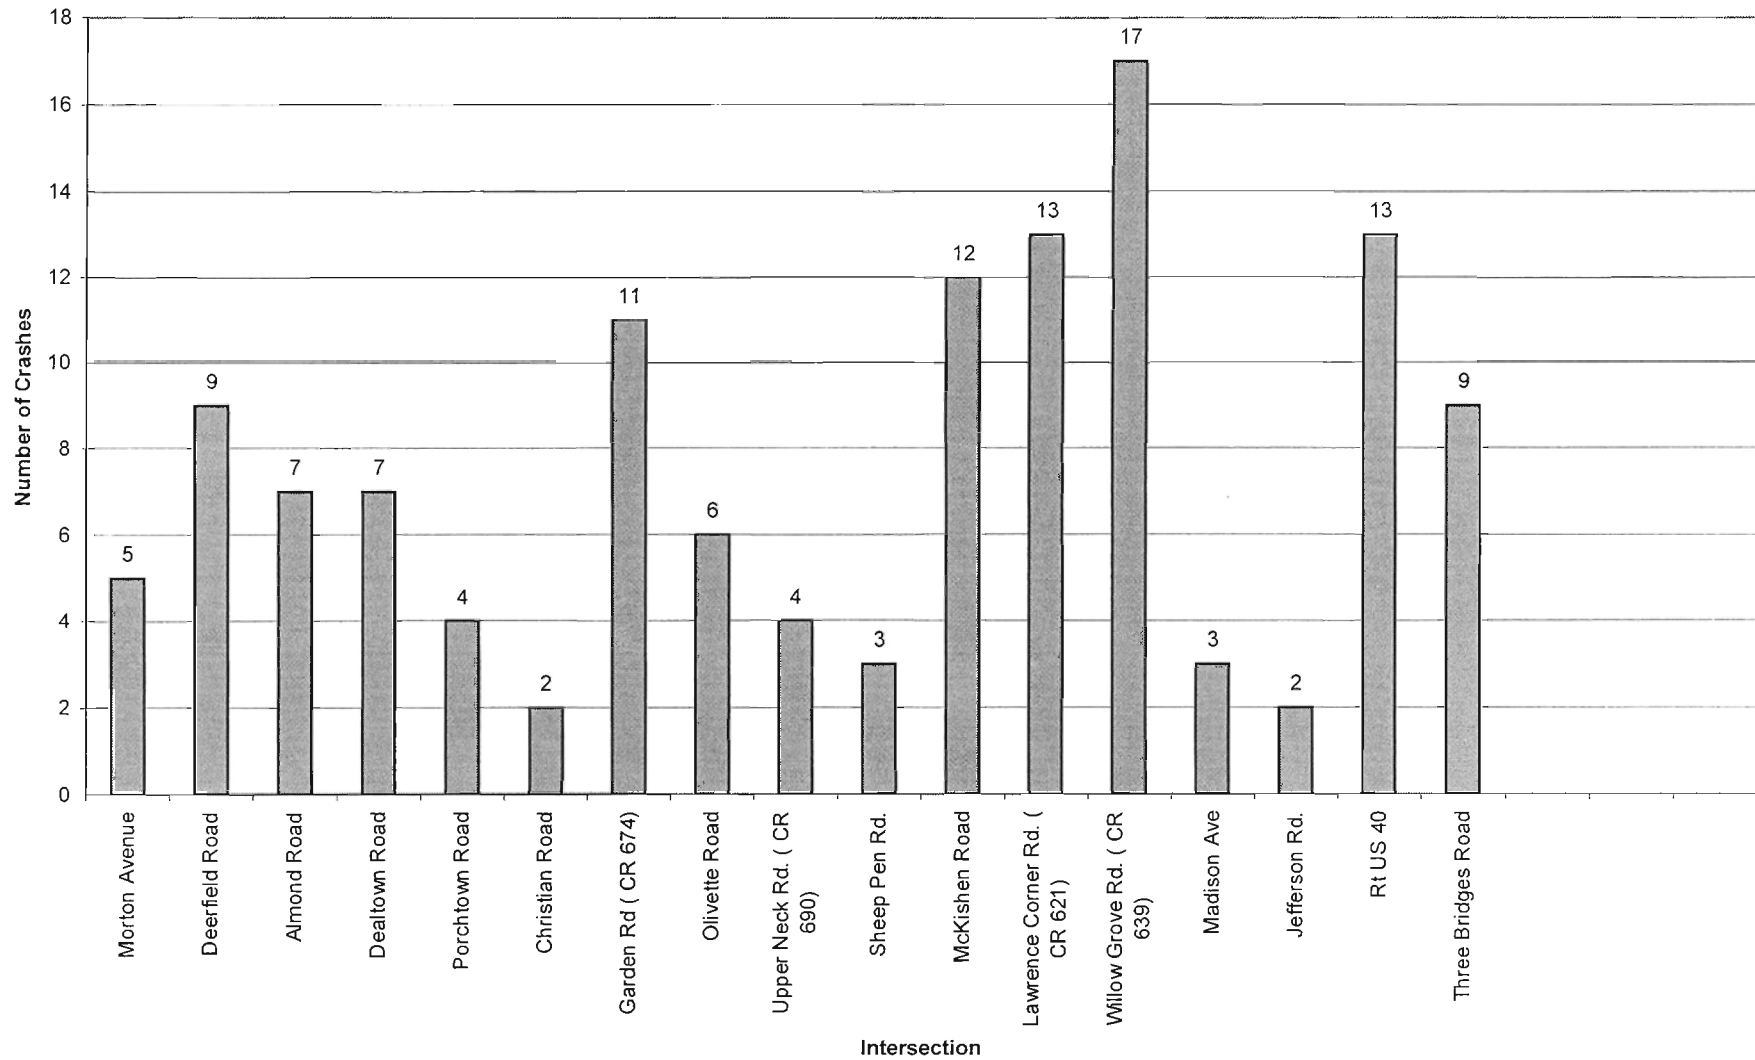
Buck Road (CR 553)
Spot Location of Crashes (Proximity to Nearest Intersection)

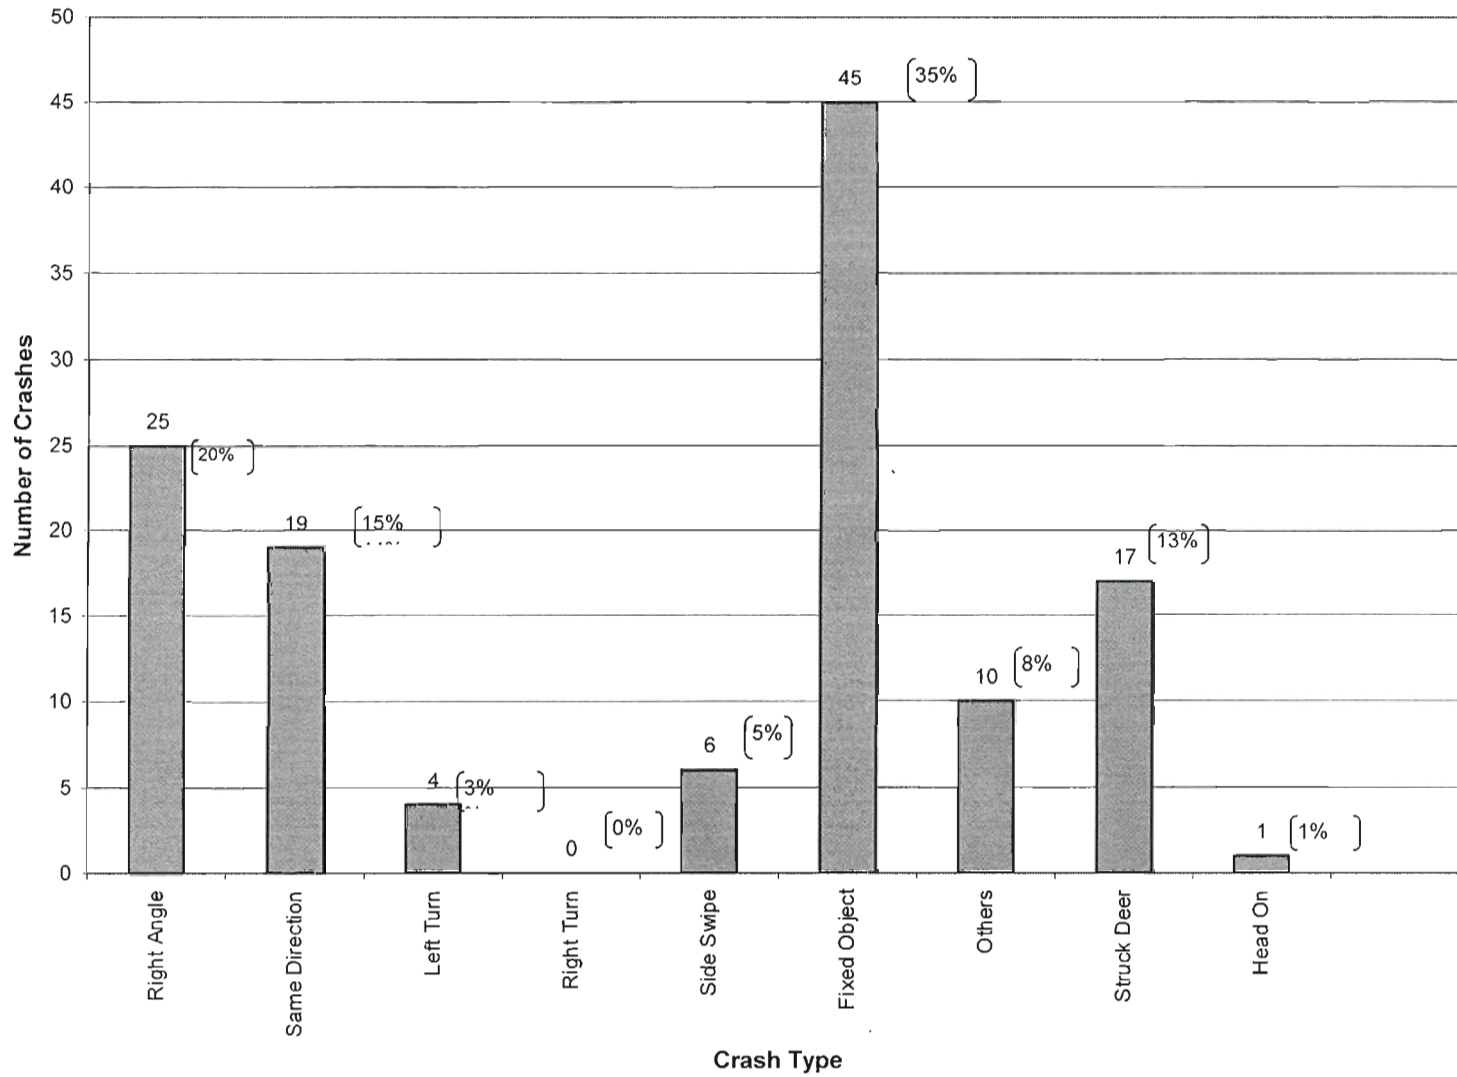
Buck Road (CR 553)
Crash Type

Right Angle	Same Direction	Left Turn	Right Turn	Side Swipe
<u>25</u>	<u>19</u>	<u>4</u>	<u>0</u>	<u>6</u>
Fixed Object	Head On	Other	Struck Deer	Bike
<u>45</u>	<u>1</u>	<u>9</u>	<u>17</u>	<u>1</u>
