Safety Benefits:

Backplates with Retroreflective Borders

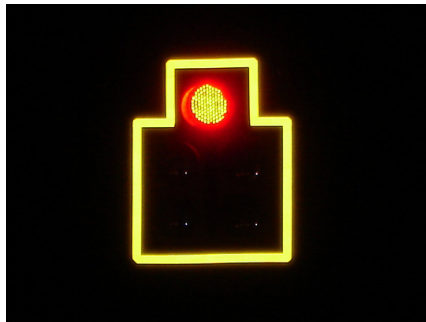
Retroreflective borders are highly visible during the night. Source: South Carolina DOT

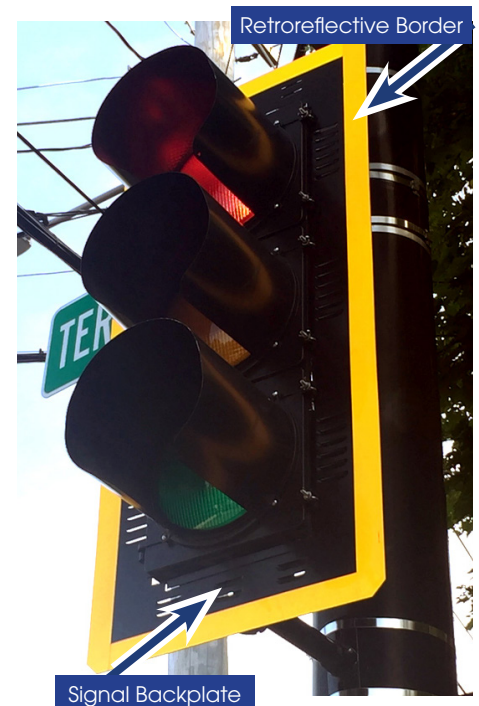
Signal backplate framed with a retroreflective border. Source: FHWA

Backplates added to a traffic signal head improve the visibility of the illuminated face of the signal by introducing a controlled-contrast background. The improved visibility of a signal head with a backplate is made even more conspicuous by framing it with a 1- to 3-inch yellow retroreflective border. Signal heads that have backplates equipped with retroreflective borders are more visible and conspicuous in both daytime and nighttime conditions.
